Recall No: 12106C

Subject: Automatic Transmission Shift Cable

Models: 2008-2010 Chevrolet Malibu

2005-2010 Pontiac G6 2007-2010 Saturn Aura

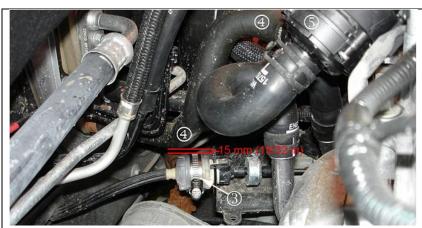
Hybrid vehicle shown. Combustion engine vehicle is similar.

Cable Kit consists of:

- (1) Clam Shell in Two Pieces
- (2) Clam Shell Around Shift Cable Locking Tabs
- (3) Clamp on Clam Shell
- (4) Inlet Coolant Hose and
- (5) Heater Cooler Pump.
