# Technical product information

<b>Topic</b>	New Continental GTC - Power boot close switch - Correct diagnosis
<b>Market area</b>	Worldwide Bentley (1WBE)
<b>Brand</b>	Bentley
<b>Transaction No.</b>	2038255/1
<b>Level</b>	EH
<b>Status</b>	Approval
<b>Release date</b>

## New Continental GTC

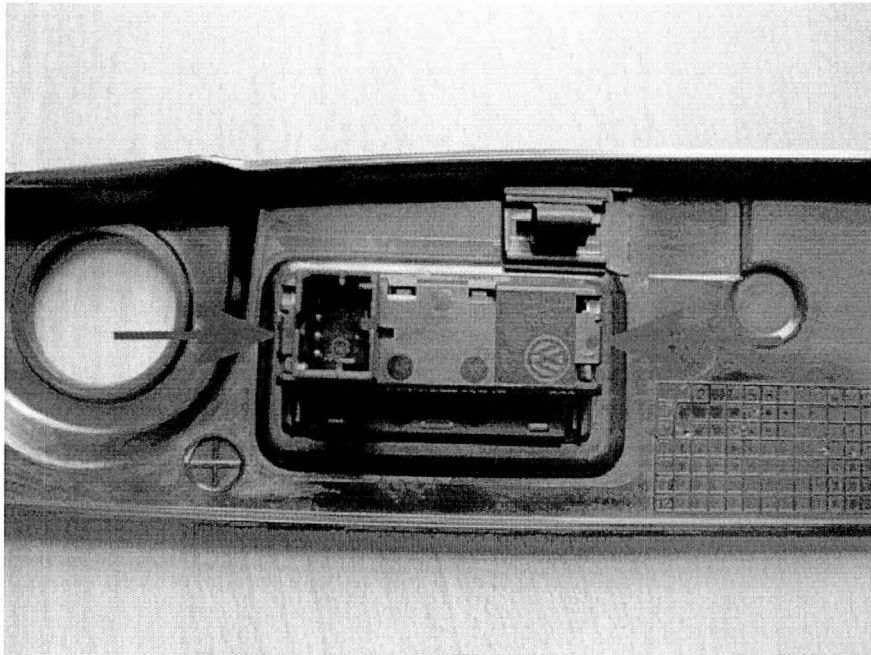
Figure 1

1. Press the boot close switch to confirm the switch does not attempt to close the boot. **NOTE:** Should the boot lid start and attempt to close please still commence with this TPI to test the full serviceability of the switch as the fault within the switch may be intermittent.
2. Remove the boot lid latch cover Refer to Workshop Manual Rep.Gr 70 - Boot lid latch cover panel - To remove and fit
3. Remove the switch from the cover panel by pressing the two retaining clips inboard and remove the switch from the cover panel (Figure 1)

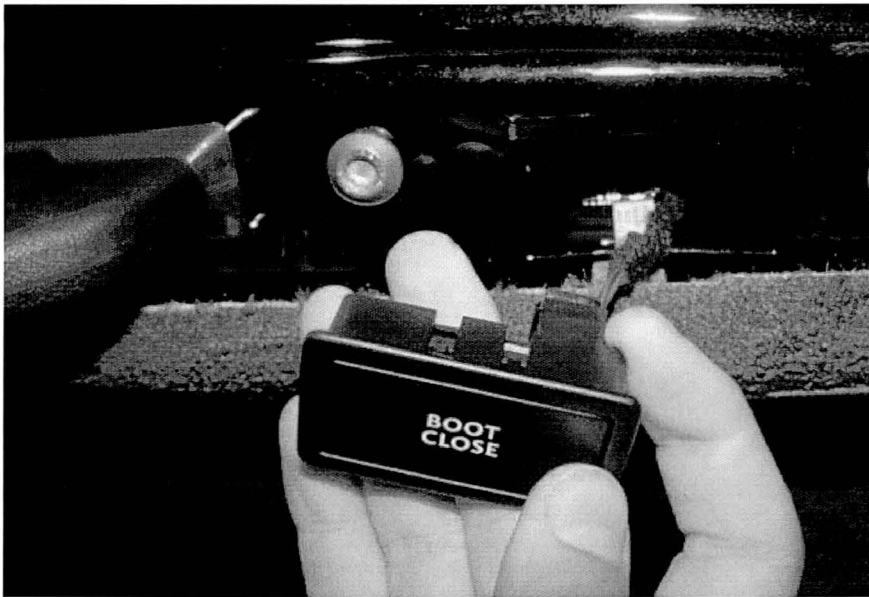
Figure 2

4. Reconnect the switch to the electrical connection (Figure 2) allowing the switch to hang in free air

-With the boot close switch hanging in free air press the switch to check if the boot lid starts to close, should this be the case and the boot lid starts to close the switch is serviceable, you should now proceed with procedure 6 **NOTE:** should the boot not start to close proceed to procedure 5

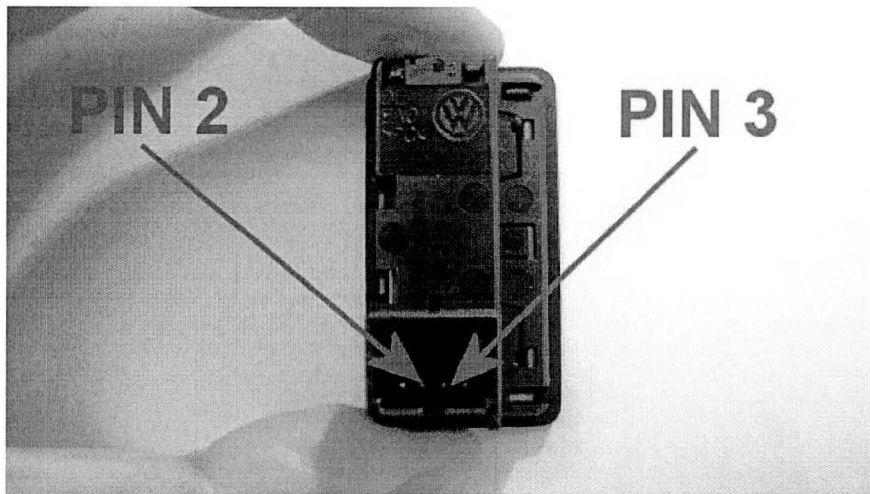
Figure 3

- Measure the resistance between pins 2 and 3 (Figure 3) The button on the boot close switch must be pressed and held in otherwise a correct reading will not be obtained

The resistance for a fully serviceable switch when operated (pressed) is 0.2 Ohms

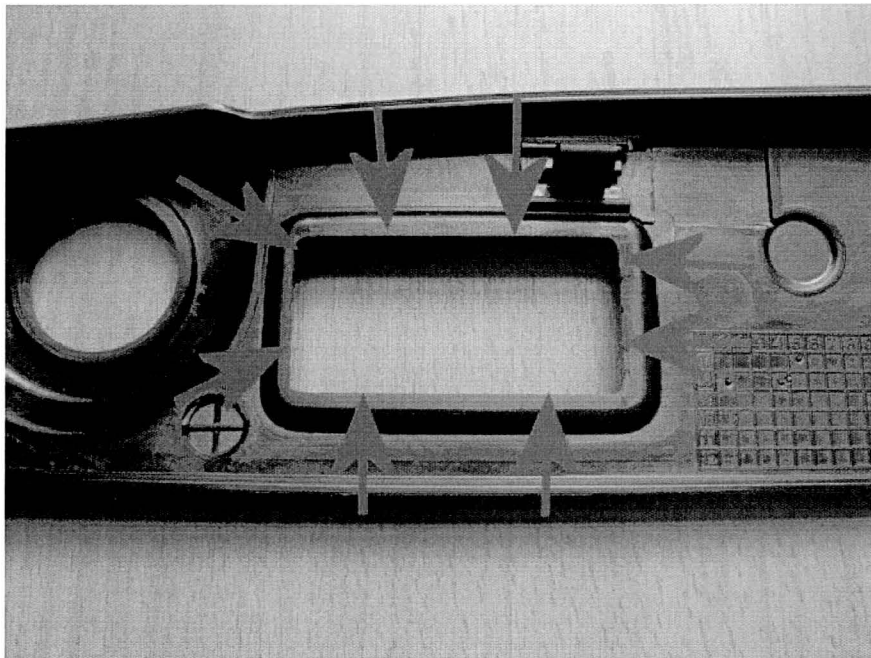
Figure 4

6.Before refitting the existing or new switch it is essential that the switch fits into the cover without any excessive resistance, should there be any burrs or jagged edges around the aperture (Figure 4) you should carefully smooth away any burrs or jagged edges using fine sandpaper taking care not to enlarge the aperture

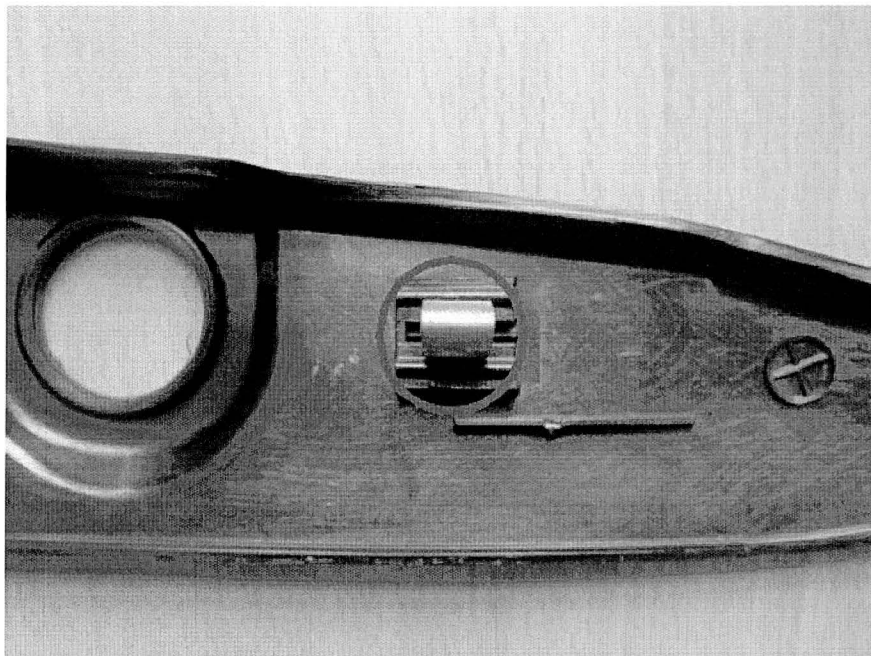
Figure 5

7. Refit the switch into the aperture ensuring correct orientation and the two clips are fully locked into position  
 -Check that the latch cover clips are centrally positioned before refitting the latch cover (Figure 5)
