| Topic | GTC hood ram – cover deletion (SC14/13) |
| Brand | Bentley |
| Campaign number | EA13 |
| Type | Service campaign |

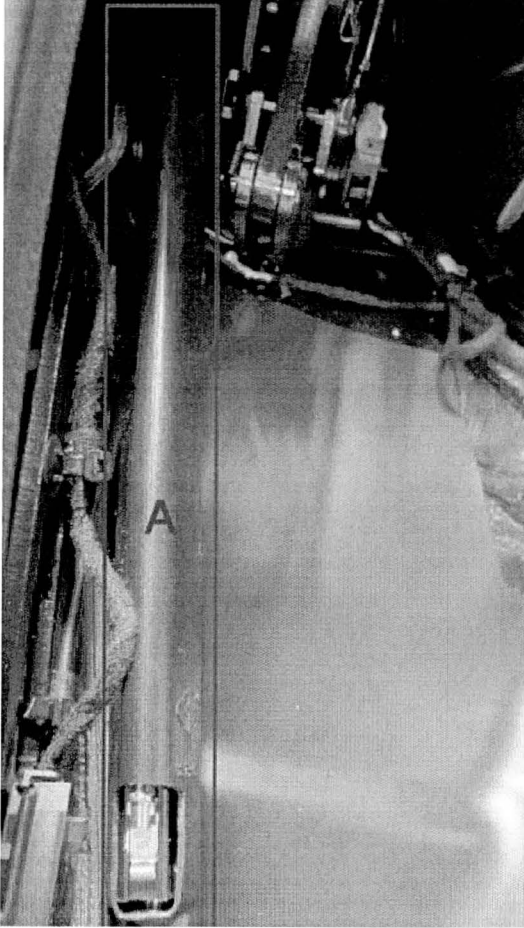
Figure 2

2. Identify the plastic cover 'A' fitted to the tonneau ram (see Figure 2)

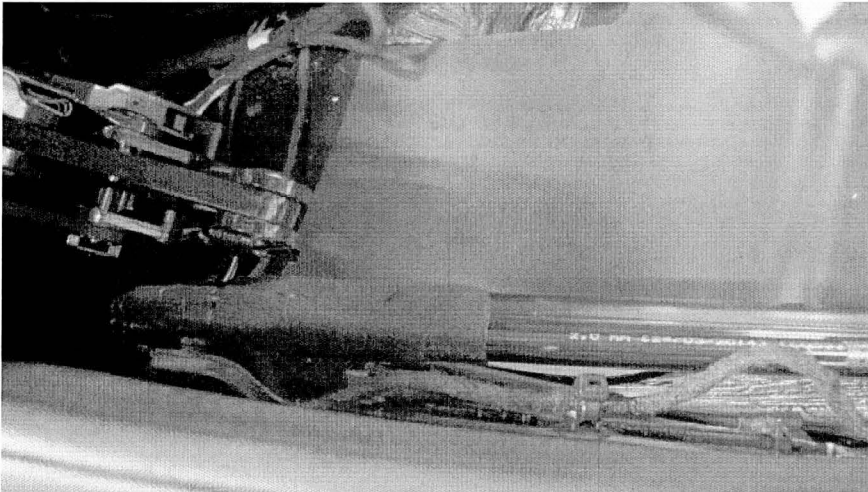
Figure 8 shows the completed taping exercise
