Field campaign

Topic	Tonneau micro switch – mounting bush orientation (SC14/21)
Market area	Bentley: worldwide (2WBE)
Brand	Bentley
Transaction No.	2037971/1
Campaign number	EA21
Note	
Type	Workshop campaign
US code

New Continental GT Convertible

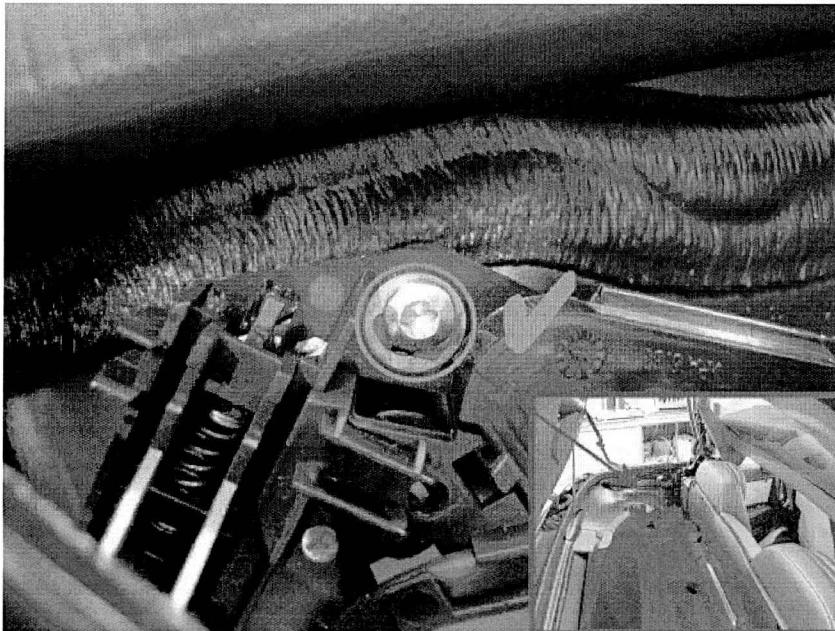
Figure 2

2. Referencing figure 2 locate the tonneau cover hinge micro switch assembly, it is located on the left hand tonneau hinge

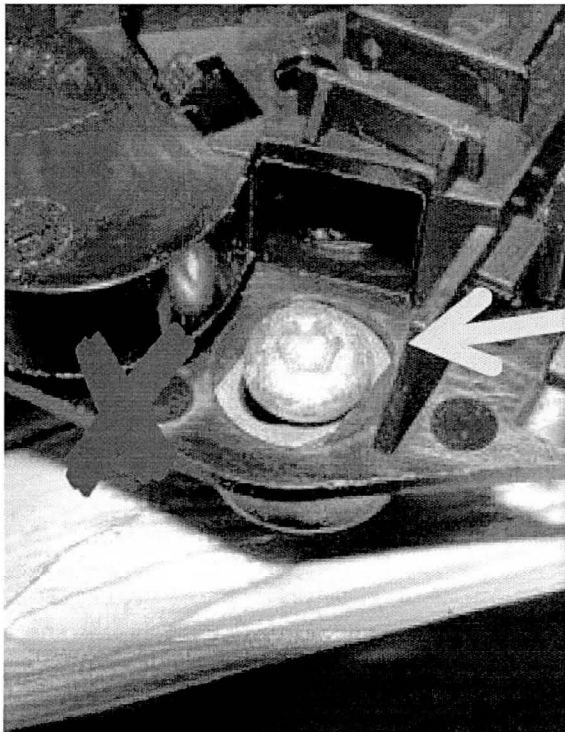
3. Inspect the tonneau cover hinge microswitch assembly securing bush. Figure 2 shows the correctly oriented brass bush with the fastener head bearing on the 'top hat' section of the brass bush. Figure 3 depicts an incorrectly manufacture assembly where the brass bush is inverted and the top hat section is not visible. This failure will result in the switch housing assembly lifting off the bush resulting in the convertible roof failing to operate
