Technical product information

| Topic | New Continental GT - Power boot close switch - Correct diagnosis |
| Transaction No. | 2038253/1 |

New Continental GT

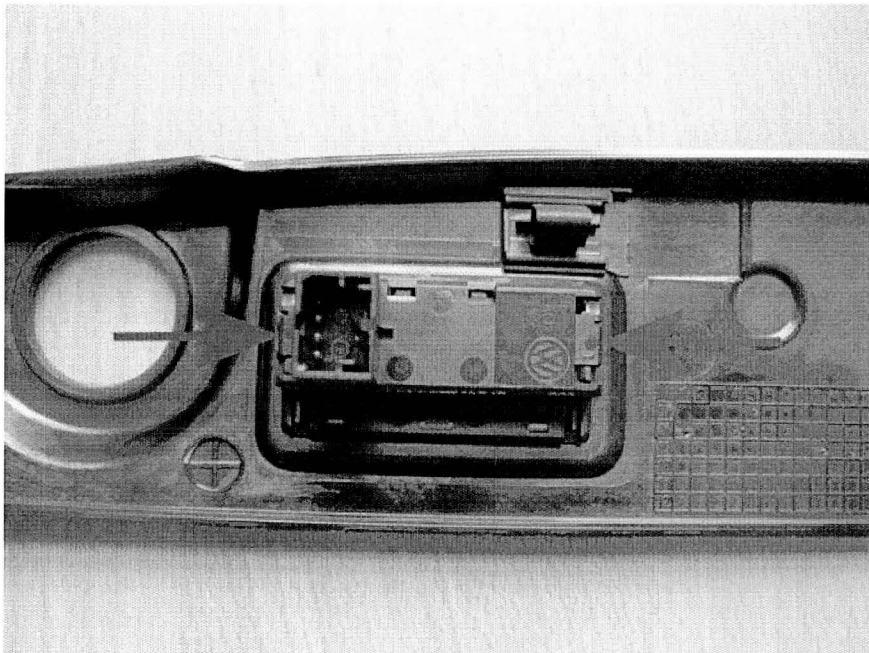
Figure 1

1. Press the boot close switch to confirm the switch does not attempt to close the boot. **NOTE:** Should the boot lid start and attempt to close please still commence with this TPI to test the full serviceability of the switch as the fault within the switch may be intermittent.
2. Remove the boot lid latch cover - Refer to Workshop Manual Rep.Gr 70 - Boot lid latch cover panel - To remove and fit
3. Remove the switch from the cover panel by pressing the two retaining clips inboard and remove the switch from the cover panel (Figure 1)

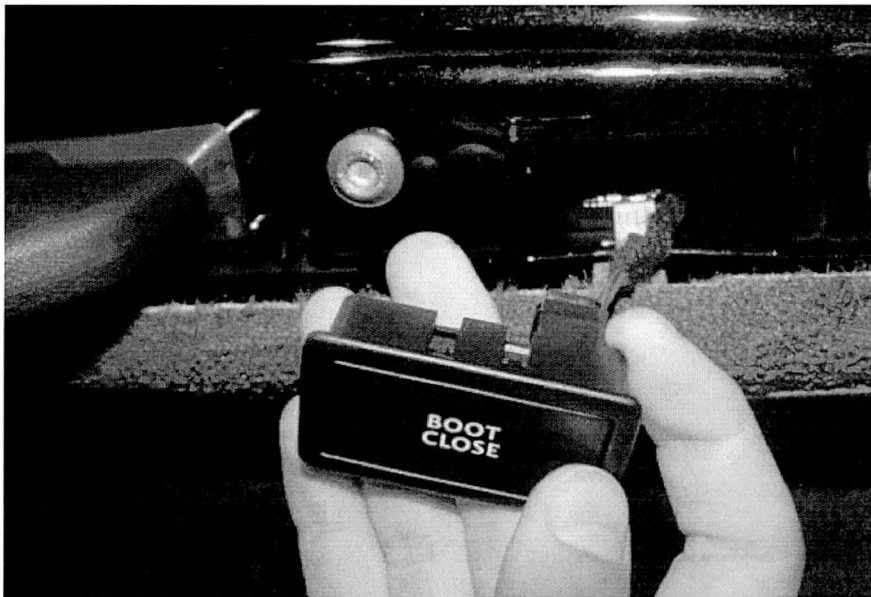
Figure 2

4. Reconnect the switch to the electrical connection (Figure 2) allowing the switch to hang in free air

-With the boot close switch hanging in free air press the switch to check if the boot lid starts to close, should this be the case and the boot lid starts to close the switch is serviceable, you should now proceed with procedure 6 **NOTE:** should the boot not start to close proceed to procedure 5

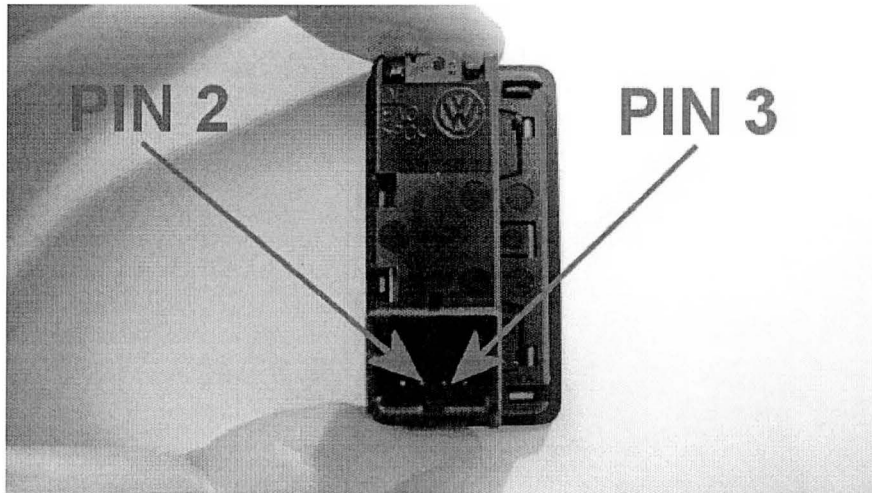
Figure 3

- Measure the resistance between pins 2 and 3 (Figure 3) The button on the boot close switch must be pressed and held in otherwise a correct reading will not be obtained

The resistance for a fully serviceable switch when operated (pressed) is 0.2 Ohms

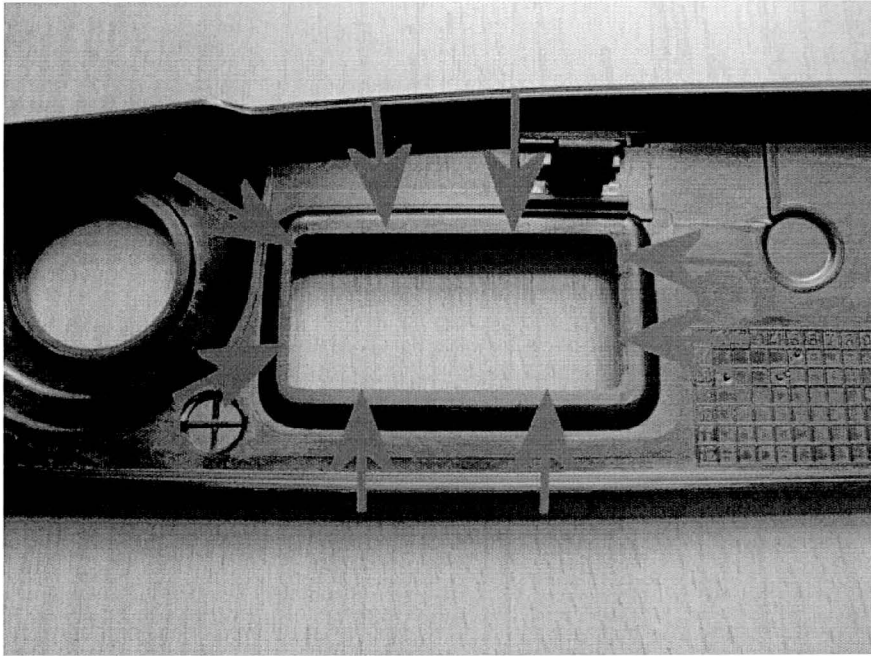
Figure 4

6.Before refitting the existing or new switch it is essential that the switch fits into the cover without any excessive resistance, should there be any burrs or jagged edges around the aperture (Figure 4) you should carefully smooth away any burrs or jagged edges using fine sandpaper taking care not to enlarge the aperture

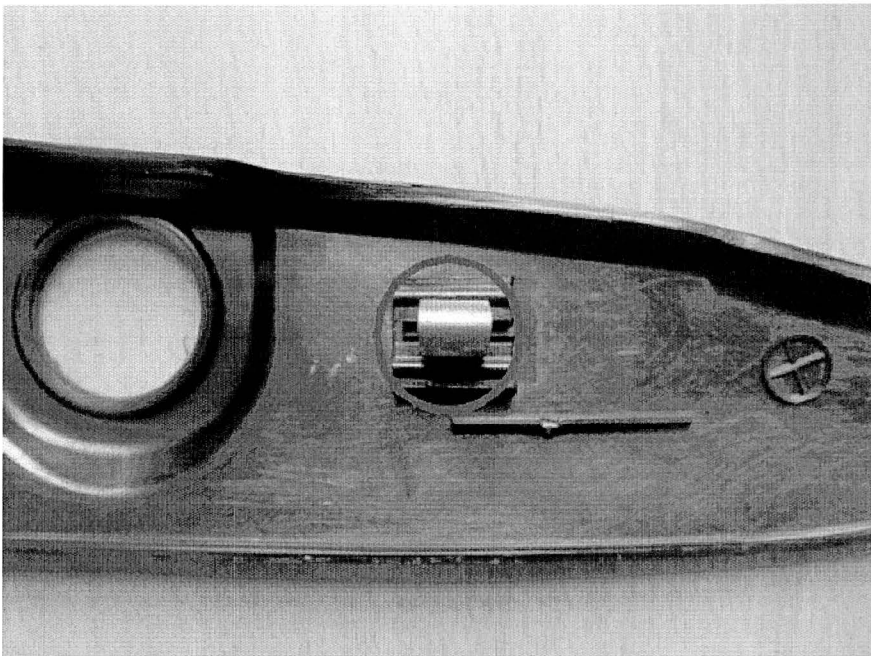
Figure 5

7. Refit the switch into the aperture ensuring correct orientation and the two clips are fully locked into position
 -Check that the latch cover clips are centrally positioned before refitting the latch cover (Figure 5)
