48 Power steering warning in cluster, DTC for low starting voltage

48 13 53 2035178/1 September 10, 2013.

Model(s)	Year	VIN Range	Vehicle-Specific Equipment
A4, A5, A5 Cab, Q5	2013	All	Not Applicable

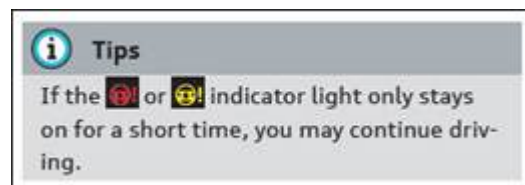
Figure 1. Owner's Manual Tip

- The message could be either of the following, as illustrated in the owner's manual (Figure 1):
 - A yellow steering warning symbol with the message "Steering fault. You can continue driving."

- A red steering warning symbol with the message "Steering defective. Do not drive the vehicle."
- One of the following symptom codes may be stored in the diagnostic log under the power steering control module, J500 (address word 44):

- 2305** (restricted function through low starting voltage)
 - 2306** (restricted function through low starting voltage)

The vehicle system voltage drops when the starter motor is operating. Because the power steering control module has a parallel circuit with the starter motor (terminal 29), this normal voltage drop may set a symptom code within the scenario described in the *Condition* section of this bulletin.

1. Do not replace the steering gear for this condition.
2. Ensure that the power steering control module, J500 (address word 44), already has software version 0507. If the software version is under 0507, perform campaign 48K8 before proceeding to the next step.

3. Update the software using the instructions below.
