Field campaign

Topic	V8T engine oil leak check (SC12/08)
Market area	Worldwide Bentley (1WBE)
Brand	Bentley
Transaction No.	2031047/1
Campaign number	E768
Note	
Type	
US code

Continental GT and GTC with V8T engine

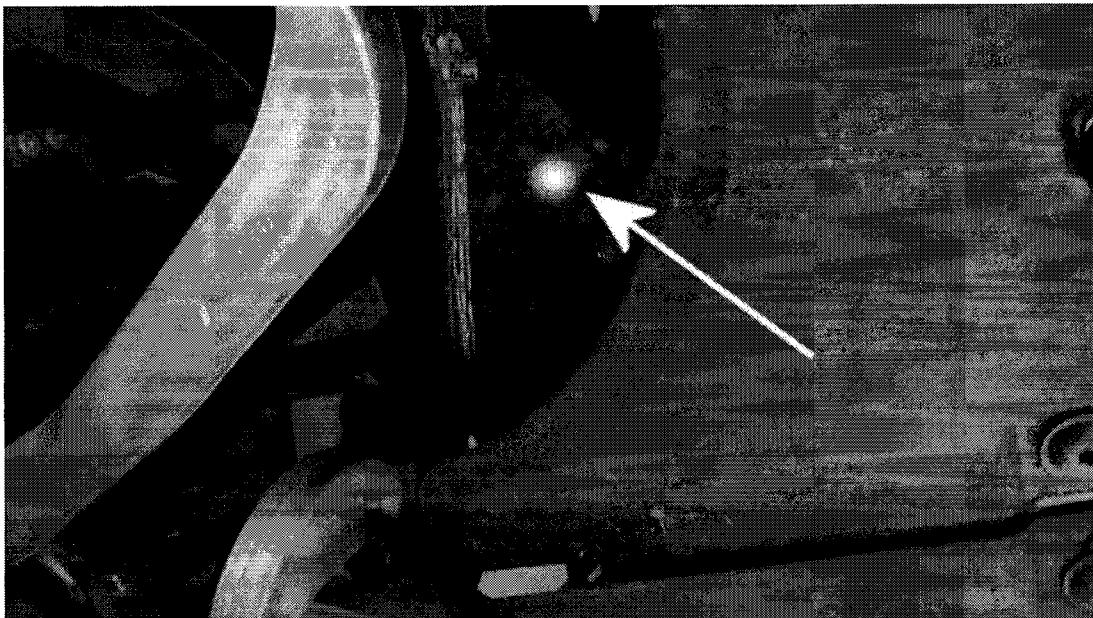
If the vehicle is not already listed as repaired in the "Repair history" (in Elsa pro), check for the campaign identification mark which is a small White paint completion mark located on the left hand lower face of the front sub frame (Figure 1) should neither be evident carry out the required work in accordance with the instructions

-Should no leak be evident, refit the undersheet and place a white paint completion mark as shown in Figure 1 on the left hand lower face of the front sub frame.

White paint completion mark as shown in Figure 1

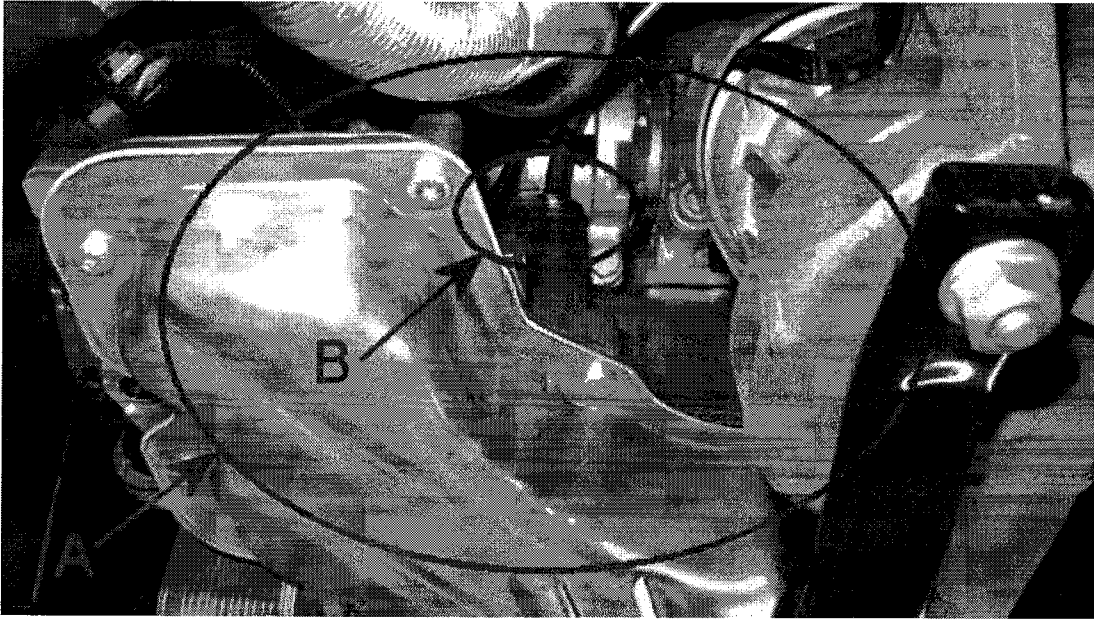
The possibility of an engine oil leak has been identified on the Continental V8T around the base of the engine oil dipstick tube.

2. Referring to Figure 2 check for any evidence of an engine oil leak within the area circled (point A), particular attention should be made around the base of the dipstick tube (point B)

-If an engine oil leak is evident from the area described raise a DISS ticket including as much information as possible please also include photographs and await clarification from your TSC before commencing with any other work.
