## Field campaign

<b>Topic</b>	Mulsanne - Bottle cooler - Refrigeration performance check (SC12/14)
<b>Market area</b>	Russische Föderation (5RU), Russian Federation 935 Volkswagen Group RUS (6935), United Kingdom E01 Bentley UK (6E01), Germany E02 Bentley rest Europe (6E02), United States E05 Bentley USA and rest America (6E05)
<b>Brand</b>	Bentley
<b>Transaction No.</b>	2031363/1
<b>Campaign number</b>	E774
<b>Note</b>	
<b>Type</b>	
<b>US code</b>

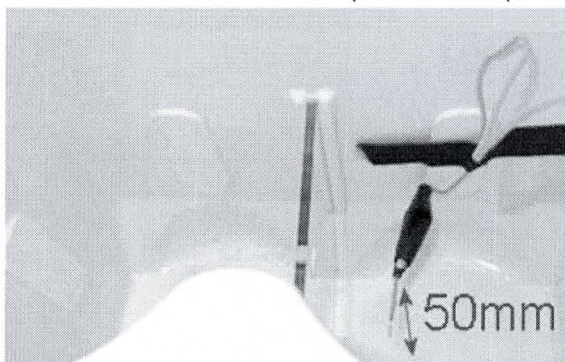
Figure 1

2. A calibrated temperature measuring device, temperature probe or thermocouple, should be positioned inside the cooler cabinet 50mm above the base of the unit (see Figure 1) or alternatively the thermocouple can be taped directly to the outside surface of a glass bottle at a height of 50mm from the base of the bottle. This bottle can then be placed inside the cooler cabinet

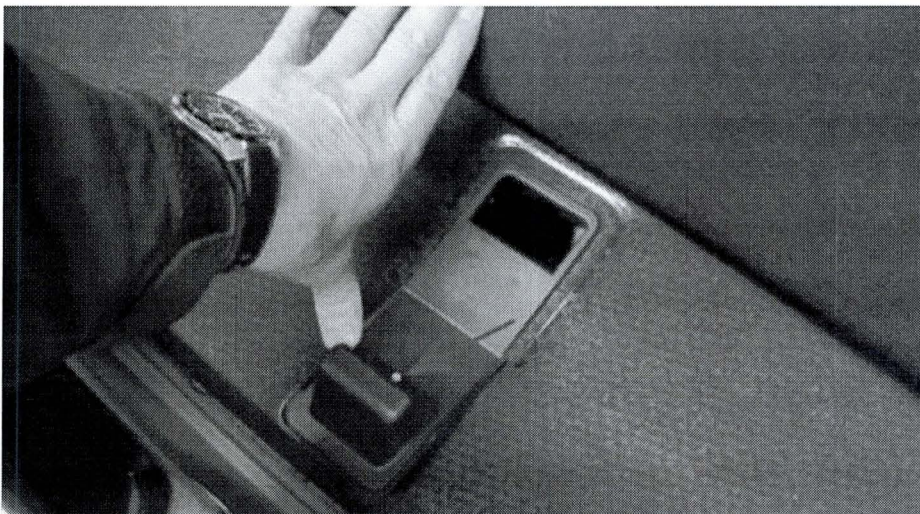
**Figure 3**

On completion apply a white paint mark to the underside of the spare wheel access handle

7. If the temperature achieved are within the specification detailed above then apply a white paint completion mark to the underside of the spare wheel access handle (see Figure 3). If the temperatures are outside of this specification submit a DISS BAID attaching the completed table quoting the TPI number and await instructions from your TSC
