# Service Bulletin

Bulletin No.: 16-NA-001

**Subject:** Sharp Edge on Underside of Trunk Shelf

Brand:	Model:	Model Year:		VIN:		Engine:	Transmission:
		from	to	from	to		
Buick	LaCrosse	2015	2016			All	All

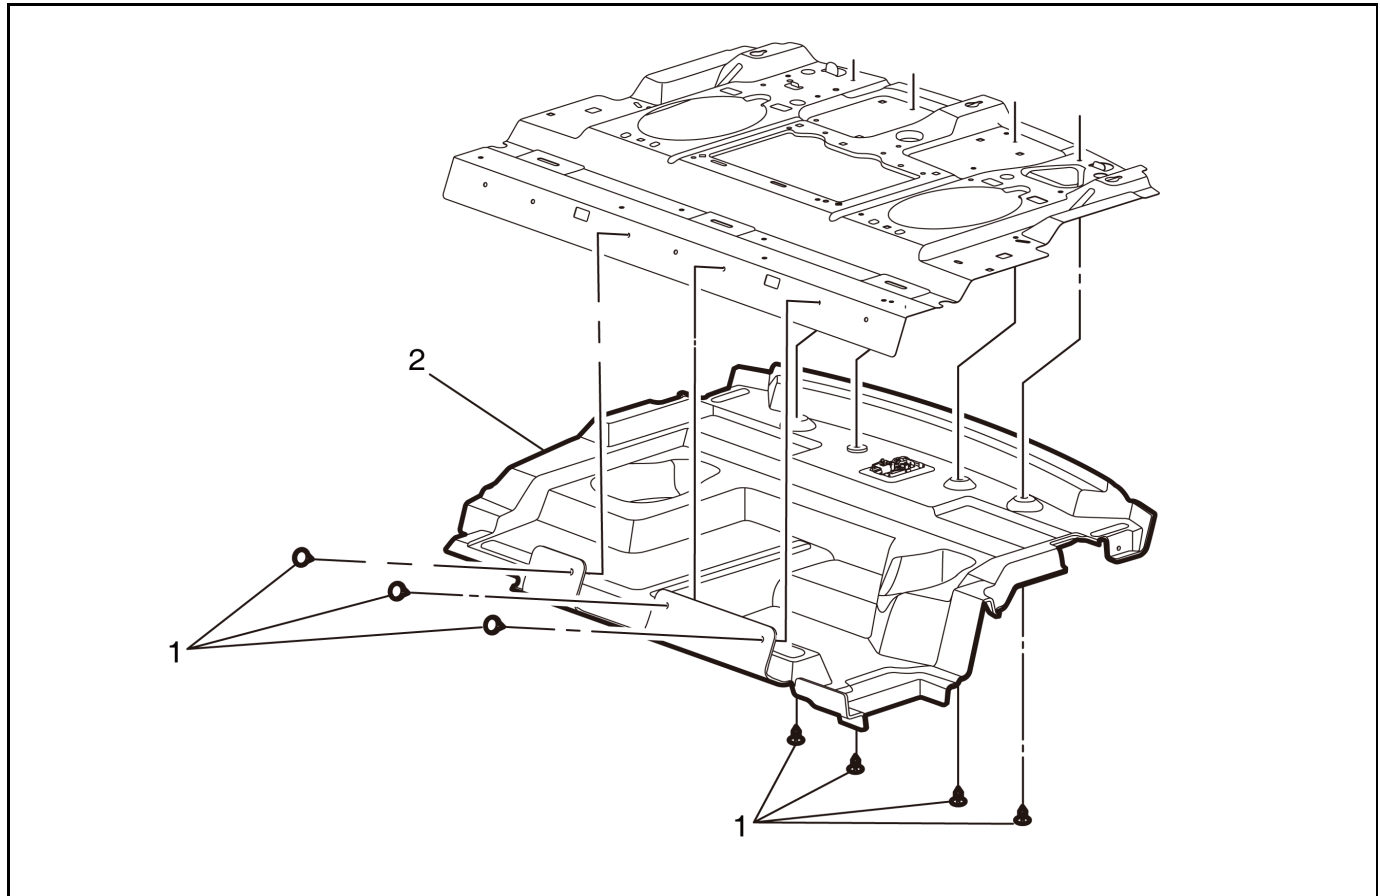
3291448

<b>Condition</b>	Some customers may comment on a sharp edge on the underside of the trunk shelf.
<b>Cause</b>	This may be caused by the underside trim piece (rear window panel storage compartment cover) being removed from some vehicles, leaving a sharp edge.
<b>Additional Options</b>	Equipped with RPO U65 or UQS

If you encounter a vehicle with the above concern, install the rear window panel stowage compartment cover. Refer to Rear Window Panel Stowage Compartment Cover Replacement in SI for installation instructions.
