NUMBER: 23-015-16 REV. A

Water On Front Carpet Or In Rocker Side Sill

2015 - 2016 (KL) Jeep Cherokee

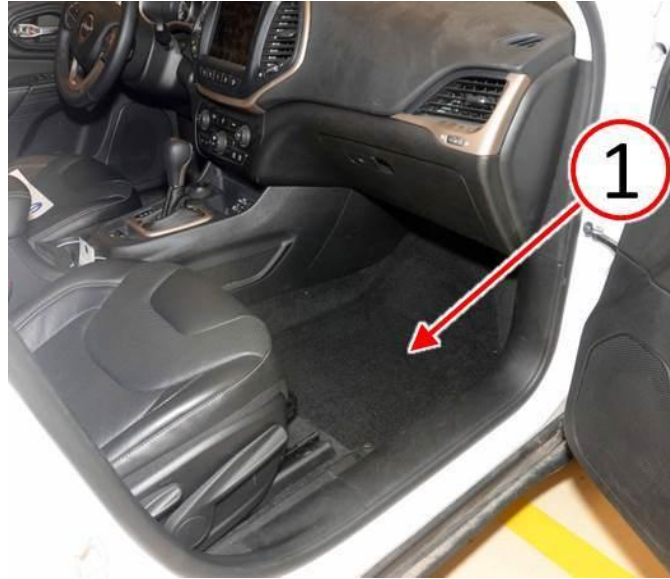
Fig. 1 Water in Front Footwell

The customer may describe damp or wet carpet in the front footwell or in the rocker sill. This condition is primarily found on the left side but may be on the right (Fig. 1) or both footwells. The cause of this leak may be due to a sealant void on the body seam, allowing water to enter the vehicle interior.

Right side shown, left side similar

1 - Front footwell

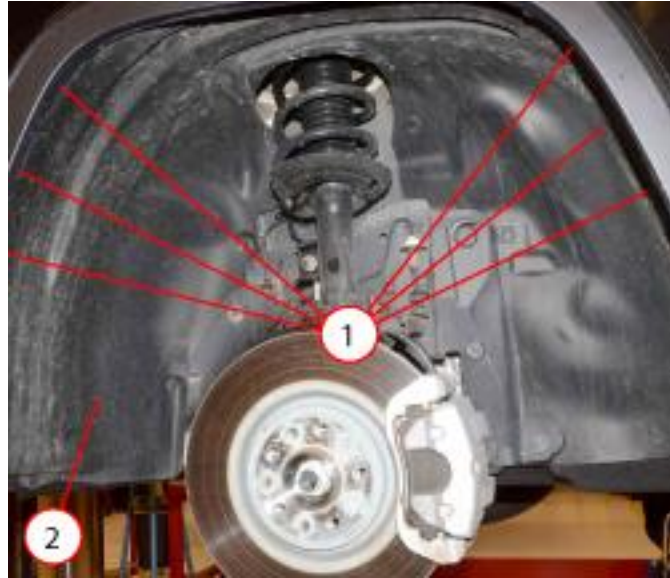
Fig. 2 Inner Fender Well

Right side shown, left side similar

1 - Fastener locations

2 - Inner Fender

3. Remove inner fender well fasteners (Fig. 2) and move out of the way.

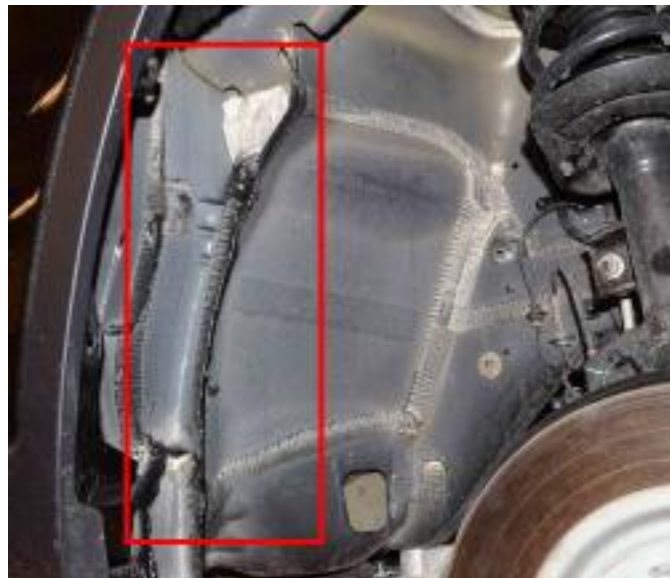
Fig. 3 Body Sealer Leak Area

-
4. Using a test air nozzle or equivalent, blow air around the bulkhead body seams . Look for gaps, disruptions or blemishes in the body seam sealer (Fig. 3).

Right side shown, left side similar

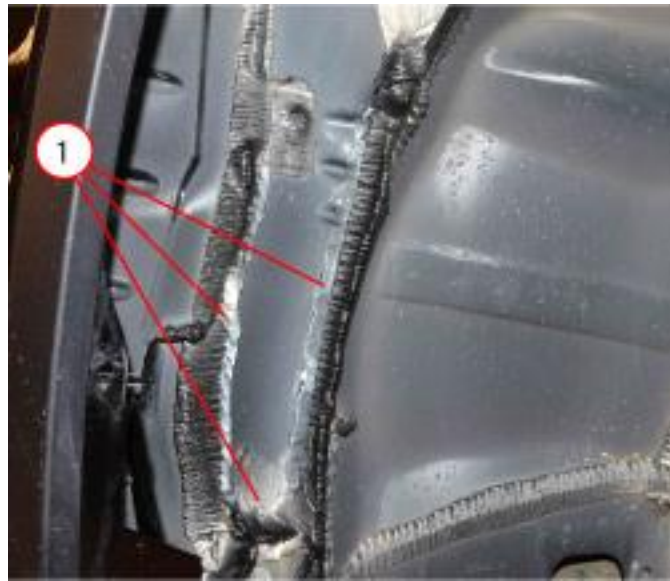
Fig. 4 Apply Kent Sealer

Right side shown, left side similar

1 - Apply on seam locations

5. Clean and prepare application area as needed before applying sealer. Using seam sealer (Kent products High-Tech clear #P10200 or equivalent), repair gaps in sealant ([Fig. 4](#)). You may have to cut away portion of vinyl sealer to expose and seal the leak path.

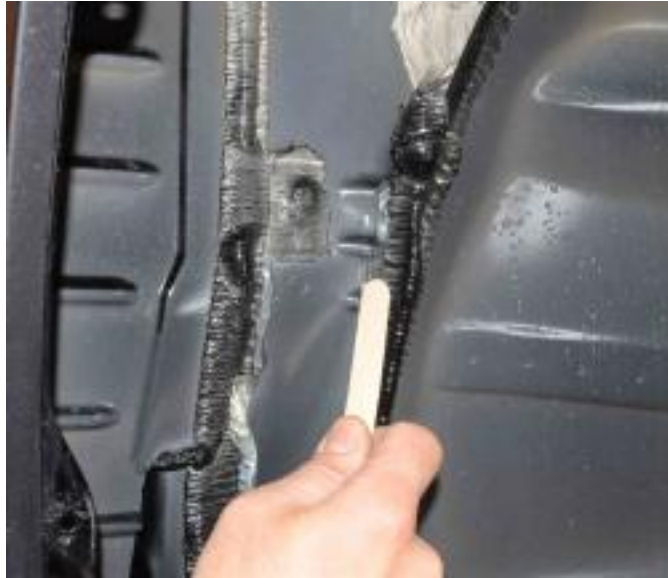
Fig. 5 Smooth Sealer With Wood Stick

Right side shown, left side similar

6. Smooth out newly applied sealer with wood applicator (Fig. 5).
