**NUMBER:** 18-017-16

**DATE:** February 17, 2016

Flash: 3.0L Powertrain Diagnostic And System Enhancements

2014 (DS) RAM 1500 Pickup

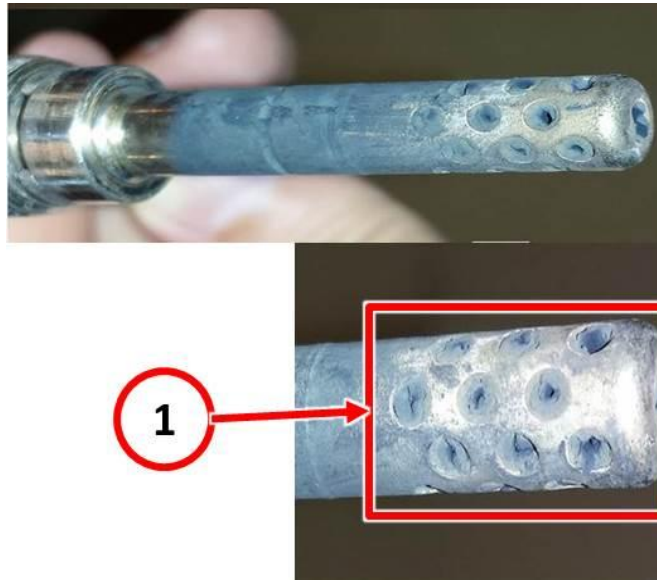
**Fig. 1 EGT Sensor Bank 1 Sensor 1**

13. Inspect the sensor body and probe for any signs of damage or excessive soot. See (Fig. 1).

1 - Excessive soot blocking sensor ports

- 
14. Was excessive soot found on the sensor?
- a. Yes>>> Proceed to [Step #15](#).
  - b. No>>> Proceed to [Step #16](#).
15. Using shop air set to a maximum of 80 psi, clean all excessive soot from the sensor probe.

16. Using a suitable multi-meter with appropriate test probes, test the resistance between the sensor connector terminals 1 and 2. With the sensor at room temperature, 65-75 °F (18-25 °C), the resistance should measure between 200 and 240 ohms.
