NUMBER: 18-019-16

DATE: February 18, 2016

Flash: 3.0L Powertrain Diagnostic And System Enhancements

2015 (WK) Jeep Grand Cherokee

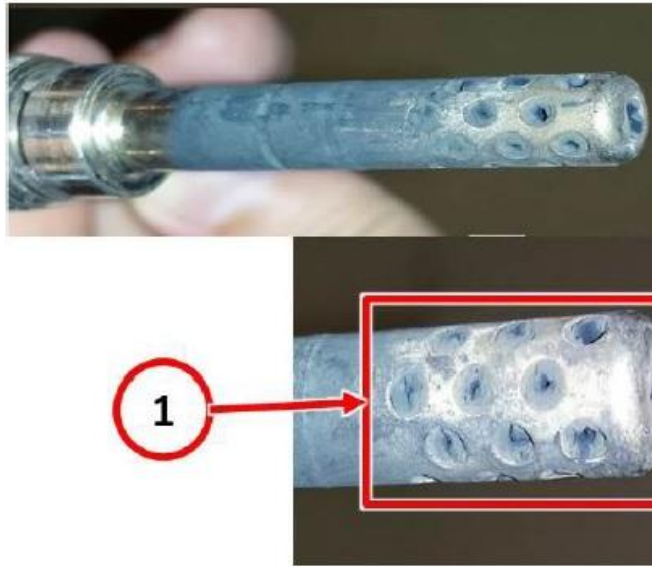
Fig. 1 EGT Sensor Bank 1 Sensor 1

11. Inspect the sensor body and probe for any signs of damage or excessive soot. See (Fig. 1).

1 - Excessive soot blocking sensor ports

-
12. Was excessive soot found on the sensor?
- Yes>>> Proceed to [Step #13](#).
 - No>>> Proceed to [Step #14](#).
13. Using shop air set to a maximum of 80 psi, clean all excessive soot from the sensor probe.

14. Using a suitable multi-meter with appropriate test probes, test the resistance between the sensor connector terminals 1 and 2. With the sensor at room temperature, 65-75 °F (18-25 °C), the resistance should measure between 200 and 240 ohms.

15. Is the temperature sensor resistance within specifications?
- Yes>>> Install the original EGT sensor 1/2 and/or Catalyst Temperature Sensor. Refer to detailed installation procedures available in DealerCONNECT> TechCONNECT> Service Info Section 11 - Exhaust System> Sensor, Exhaust Temperature> Installation> Exhaust Gas Temperature Sensor 1/2.

- No>>> Install a new EGT sensor 1/2 and/or Catalyst Temperature Sensor. Refer to detailed installation procedures available in DealerCONNECT> TechCONNECT> Service Info Section 11 - Exhaust System> Sensor, Exhaust Temperature> Installation> Exhaust Gas Temperature Sensor 1/2.
