**GROUP:** Body

DATE: February 12, 2016

Right Front Door Outer Belt Molding Too High

Ram 1500 Pickup

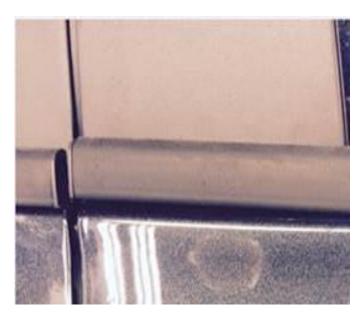
The customer may describe that the outer belt molding is sitting too high on the door.

- 1. Inspect the right front outer belt molding for fit and finish.
- 2. Is the right front outer belt molding sitting too high on the door as shown in (Fig. 1)?
  - a. YES>>> Proceed to Step #1.
  - b. NO>>> This bulletin has been completed, use LOP (23-51-16-9C) to close the active RRT.

# Fig. 1 Outer Belt Molding Difference

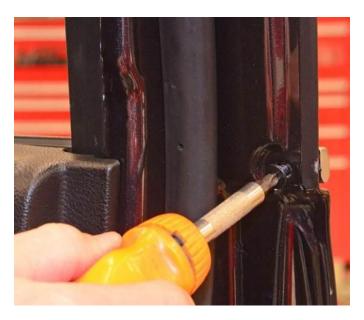
# Fig. 2 Screw Securing Belt Molding

1. Remove the outer belt molding retaining screw(Fig. 2).

8. Remove the tape used to protect B pillar surface and trim stick (Fig. 3) install and align the outer belt molding back into place to match the rear door outer belt molding and install the screw (Fig. 2).

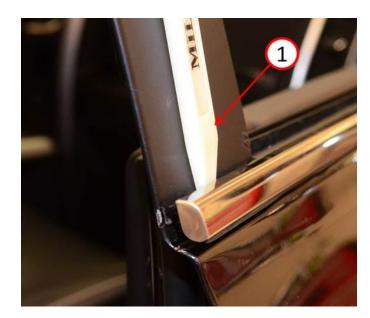
Fig. 3 Trim Stick

3. Insert a trim stick between the B pillar and belt molding (Fig. 3).

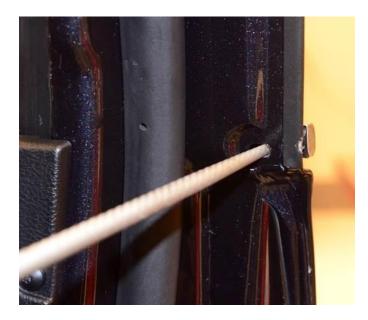
Fig. 4 File Area

4. Use a file to open up the bottom of slot for the screw hole on the door (Fig. 4). The final height of the slot should be around 8mm (0.315 in). Do not exceed 10mm (0.4 in) slot height (Fig. 5). Be careful not to damage the surface or molding with the file.

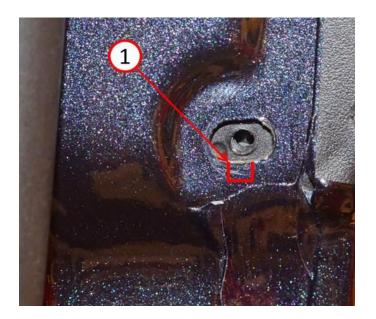
Fig. 5 Area To Be Filed

1 - Material To Be Removed Around 8mm (0.315 in)
