NUMBER: 21-008-16

Flash: Power Transfer Unit (PTU) Motor Position Enhancements

2014 -**2016**	(KL)	Jeep Cherokee
2015 - **2016**	(UF)	Chrysler 200

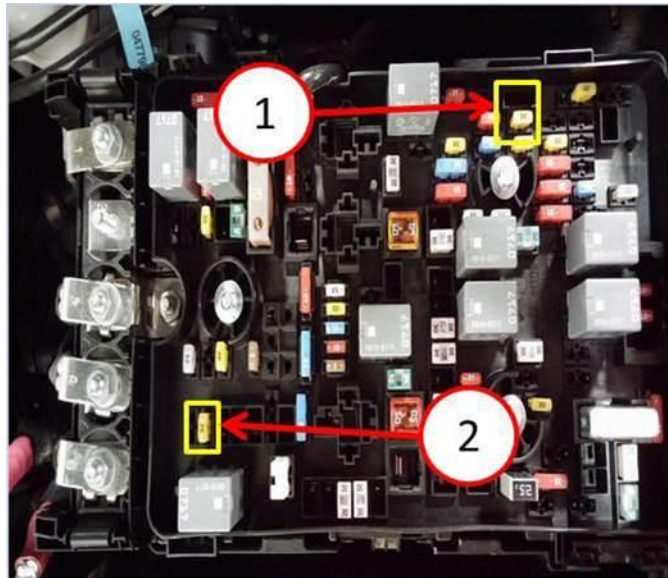
Fig. 1 Module Fuse Locations

- 1 - F76 RMD 4WD
- 2 - F10 PTU 4WD

5. Perform the PTU flash, using the procedure below:
 - a. Turn the ignition off.
 - b. Pull fuse F76 (RDM 4WD, 20 amp) in the PDC (Power Distribution Center) ([Fig. 1](#)).
 - c. Turn the ignition key to the RUN position and perform the PTU flash.
 - d. When the flash is complete, turn the ignition key OFF and reinstall fuse F76.
