**NUMBER:** 23-004-16

Tailgate Contacting Pickup Box Panel When Closing

2015 - 2016 (DS) Ram 1500 Pickup

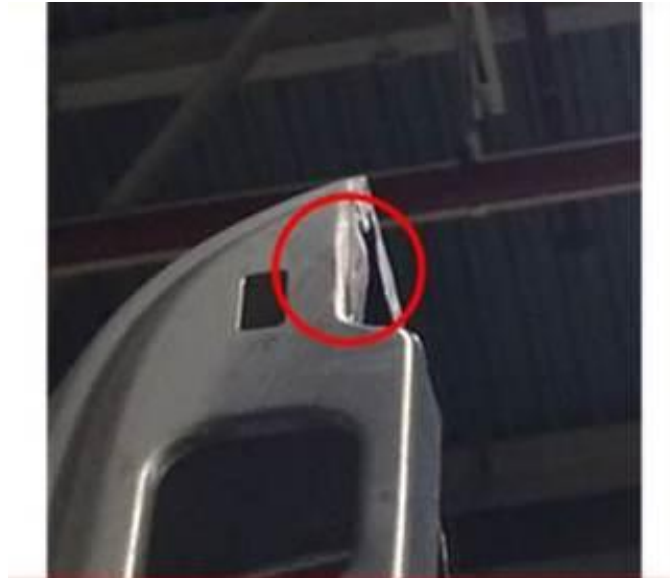
The customer may describe the tailgate making contact with the passenger side outer box panel.

1. Visually inspect the passenger side of the tailgate for contact with the outer box panel as shown in (Fig. 1).

**Fig. 1 Flange Bent Inboard**

3. Flatten the passenger side outer pickup box sheet metal flange to prevent contact with the tailgate.
  4. Feather sand the surface area with P500 sandpaper.
