New Bonneville Cylinder Head Oil Residue

TOL NOTICE (US&CAN) – February 25, 2016

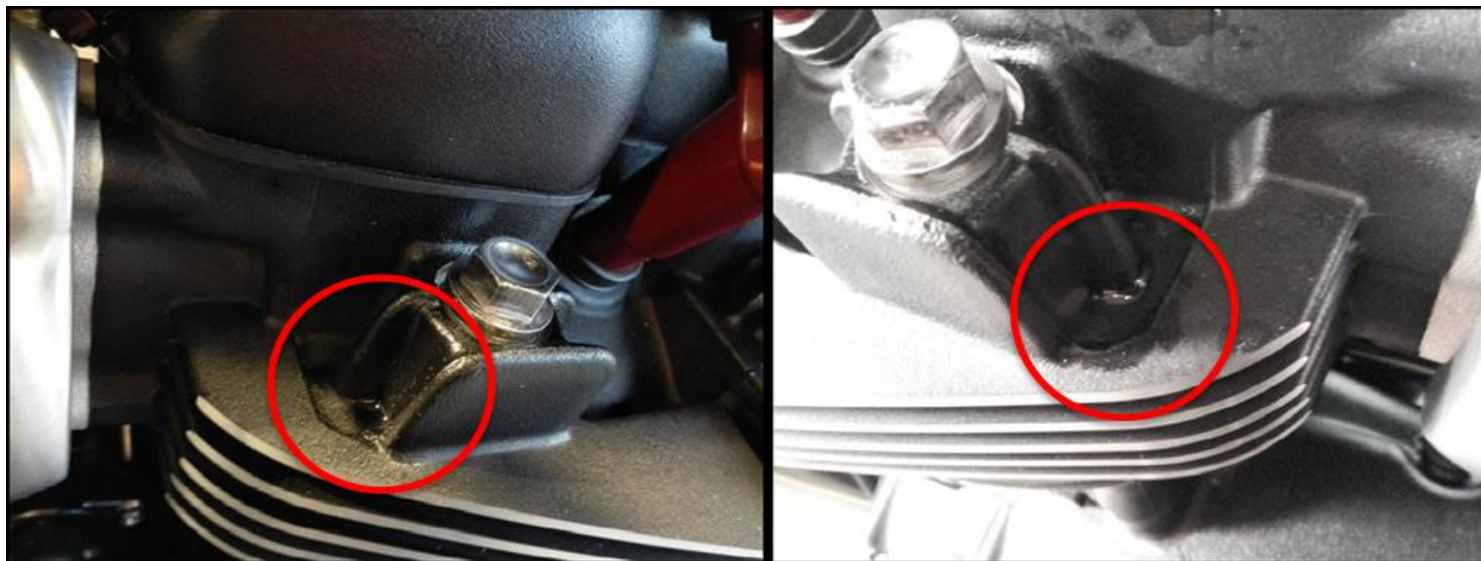
It has been reported that there may be instances of excess oil visible around the cylinder head bolts on the new Bonneville series engines (Street Twin, Bonneville T120, Thruxton). This excess oil residue may appear to be an oil leak, as shown in the photos below.

Please be assured this is not a fault or the result of an oil leak, rather it is a small amount of excess oil that can become trapped around the cylinder head bolts during assembly. When the engine is heated, the trapped oil may then seep out. If this oil spotting is observed, thoroughly clean the area using a proprietary degreaser and run the engine again, monitoring the area to ensure oil seepage stops.
