Technical Bulletin

2013 - 2015 SENTRA; MIL ON WITH DTC P0101

APPLIED VEHICLE: 2013 – 2015 Sentra (B17)

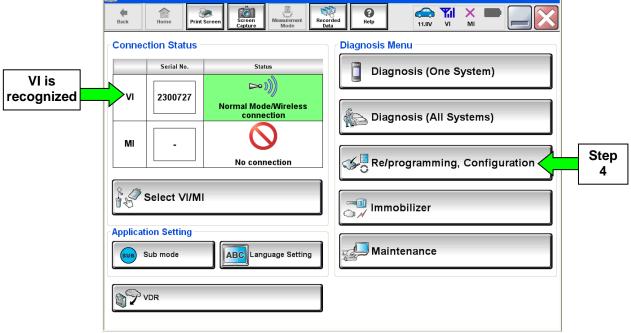
Figure 1

- 4. Select **Re/programming**, **Configuration**.

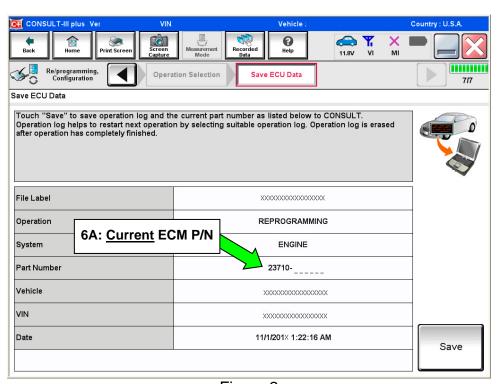
Figure 2

- 6. When you get to the screen shown in Figure 2, confirm this bulletin applies as follows.
 - A. Find the ECM Part Number and write it on the repair order.

NOTE: This is the <u>current</u> ECM Part Number (P/N).

- B. Compare the P/N you wrote down to the numbers in the **Current ECM Part Number** column in **Table A** on the next page.
 - If there is a <u>match</u>, continue with the reprogramming procedure.
 - If there is <u>not a match</u>, reprogramming is not needed.

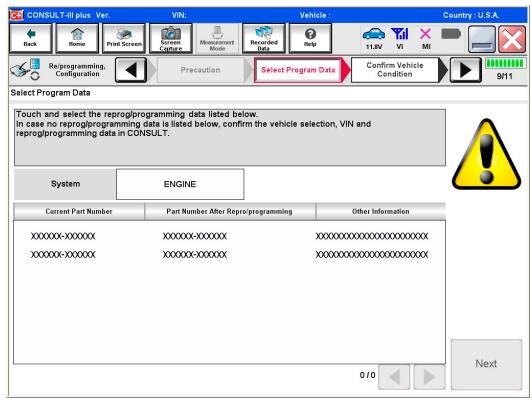
- In some cases, more than one new P/N for reprogramming is available.
 - ➤ If there is more than one new P/N, the screen in Figure 3 displays.
 - > Select and use the reprogramming option that **does not** have the message "Caution! Use ONLY with NTBXX-XXX".
- If you get this screen and it is <u>blank</u> (no reprogramming listed), it means there is no reprogramming available for this vehicle.

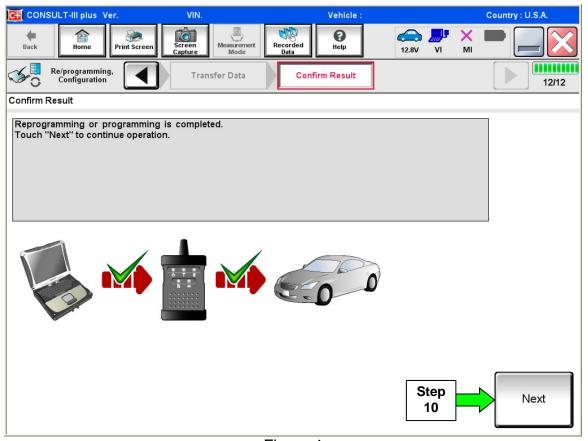
8. When the screen in Figure 4 displays, reprogramming is complete.

NOTE: If the screen in Figure 4 does <u>not</u> display (indicating that reprogramming did <u>not</u> complete), refer to the information on page 8.

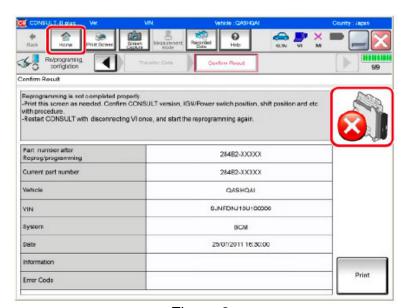
Figure 6

If reprogramming does \underline{not} complete and the "X" icon displays as shown in Figure 6:

- Check battery voltage (12.0 – 15.5 V).
- CONSULT A/C adapter is plugged in.
- Ignition is ON, engine OFF.
- Transmission is in Park.
- All C-III plus / VI cables are securely connected.
- All C-III plus updates are installed.
- Select <u>Home</u>, and restart the reprogram procedure from the beginning.

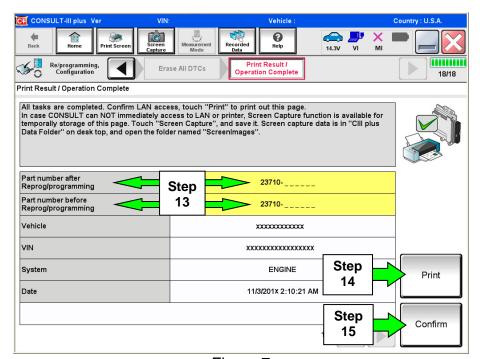
- 12. When the entire reprogramming process is complete, the screen in Figure 7 will display.
- 13. Verify the before and after part numbers are different.
- 14. Print a copy of this screen (Figure 7) and attach it to the repair order for warranty documentation.
- 15. Select Confirm.
