SERVICE BULLETIN

EC16-013a

NTB16-037a

2016 TITAN XD; MIL ON WITH ENGINE DTCs STORED

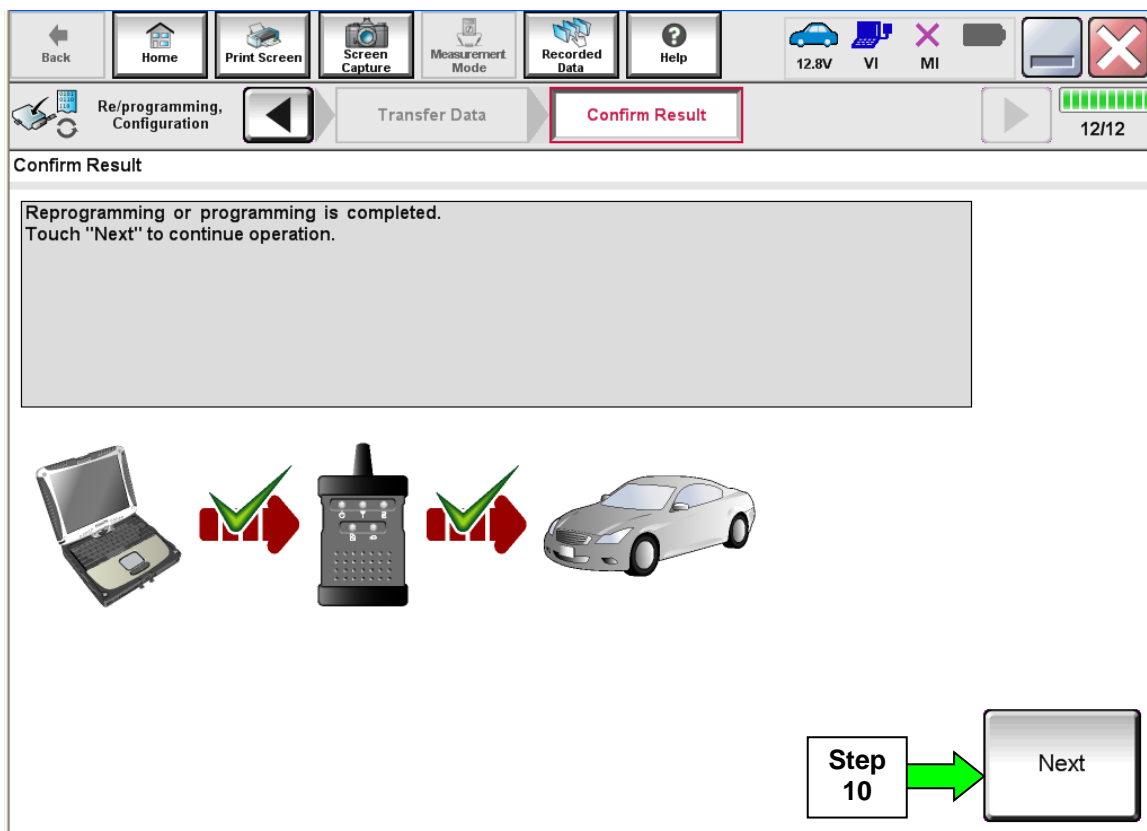
NOTE: If the screen in Figure 4 does not display (indicating that reprogramming did not complete), refer to ECM recovery on the next page.

8. When the screen in Figure 4 displays, reprogramming is complete.
