FORD:

2013-2016 Escape

The article supersedes TSB **15-0130** to add a production fix date.

ISSUE

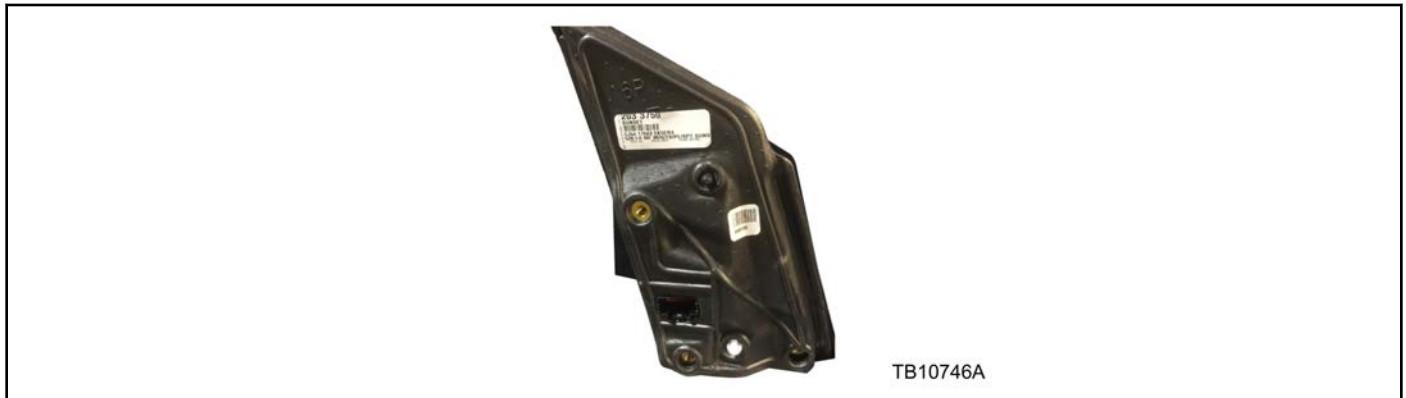
Figure 1 - Article 16-0033

Some 2013-2016 Escape vehicles built on or before 1/22/2016 may exhibit a wind or whistle noise from the exterior mirror(s) at highway speed.

1. Remove the suspected mirror assembly. Refer to Workshop Manual (WSM), Section 501-09.
2. Remove the inner sail molded gasket/barrier. (Figure 1)

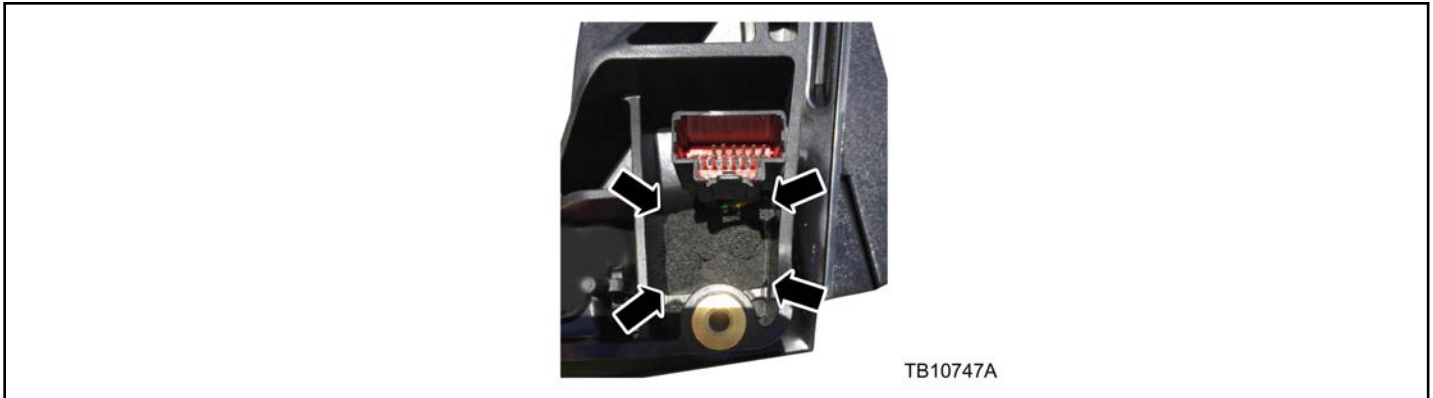
Figure 2 - Article 16-0033

3. Inspect the cavity below the electrical connector where the wiring feeds into the mirror head for the presence of a foam block to prevent air flow. Is the foam block present? (Figure 2)
 - a. Yes - proceed to Step 4.
 - b. No - proceed to Step 5.
4. Is the foam block positioned properly to seal off all 4 sides and corners of the cavity? (Figure 2)

- a. Yes - this article does not apply. Refer to WSM, Section 501-00 for normal diagnosis.
 - b. No - properly position the foam block and proceed to Step 6. (Figure 2)
5. Install a foam block with locally available material and cut to the following dimensions 30 mm x 45 mm x 50 mm (1 3/16 X 1 25/32 X 1 31/32).
 6. Reinstall mirror.
