March 24, 2016

03374 Version 2

Product Update: Roof Molding

Year	Model	Trim	VIN Range
2016	Pilot	LX, EX, EX-L	Check the iN VIN status for eligibility

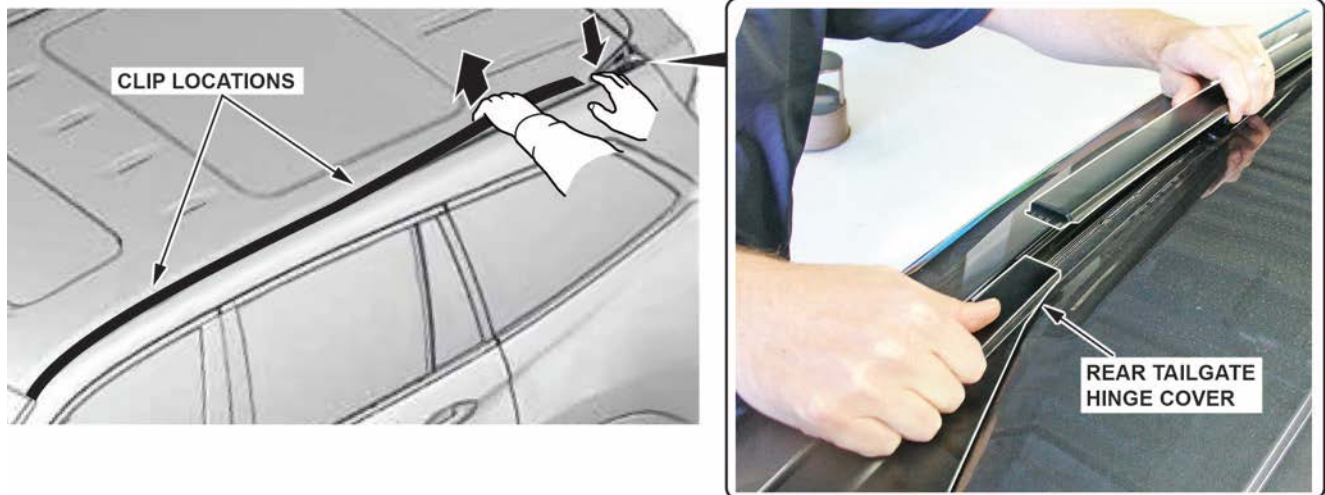
- Starting at the back of the vehicle, place your hand over the rear tailgate hinge cover and gently lift in the area shown until the roof molding tongue is free from the rear tailgate hinge cover.

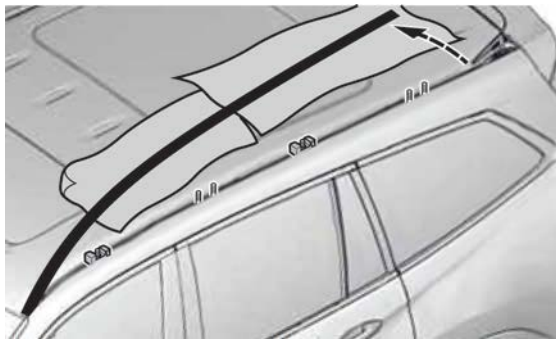
- Slide the rear of the molding out of the tailgate hinge cover.
- Moving towards the front, gently pull up on the molding to detach the two clips.
- Leave the molding attached to the front cap and place the molding towards the middle part of the roof to give yourself room to work.

NOTE: Be careful to not damage the molding or the vehicle's paint. Use a shop towel or similar item to protect the roof from being scratched.

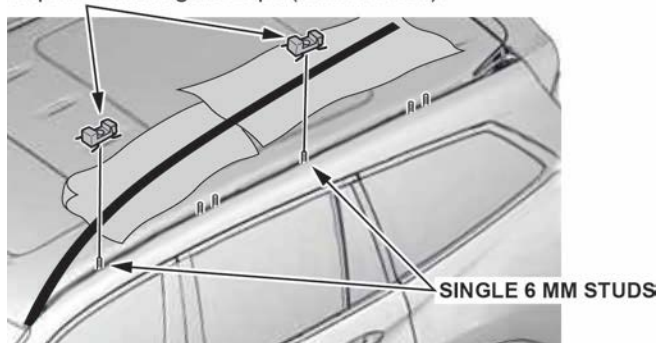
Replace existing M6 clips (natural color).

2. Remove the original clips from the roof.

3. Install the two M6 clips (natural color) in the same location as the original clips (the single 6 mm studs).

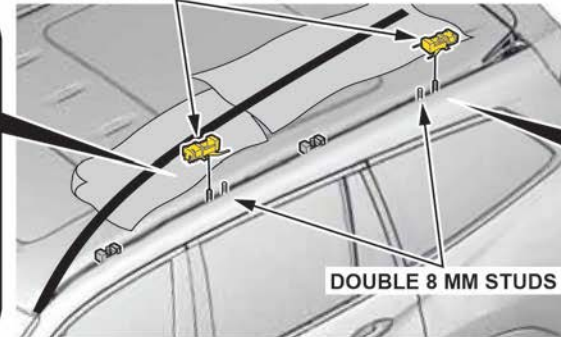
Add two M8 clips (yellow).

4. Install the front M8 roof clip (yellow color) on the first stud of the double 8 mm stud as shown, then install the second M8 roof clip on the second double 8 mm stud.
