Service Bulletin

Subject: Oil Leak from Rear of Engine After Extended Driving in Cold Temperatures Below 0 F (-18 C)

Models: 2010-2014 Buick Lacrosse
2011-2014 Buick Regal
2012-2014 Buick Verano
2012-2014 Chevrolet Captiva Sport
2010-2014 Chevrolet Equinox
2010-2013 Chevrolet Malibu
2010-2014 GMC Terrain
with 2.4L Engine (RPO LAF, LEA or LUK)

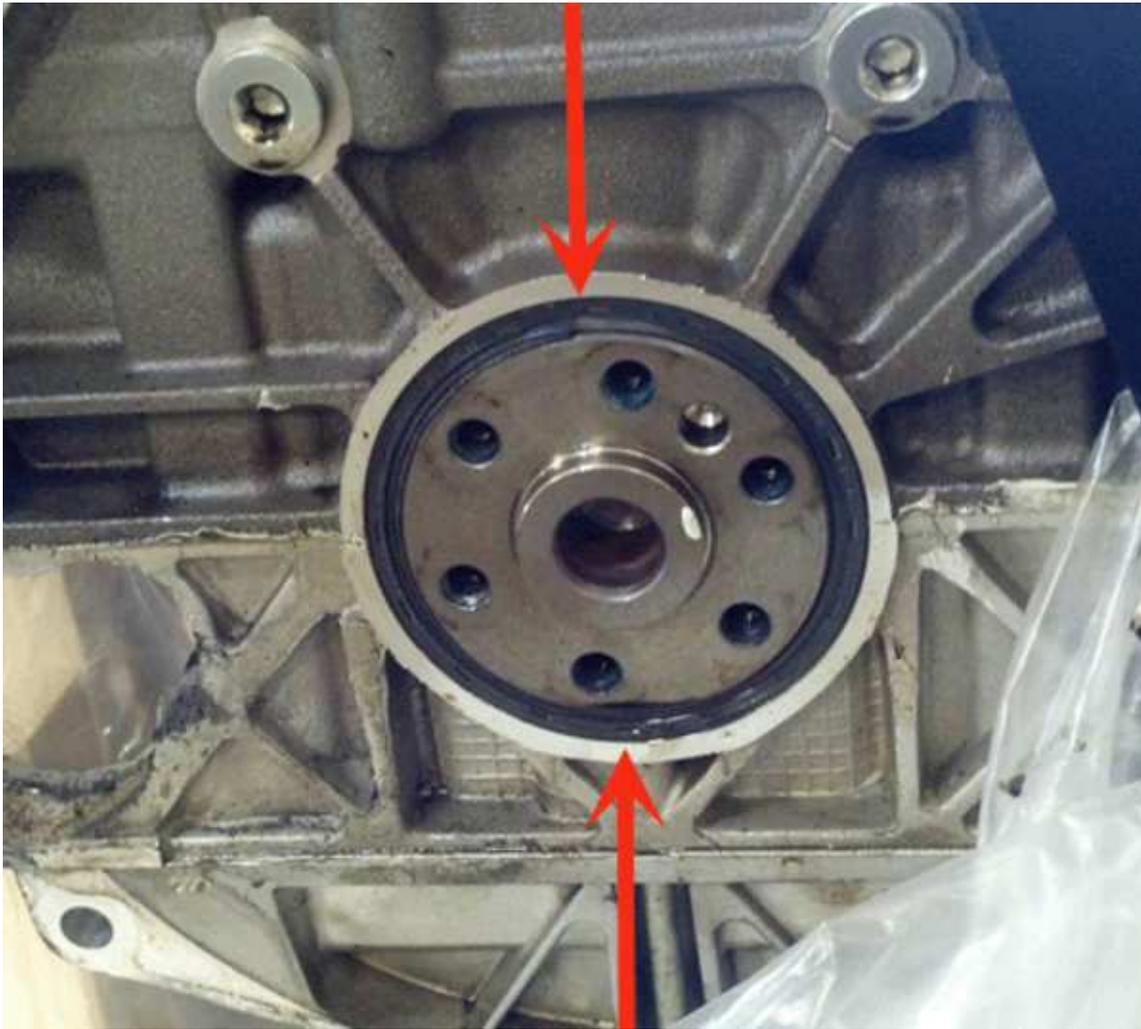
Some customers may complain of an engine oil leak that appeared as they were driving the vehicle in extremely cold ambient temperatures (Generally 0 F / -17 C or Colder). They may also comment that they heard a single "pop" noise right before the oil leak started. Upon inspection, the technician will find that the oil leak is coming from the rear main oil seal of the engine as shown below. This may be the result of a frozen PCV system and excessive crankcase pressure. If a leaking rear main oil seal is found in warmer climates, this PI does not apply.

If this concern is experienced, determine if the concern is the result of a frozen PCV system by inspecting the PCV system, dipstick, and engine oil fill cap for signs of ice, moisture, and/or sludge build up. If this is not due to a frozen PCV system, follow Service Information Procedures to diagnose and repair. If this is the result of a frozen PCV system, follow the steps below:
