Service Bulletin

Subject: Rough Idle In Drive

Models: 2015-2016 Cadillac Escalade Models
2014-2016 Chevrolet Silverado 1500
2015-2016 Chevrolet Silverado 1500, Suburban, Tahoe
2014-2016 GMC Sierra 1500
2015-2016 GMC Sierra 1500, Yukon Models
With engines 4.3L, 5.3L, 6.2L RPO L83, L86, LV1, LV3

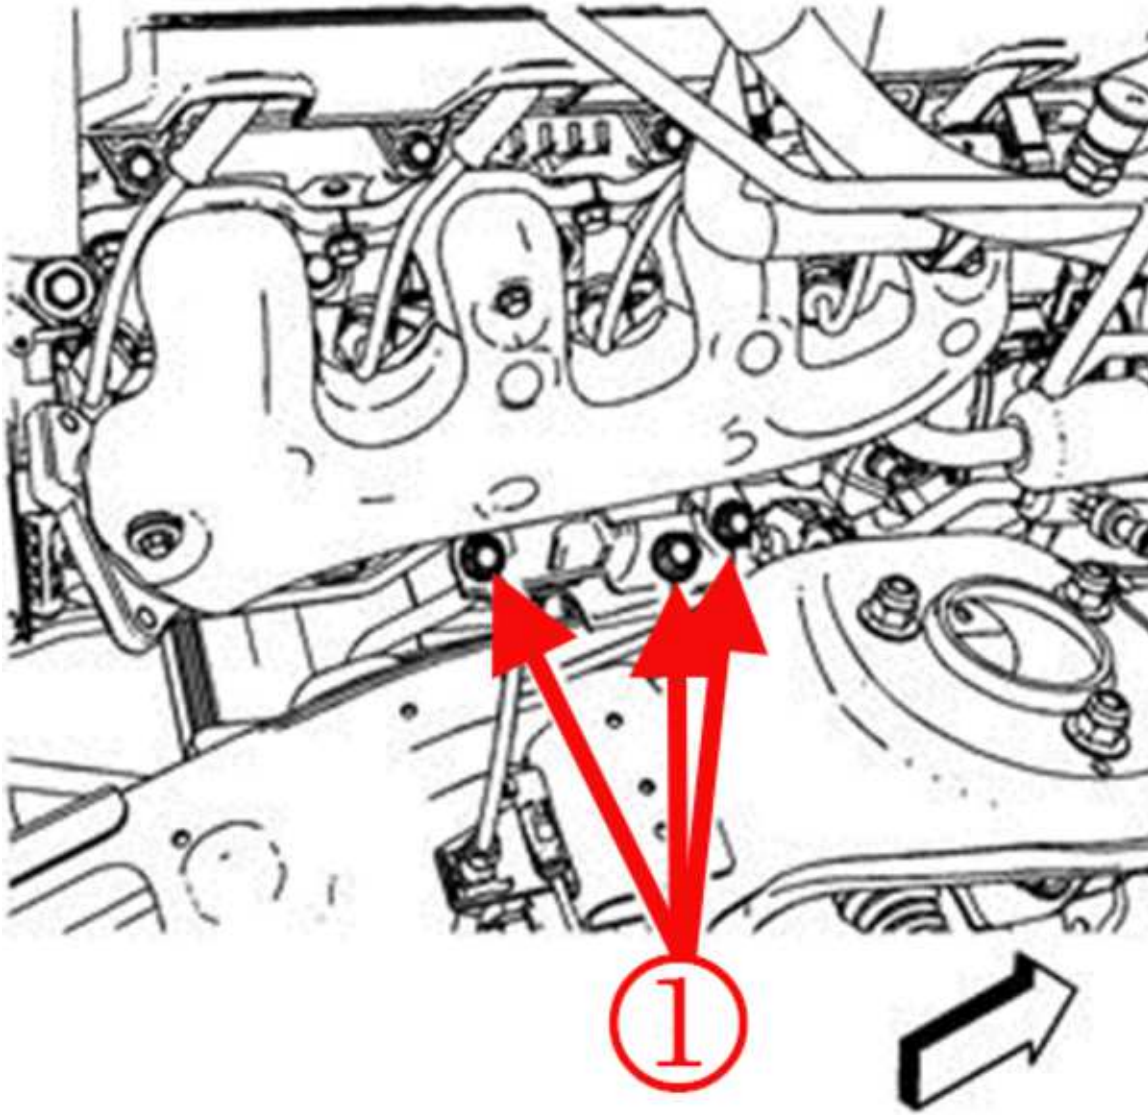
Installing shims between the mount and frame bracket at the lower inboard location (1), alleviates the ground-out in the mount (2) at the upper outboard area.

Loosen engine mount bolts at 3 frame attachment points (1) for both left and right mounts.

Loosen the trans mount to keep from putting it into a bind

Lift engine so both mounts are off frame ~10-20mm.

Install 3mm-thick "shims" (spacers, not tapered shims) between bottom surface of mount and frame bracket, on the inboard side of mount (1).
