Service Bulletin

Subject: Parallel Hybrid Truck (PHT) Part Restriction

Models: 2004-2007 Chevrolet Silverado Classic
2004-2007 GMC Sierra Classic
All With RPO HP2

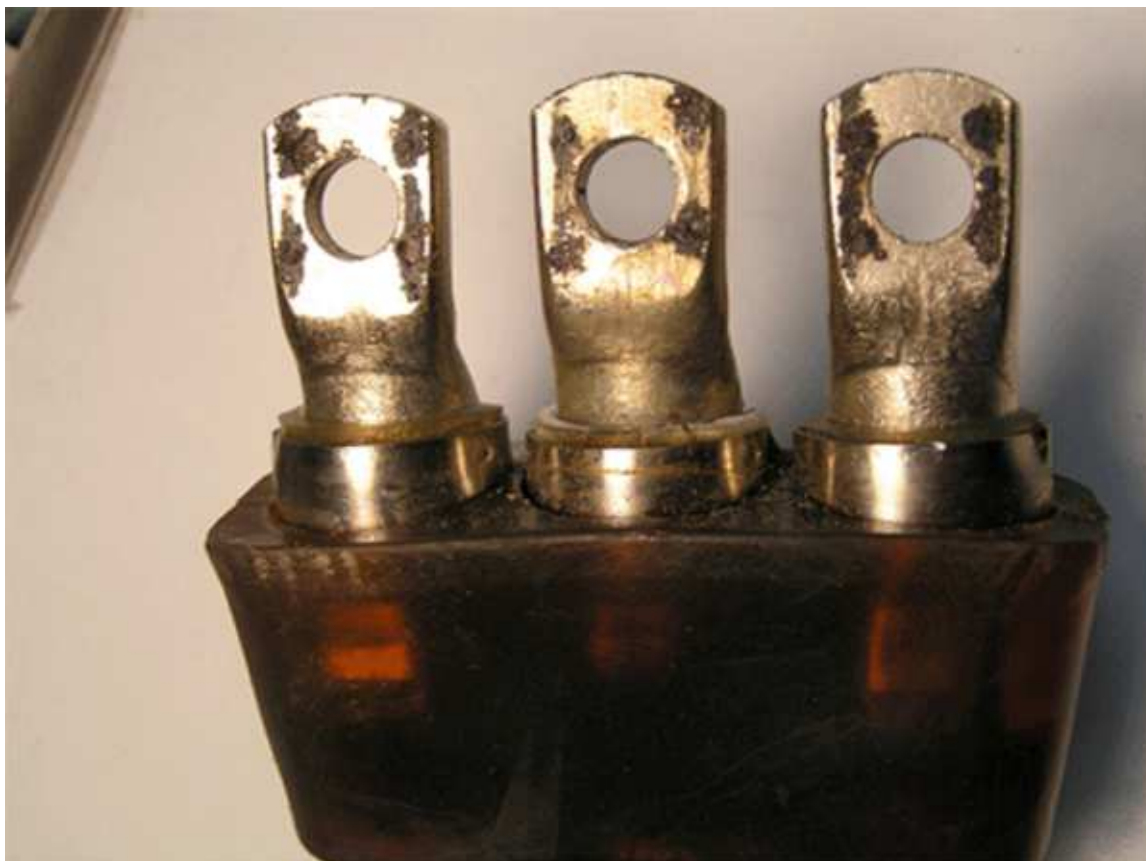
Terminals with signs of arcing/pitting that need to be replaced

1. It is recommended to inspect the Phase Cable Set when replacing the Stator. It is not necessary to replace the Phase Cable Set unless the cables show signs of arcing and heavy pitting. Minor pitting and corrosion can be cleaned up with emery or other fine abrasive.
