Service Bulletin

Subject: Hybrid No Crank or Loss of High Speed Communications

Models: 2009-2013 Cadillac Escalade Hybrid
2008-2013 Chevrolet Tahoe Hybrid
2008-2013 GMC Yukon Hybrid
2009-2013 Chevrolet Silverado Hybrid
2009-2013 GMC Sierra Hybrid
With Two-Mode Hybrid System (RPO HP2)
With one or more of the following DTCs
U0073 U0074 U0100 U0101 U0102 U0109 U0121 U0140 U0298 U1842 U1843 U186B U186A U1862

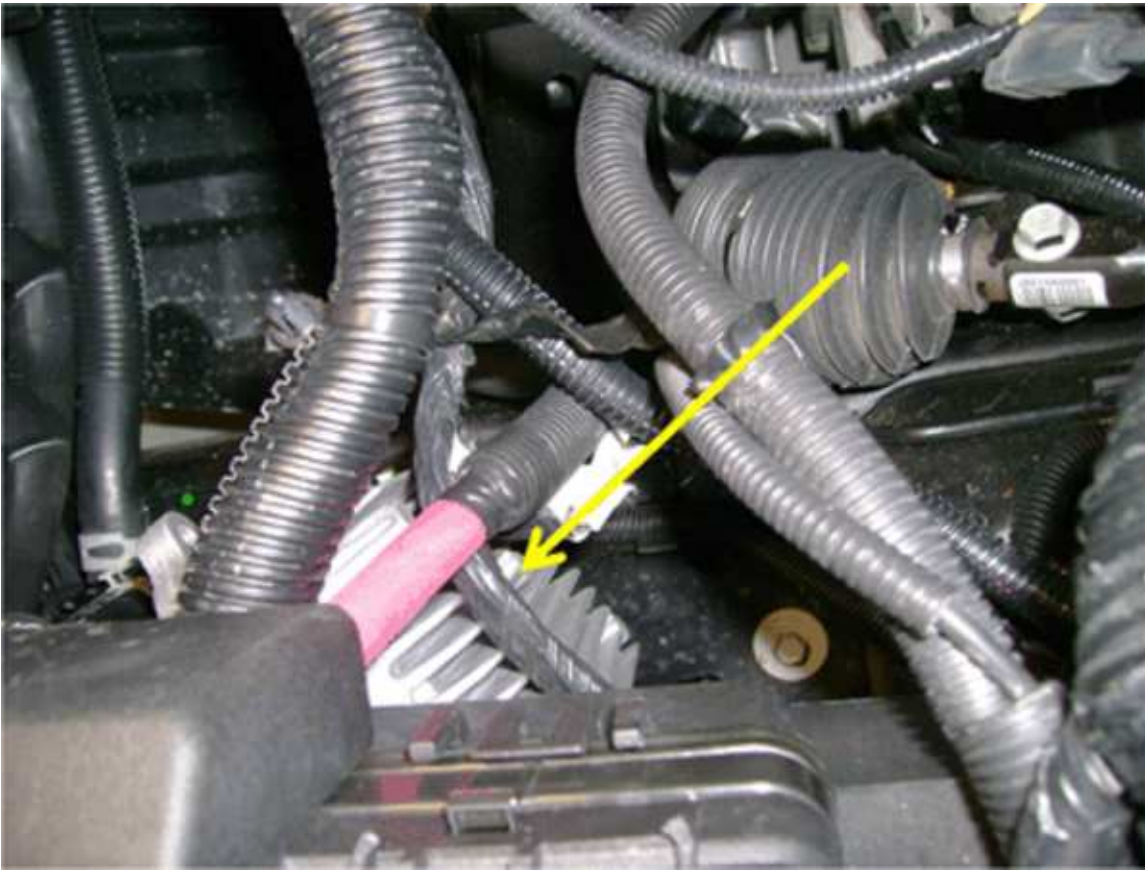
- Check G300 for a clean and tight connection. (Undercoating has been found between the eyelet and the frame causing a poor connection.)
- Inspect connector X150 and X109 for backed out, bent, or poor terminal fit using the correct terminal test probe. Also check for the connector not being fully seated together even though the lever on the connector is locked down
- Check Ground G102 for a clean and tight connection.
- If the concern is related to the high speed lan communication buss, Please review the current version of 08-07-30-021 for concerns that may also apply.
- Check for a misrouted harness rubbing on the cooling fins of the Transmission Auxiliary Fluid Pump Control Module. (See example below)

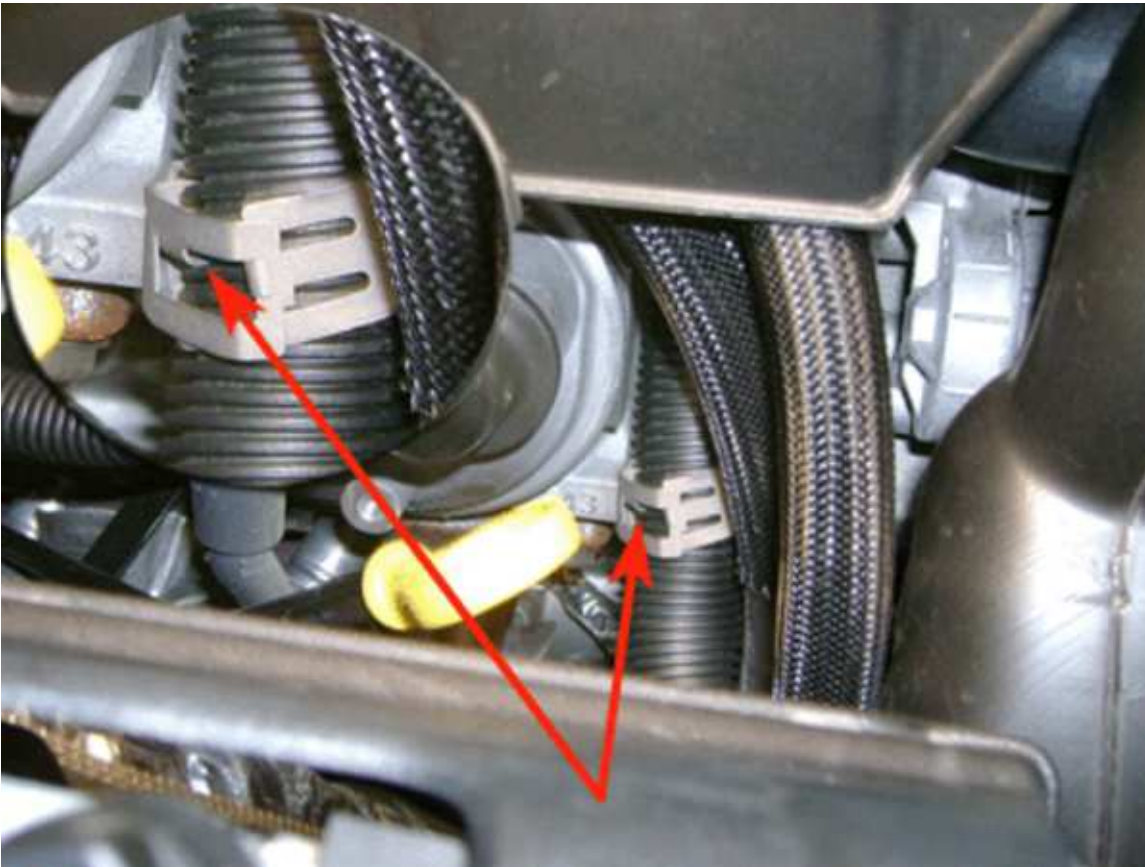
- Inspect engine harness on both sides of the engine for the holding clip being mis-positioned and the conduit tab (that is part of the clip) is cutting into the harness.

You may have to physically remove the clip and pull the harness out of the conduit and inspect the harness.

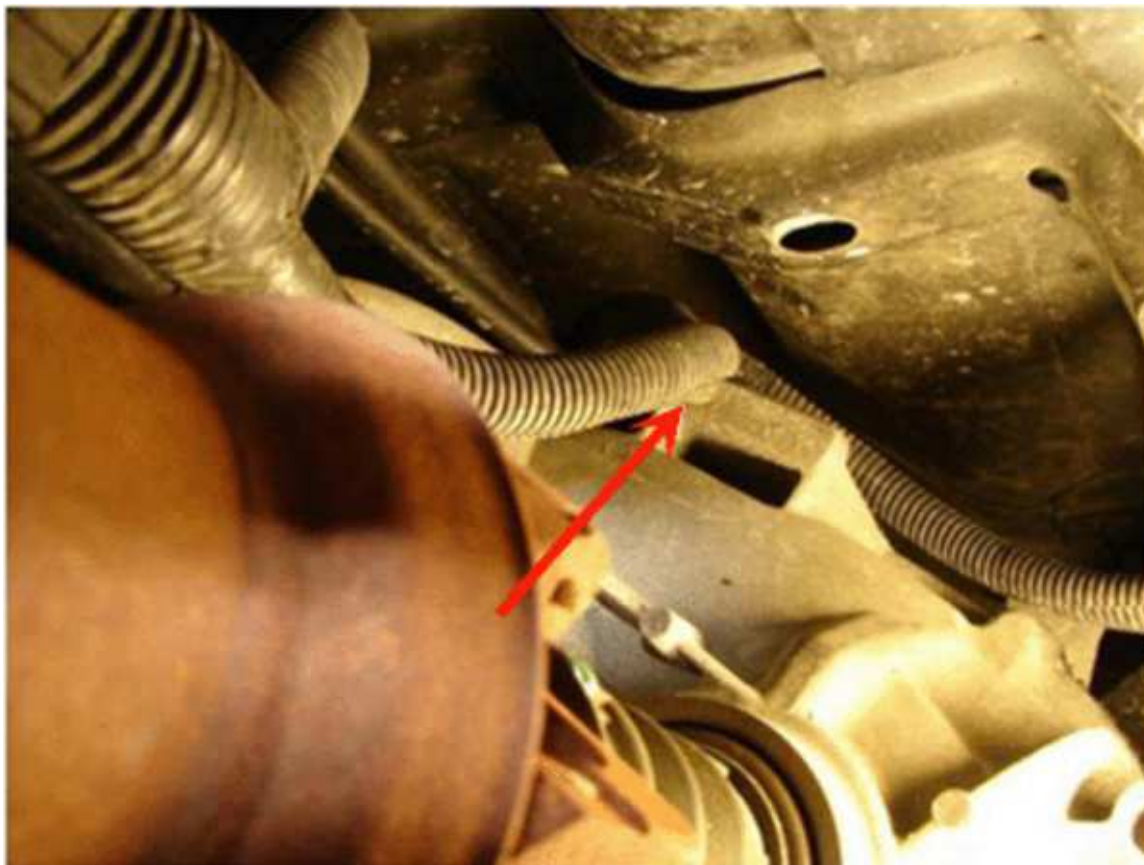
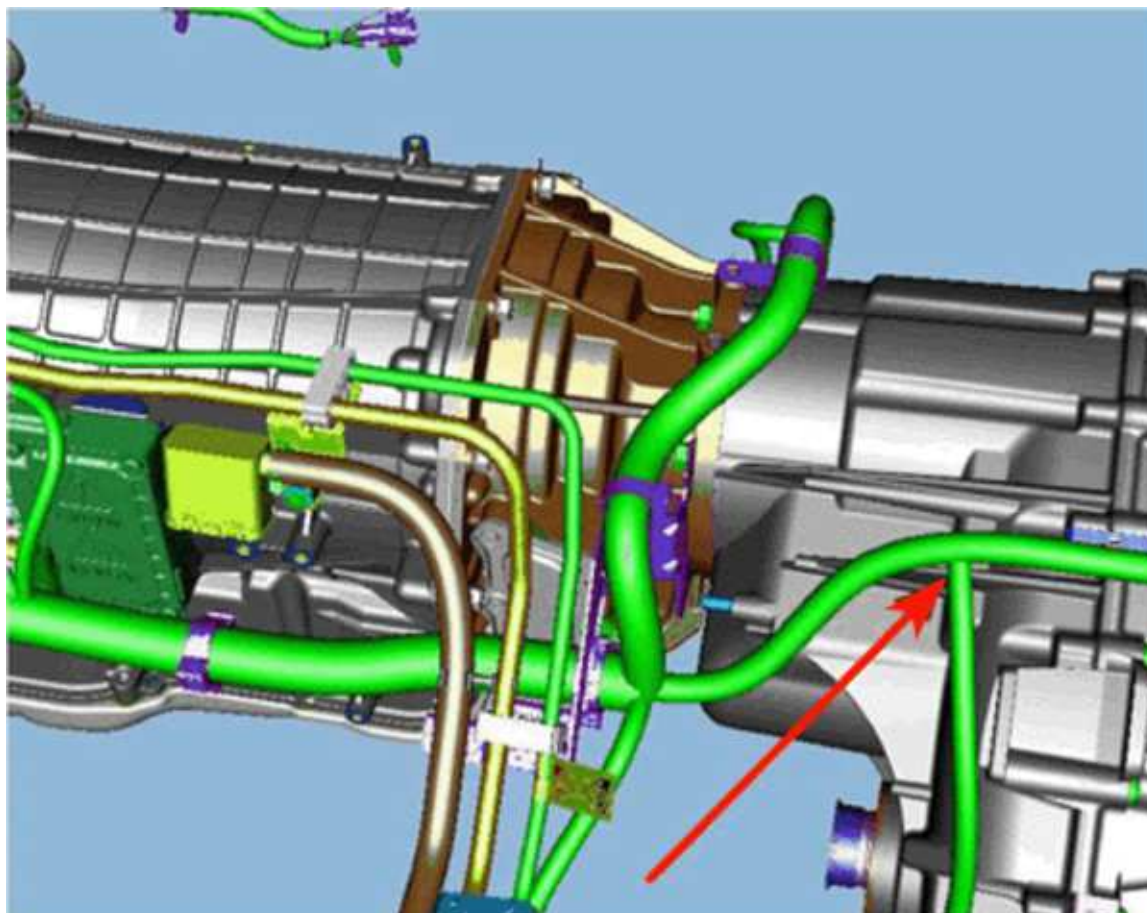
- Inspect the chassis harness that is right above the transfer case assembly. The opening in conduit can align with a boss on the transfer case and cut into the wiring.

You may have to physically remove the wiring and check the High Speed and Powertrain Expansion Bus wires for damage.
