PCM3.0 – Navigation Update (data status: model year 2016)

Concern: **New maps with data status: model year 2016 (G)**

Model Year: **As of 2009 up to 2010**

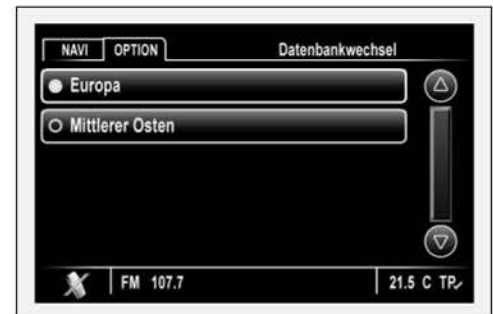
Figure 1

The customer can select the navigation database for PCM3.0 as follows:
Navi → Options → Set Navi → Download data → Change database → Select database → Confirmation (Yes) → PCM is reset automatically (see also ⇒ *Figure 1*).

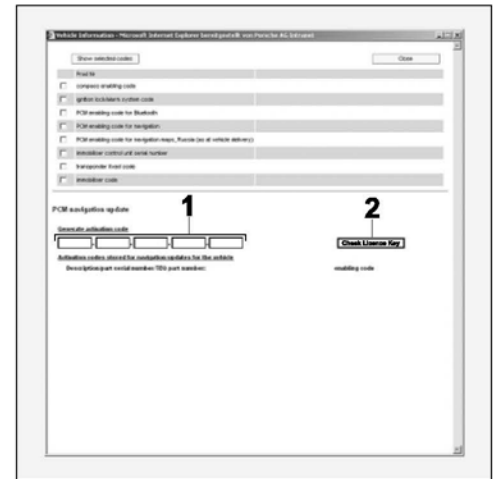
Figure 2

- 1** – License key input field
- 2** – "Check license key" field

Enter the license key in the input field ⇒ *Figure 2-1*.

Activate the "Check license key" field ⇒ *Figure 2-2* by clicking with the mouse.

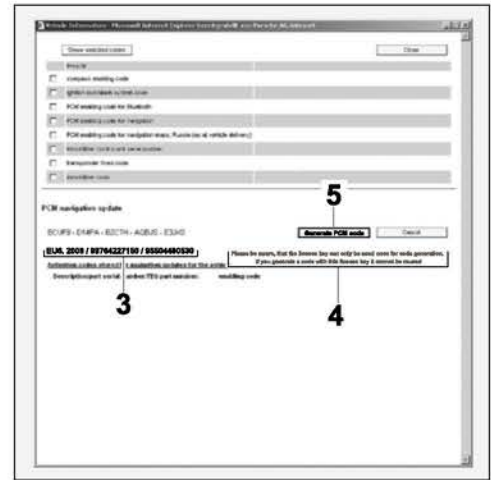
Figure 3

- 1.1.3 Generate PCM code.
 - 3 (2) – Map material/standard part number/TEQUIPMENT part number
 - 4 (3) – Note: License key can be used only once
 - 5 (3.5) – "Generate PCM code" field

After checking the license key, the related map material/standard part number/TEQUIPMENT part number ⇒ *Figure 3-3-* appears.

A message also appears informing you that the license key can ONLY be used once and is then unusable ⇒ *Figure 3-4-*.

Activate the "Generate PCM code" field by clicking with the mouse ⇒ *Figure 3-5-*.

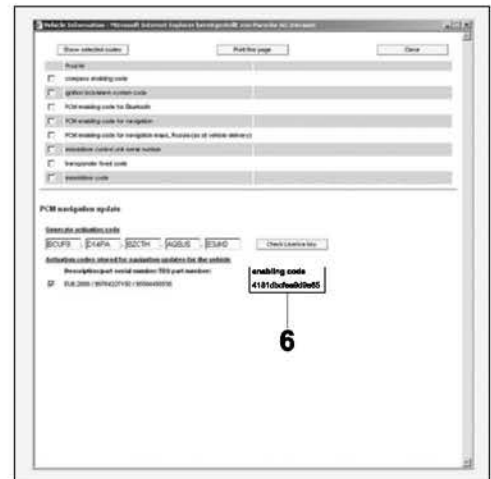
Figure 4

- 1.1.4 Take note of the enabling code.
 - 6 (4.5) – "Enabling code" field

Take note of the displayed enabling code ⇒ *Figure 4-6-*.
