**NUMBER:** 08-053-16

**GROUP:** Electrical

**DATE:** April 29, 2016

Flash: RA3/RA4 Radio Software Enhancements

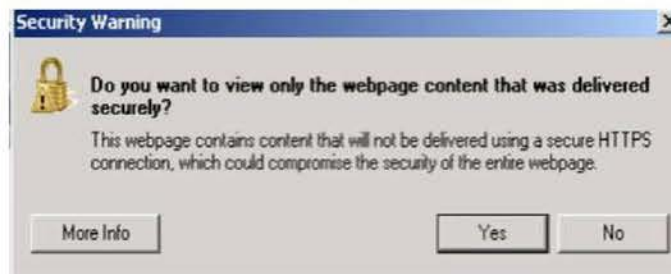
**Fig. 1 Pop-up Security Message**

1. Has the USB flash drive been created?
  - a. Yes >>> Proceed to [Step #4](#).
  - b. No >>> Proceed to [Step #2](#).
2. Go to DealerCONNECT> Service> UCONNECT Information & Utilities> Uconnect Dealer software downloads to down load the files.
3. If a security message appears "Do you want to view only the webpage content that was delivered securely?" press "NO" to continue ([Fig. 1](#)).
