**NUMBER:** 23-001-16 REV. D

Center Console Lid Binding

This bulletin involves adding a rubber bumper to the console lid to prevent the lid from binding.

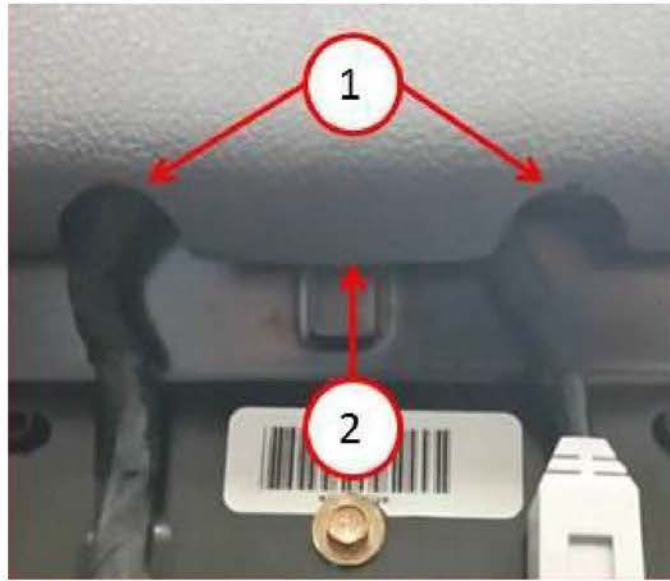
***Fig. 5 Bumper Location***

1 - Notches

2 - Location Of Bumper Installation

10. At the rear of the center console wall on the lower lid, identify the two notches as shown in (Fig. 5).

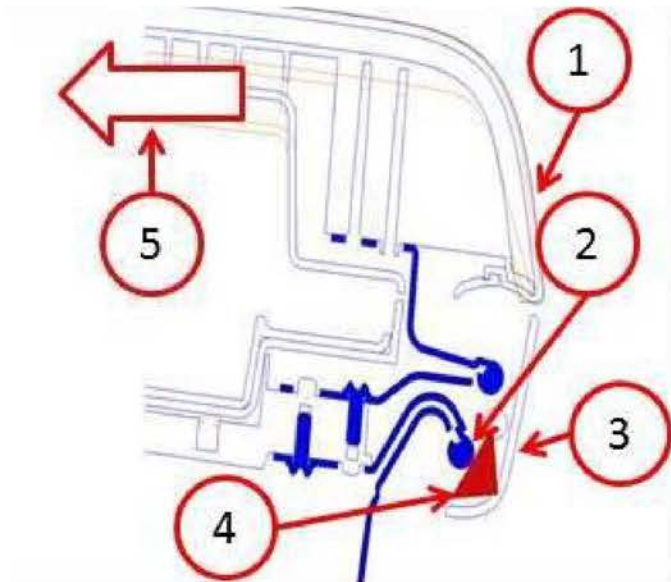
**Fig. 6 Bumper Installation**

- 1 - Rear Of The Center Console
  - 2 - Hinge
  - 3 - Lower Lid
  - 4 - Bumper
  - 5 - Front Of The Console
-

11. At the center of the console wall on the lower lid (as noted in the previous step), insert the bumper where the red triangle is shown. It will take some effort to push the bumper in flush with the edge of the lower lid as shown in (Fig. 6) and (Fig. 7).

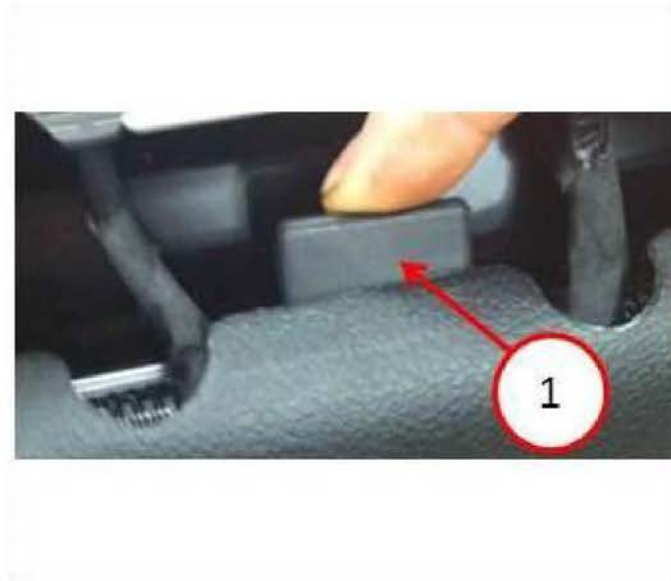
***Fig. 7 Bumper Being Installed***

1 - Bumper

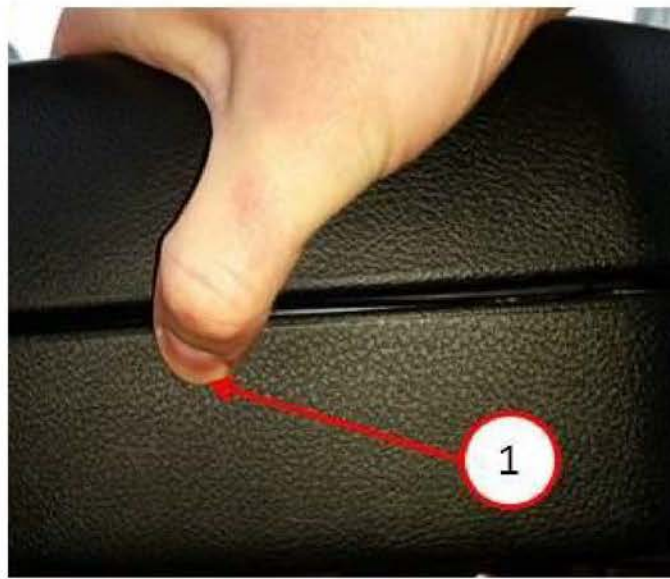
***Fig. 8 Bumper Installation Continued***

1 - Press The Back Wall

12. To assist the installation of the bumper, press the back wall of the lower lid to relieve some tension while inserting the bumper as shown in (Fig. 8).

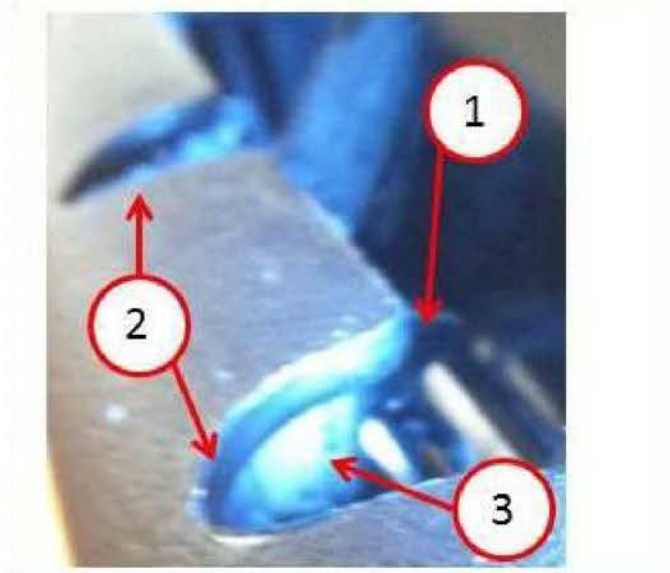
**Fig. 9 Bumper Installed**

- 1 - Metal Tab On The Lower Lid Hinge
- 2 - Notches
- 3 - Bumper Installed

13. Visually inspect the area of repair that the bumper is installed as shown in (Fig. 9).
