**NUMBER:** 23-019-16

**GROUP:** Body

Trunkpan Bolts Loose Causing Clunk When Driving Over Bumps

2016 (ZD) Dodge Viper

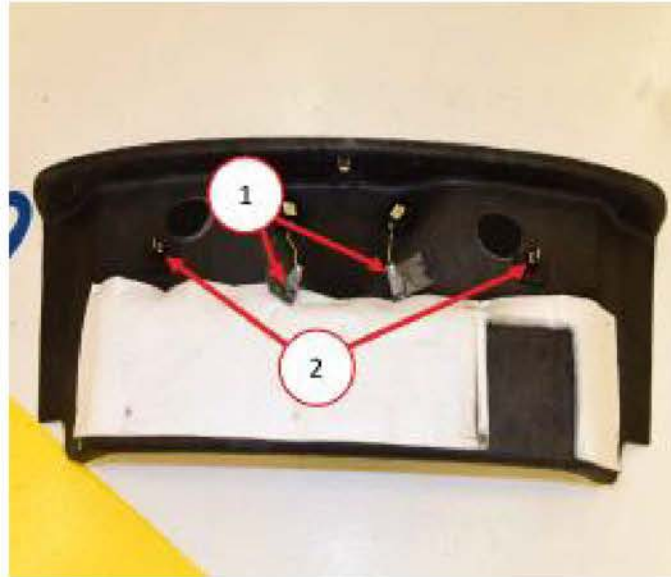
***Fig. 3 Trunk Trim Panel***

- 1 - Cargo lamp connectors
  - 2 - Spring clip tab locations
-

4. Remove the rear valance close out cover (Fig. 3). Use trim stick to assist with removing spring clip retainers. Take care in removal of panel, spring clips are bonded to panel and may be damaged if care is not taken during removal.

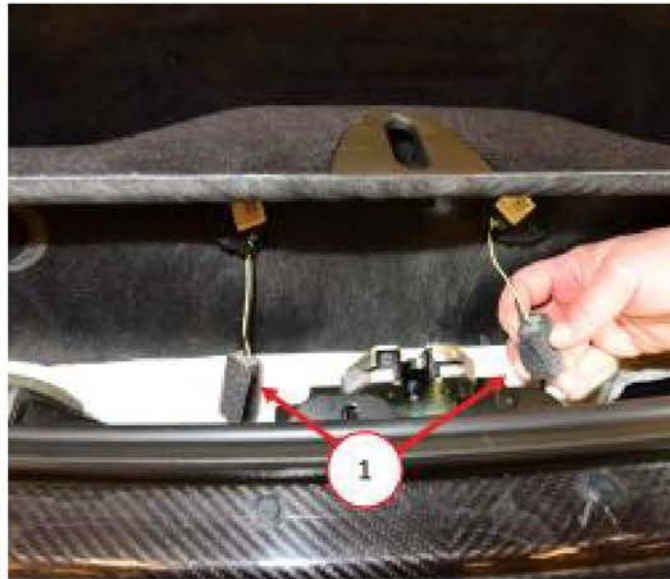
**Fig. 4 Foam Tape On Electrical Connector**

1 - Foam tape around cargo lamp connectors

5. Take care in removing foam tape from rear cargo lamp connectors (Fig. 4), during connector separation.

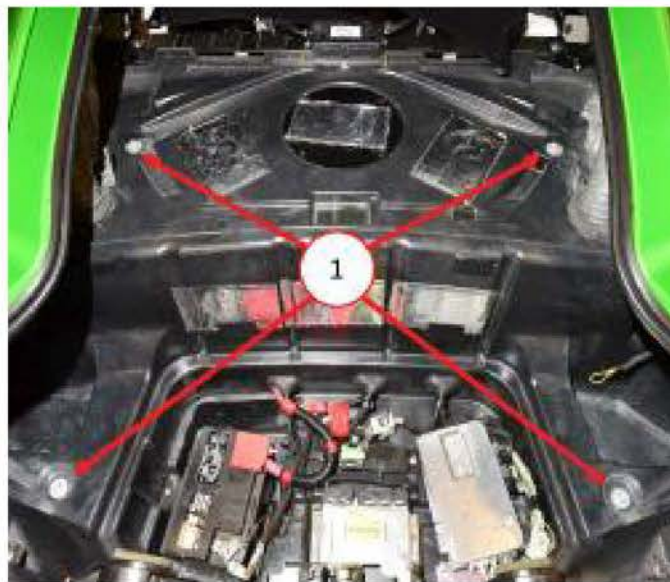
**Fig. 7 Trunkpan Bolt Locations**

1 - Trunkpan bolt locations

12. Torque the four main M-8 bolts to 22 N·m (16 Ft·Lbs) (Fig. 7).
