Subject: CORROSION AROUND SPOT WELDS IN TRUNK OPENING	Bulletin No: 09-011/16
	Last Issued: 02/23/2016

2014-15 Mazda3 vehicles with VINs lower than JM1BM*****211783 (produced before May 29, 2014)

2014-16 Mazda6 vehicles with VINs lower than JM1GJ*****416327 (produced before March 2, 2015)

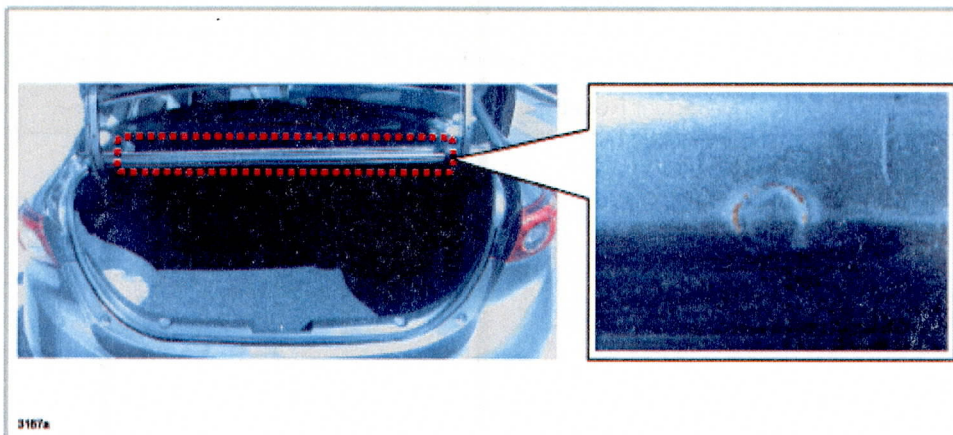
Some vehicles may exhibit corrosion around the spot welds in the trunk opening under the rear window. This is caused by insufficient paint thickness at the spot welds. To correct the problem, the paint thickness has been improved.

1. Verify customer concern.
2. Repair the rust damage on the panel.
3. Verify repair.
