Service Bulletin

Bulletin No.: 16-NA-107

Date: April, 2016

Subject: DTC U0184 Set, Radio Inoperative, Blue Screen, AM Clipping Noise, HD On/Off Status Not Retained in Stations, Time Lag on Transitions, No Audio with Internal Amp, Park Assist Symbol Position Wrong in Rear View Camera

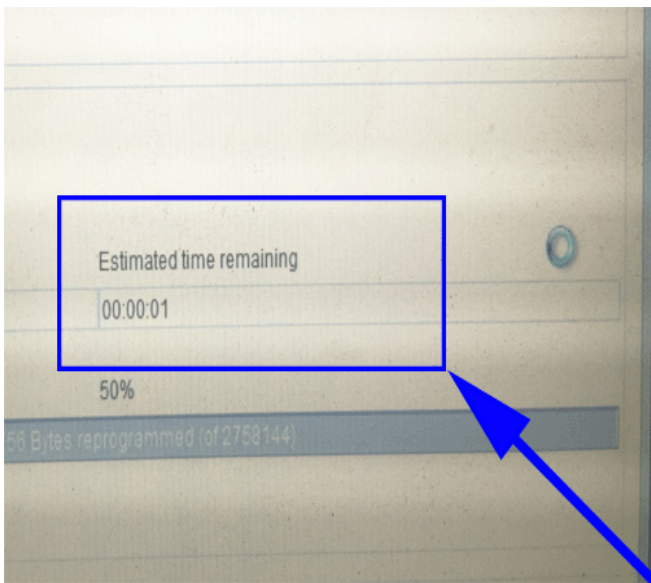
4485664

Important: During the SPS procedure, when the estimated time remaining reaches 00:00:01, it may take a few minutes to complete the reprogramming. Be sure to wait until the reprogramming is completed.

If you encounter a vehicle with the above concern, reprogram the radio with the latest calibrations. Refer to the proper SPS radio reprogramming procedure in SI.
