Service Bulletin

Bulletin No.: 15-08-51-001A

Subject: Availability of Insulator Service Part for Prevention of Liftgate Rust/Corrosion at Center Applique

Models: 2010-2015 Chevrolet Equinox
2010-2015 GMC Terrain

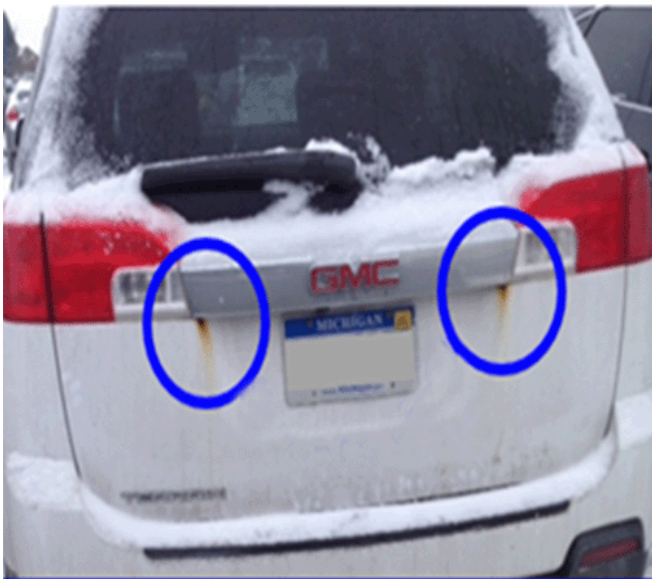
4252404

On some vehicles, due to the applique contacting and rubbing on the liftgate painted surface, rust spots (shown circled above) may be evident at the lower corners of the center chrome applique on the rear liftgate.

When repairing this rust spot condition, it will be necessary to remove the original applique, and repair any rust spot condition following common industry standards. Then, depending on model being repaired, follow the appropriate service part replacement advised below:
