# Service Bulletin

**Subject:** Poor Radio Hands-free Voice Recognition Performance or Sound Quality After OnStar Upgrade

- Models:**
- 2008-2015 Buick Enclave
  - 2012 Buick Verano
  - 2006-2011 Cadillac DTS
  - 2007-2009 Cadillac SRX
  - 2007-2013 Cadillac Escalade
  - 2008-2015 Cadillac CTS
  - 2007-2013 Chevrolet Avalanche, Silverado, Suburban, Tahoe
  - 2007-2013 GMC Denali, Sierra, Yukon
  - 2007-2015 GMC Acadia
  - 2007-2010 Saturn OUTLOOK

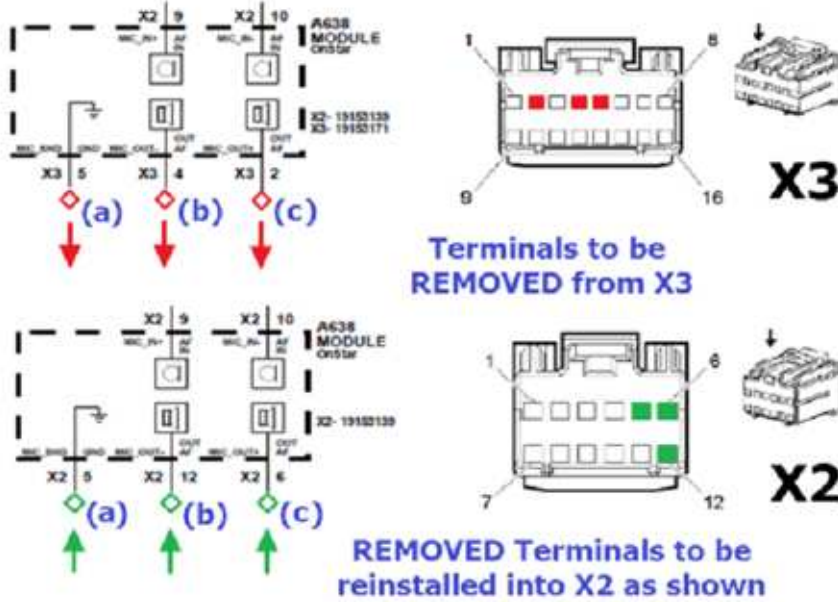
## Repair 1 - OnStar Module, Relocate the Microphone and Ground Circuits from X3 to X2 Connector

After the GM of Canada OnStar Cellular Communication Upgrade (Bulletin 15-08-44-001 or later), some vehicles with radio hands-free voice recognition are at risk of experiencing performance and sound quality issues such as:

- a: Move terminal 5 on X3 to terminal 5 on X2.
- b: Move terminal 4 on X3 to terminal 12 on X2.
- c: Move terminal 2 on X3 to terminal 6 on X2.

- (a) Move terminal 5 on X3 to terminal 5 on X2
- (b) Move terminal 4 on X3 to terminal 12 on X2
- (c) Move terminal 2 on X3 to terminal 6 on X2
