Service Bulletin

Bulletin No.: 16-NA-109

Subject: Grease or Sealant Visible on Electronic Power Steering Gear - Should Not Be Interpreted as Leak

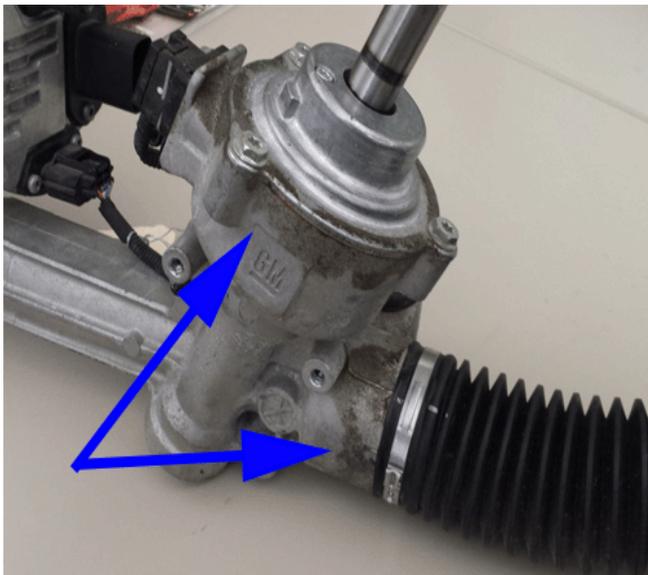
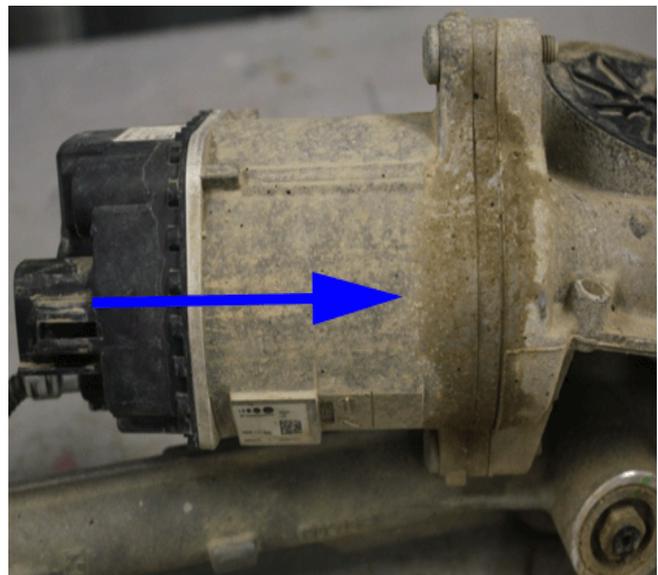
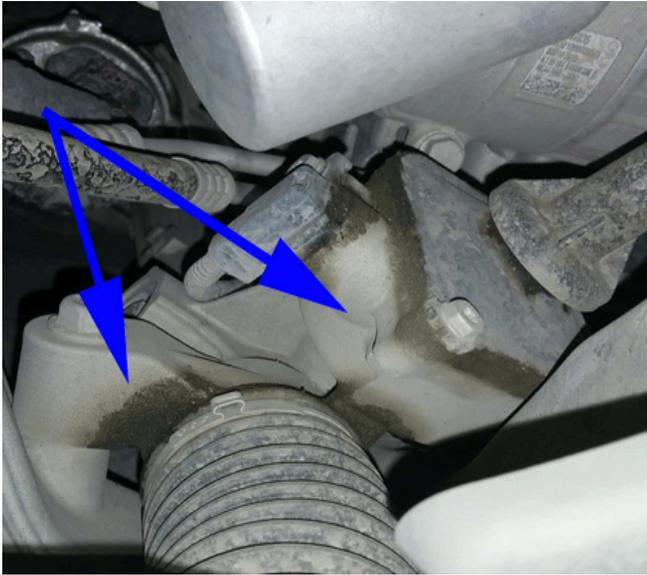
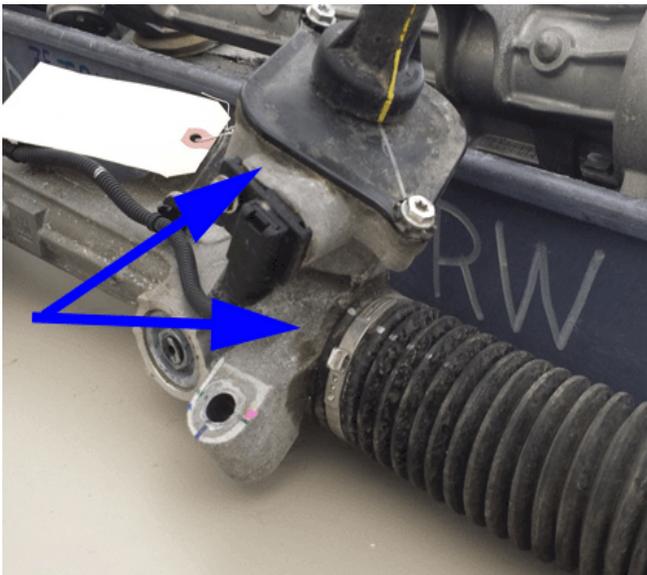
The graphics below are photo examples, which include arrows showing some of the common areas where grease may be evident after the vehicle has been driven for a length of time.

If upon inspection, the steering gear assembly clamps, boots, and fasteners are all in place, the visual evidence of grease/sealant on the exterior of the steering gear is considered normal and no correction is necessary. If excess grease is noted, it should be wiped off the exterior of the gear, however, sealant should be left in place as a barrier to water and contamination, and no cleaning is required.
