Service Bulletin

Bulletin No.: 16-NA-118

Subject: Engine Wiring Harness Chafing, No Start or Malfunction Indicator Lamp (MIL) ON

Brand:	Model:	Model Year:		VIN:		Engine:	Transmission:
Branu.	Woder.	from	to	from	to		
Chevrolet	Sonic	2013	2014			LUW, LWE	All

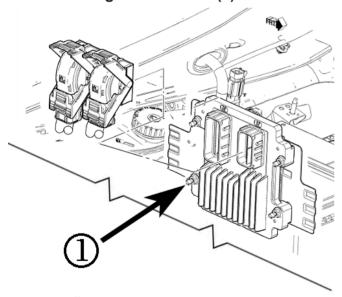
4487333

Condition	Some customers may comment on various conditions such as; no start, Malfunction Indicator Lamp (MIL) ON, and possible loss of steering assist.	
Cause	Technicians may find the engine harness routed too close to the ECM lower mounting bracket stud. The stud can pierce the harness, and chafe and short wires inside the harness.	
Additional Options	Equipped with 1.8L L4 LUW or 1.8L L4 LWE engine

ECM Mounting Bracket Stud (1) Contact Area

Inspect the harness for signs of contact or damage. Reroute or repair as necessary.
