Service Bulletin

Bulletin No.: 16-NA-120

Subject: Rattle Noise Under Vehicle When Turning Left During Rough Road Conditions

Brand: Model:		Model Year:		VIN:		Engine:	Transmission:
Branu.	woder.	from	to	from	to		
Chevrolet	Trax/Tracker	2015	2016	July 7, 2015	July 10, 2015	All	All

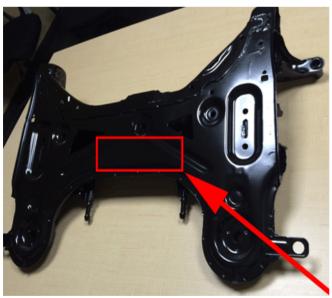
4489155

2. Visually inspect the cradle in the approximate location above for the julian date.

If the julian date is 189 or 190, continue on to step 3. If the julian date is not 189 or 190, continue diagnosis referring to SI.

3. Replace the cradle. Refer to *Drivetrain and Front Suspension Frame Replacement* in SI.

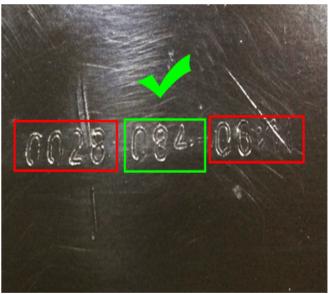
4489156

The julian date will be the middle three numbers as illustrated above.
