Service Bulletin

Bulletin No.: 16-NA-123

Subject: Cooling Fan Inoperative, Malfunction Indicator Lamp ON (Check Engine Light), and/or DTC P0480, P0691 Set

Models: 2016 Chevrolet Malibu (VIN Z)

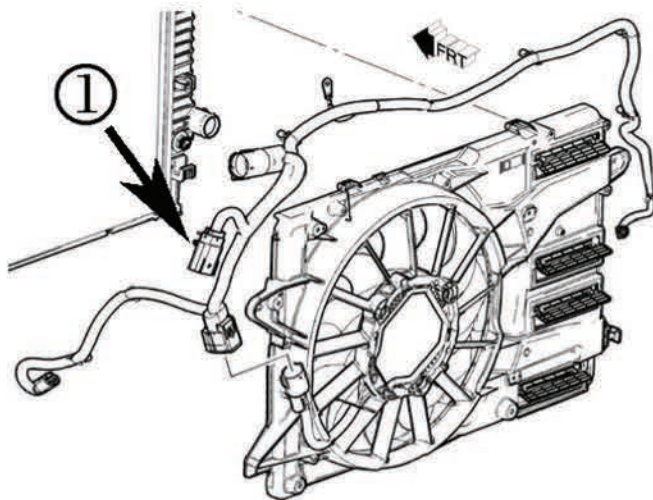
4452764

Involved Region or Country	North America and Israel
Condition	Some customers may comment that the Malfunction Indicator Lamp (MIL) or (Check Engine Light) is ON. Technicians may find DTC P0480 and/or P0691 set.
Cause	Upon inspection, technicians may find water intrusion in the X117 cooling fan connector.

Cooling fan harness connectors (1) are to be inspected. The harness connector on the engine side is to be cleaned if possible, and the cooling fan jumper harness should be replaced if needed.
