# Service Bulletin

**Subject:** Rattle Noise Diagnostics with LWN 2.8L Diesel

**Models:** 2016 Chevrolet Colorado  
2016 GMC Canyon  
W/ LWN 2.8L Diesel Engine

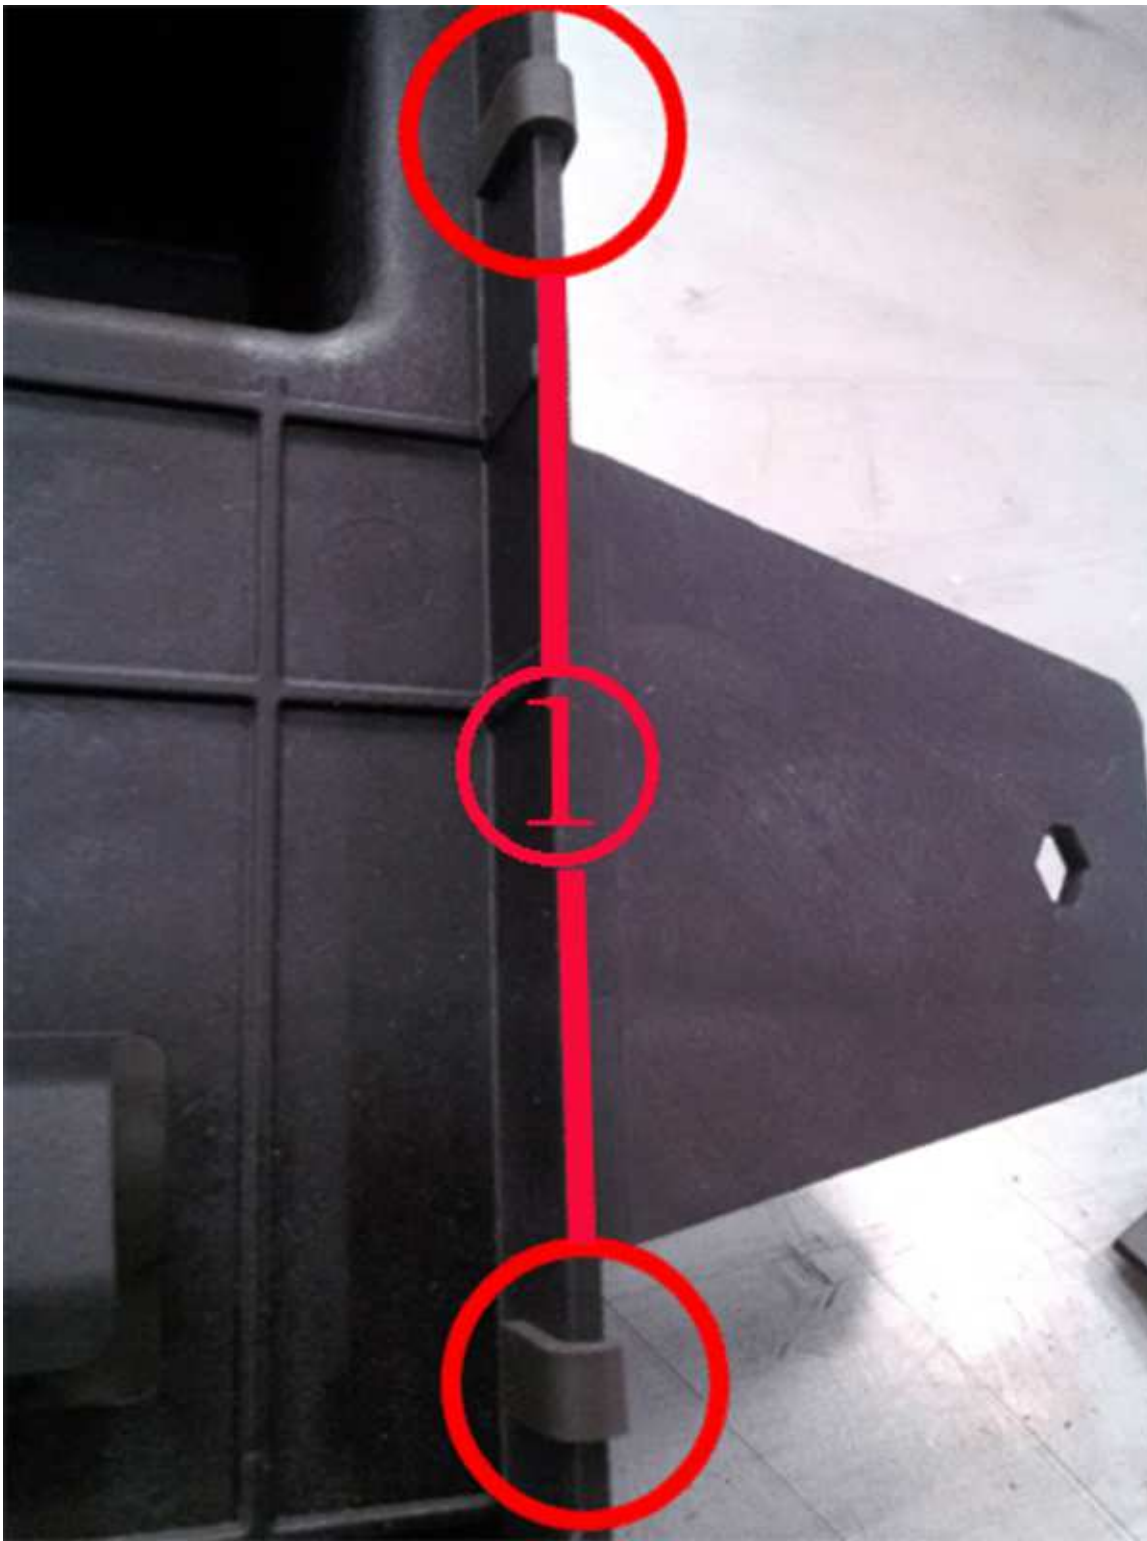
Engineering has identified 3 possible areas to inspect for a rattle noise.

1. The ECM may be loose in the mounting bracket. If you can move the ECM in the bracket remove it from the mount and apply 2 foam strips, 2mm thick, 20mm by 15mm to the body of the bracket and reinstall the ECM. (Recommend Walco 215 or 3M 4696 adhesive backed foam.) Place the foam strips as shown below.
