Service Bulletin

Subject: Service ABS / TCS / Power Steering and/or Suspension Message DTC U0077 U0121 U0126 U0131 U0139 U0151 U0401 U0415 U0428 (Circuit 5986 High Resistance)

Models: 2015-2016 Cadillac Escalade Models
2014 Chevrolet Silverado 1500
2015-2016 Chevrolet Silverado, Suburban, Tahoe
2014 GMC Sierra 1500
2015-2016 GMC Sierra, Yukon Models

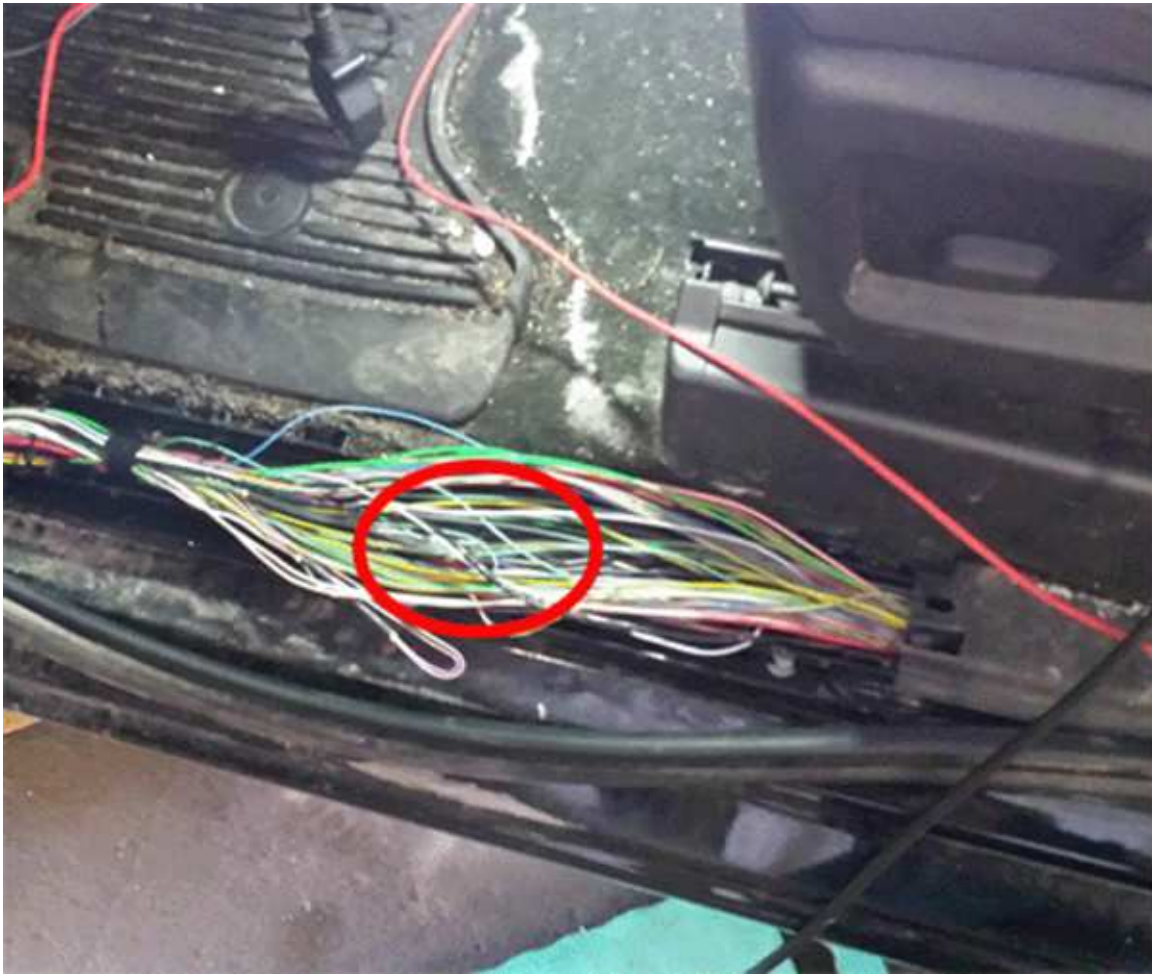
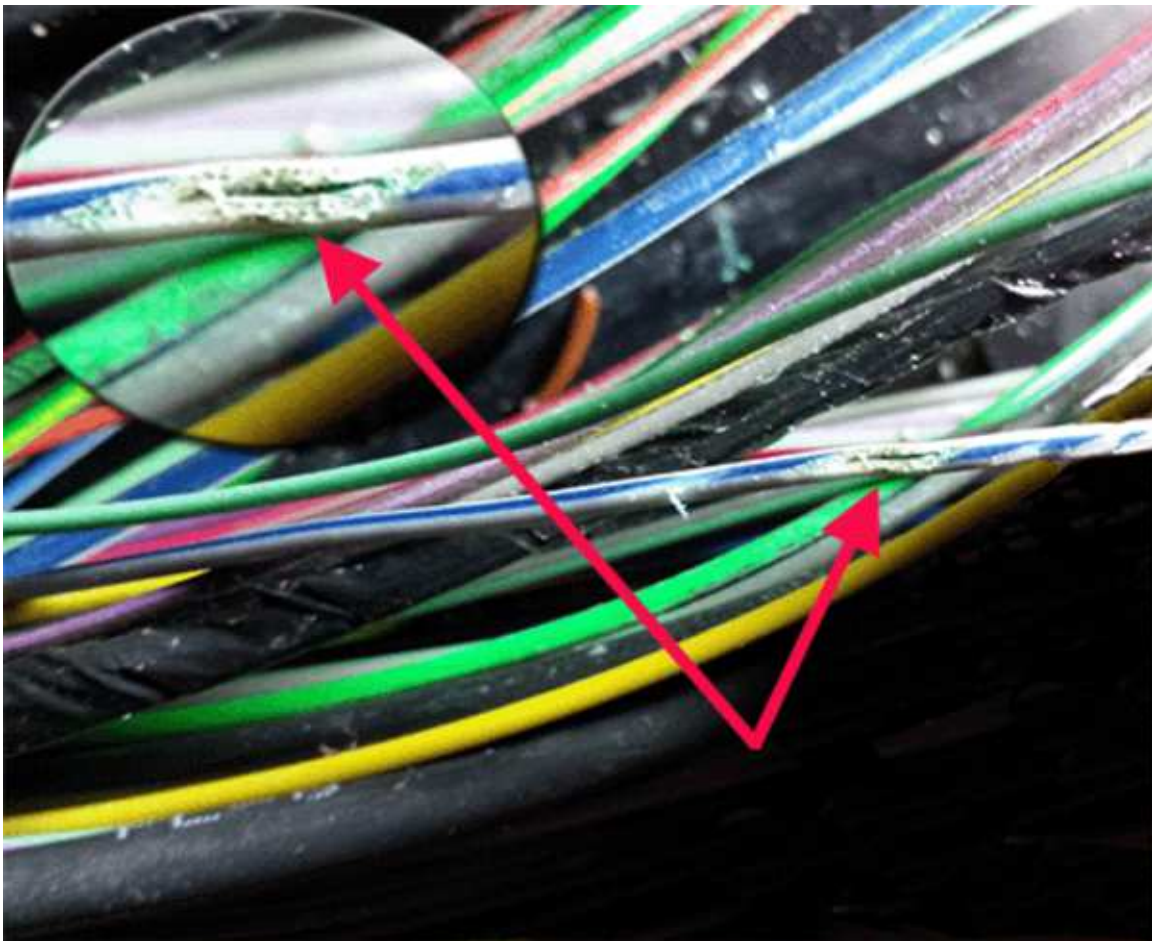
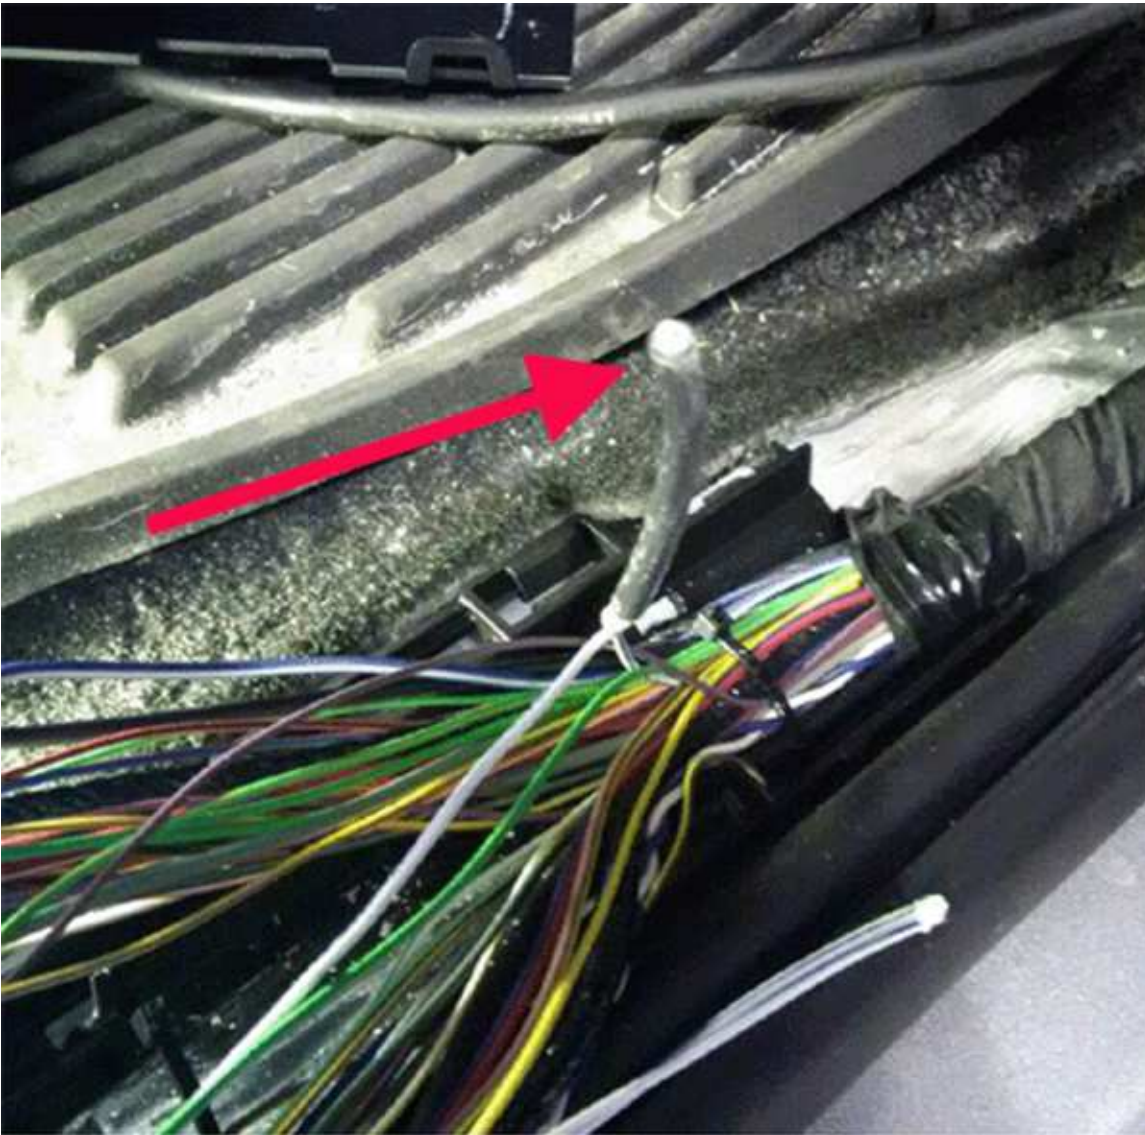
These concerns could be caused by high resistance/open in the Communication Enable circuit 5986. The BCM activates this circuit when the ignition key is in ACC, ON, and START positions (There will be voltage present in the OFF position only for a short time until the BCM goes to sleep). The communication enable circuit wakes up the module for serial data bus communication. Circuit 5986 will have approximately 12 volts and should light a test light, but is not designed to handle heavier electrical loads like a headlight bulb. Shown below are two known areas where circuit 5986 has been found to be open or have high resistance:

1. Under the driver's sill plate
2. Splice J365 located under the passenger front sill plate

Monitor the voltage on the communication enable circuit 5986 at any of the modules affected, example EBCM, PSCM, SDM, and/or SCM. If low voltage or no voltage is present when the concern occurs, inspect for high resistance under the driver's or passenger's sill plate area. Repair any opens or high resistance in the circuit.
