Service Bulletin

Subject: Steering Feels Loose And/Or Excessive Lash (Adjust Steering Gear)

Models: 2016 Chevrolet Silverado 2500/3500
2016 GMC Sierra 2500/3500
With Digital Steering Assist (RPO NV8)

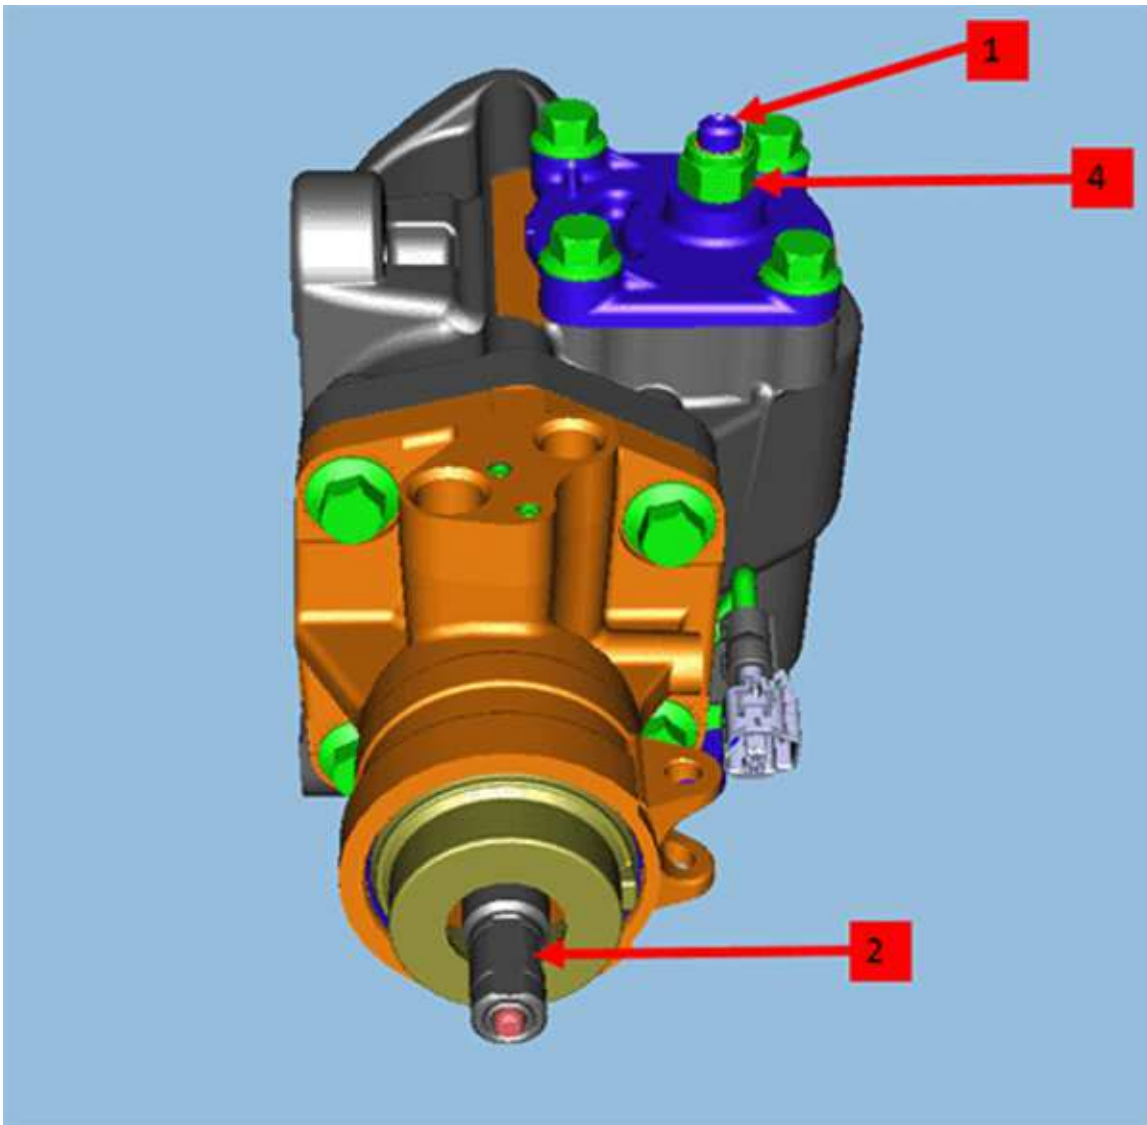
Some owners may comment the steering feels loose or has excessive play. This concern could be caused by an incorrect Pitman Shaft Over-Center Preload Adjustment.

1. Remove the steering gear from the vehicle

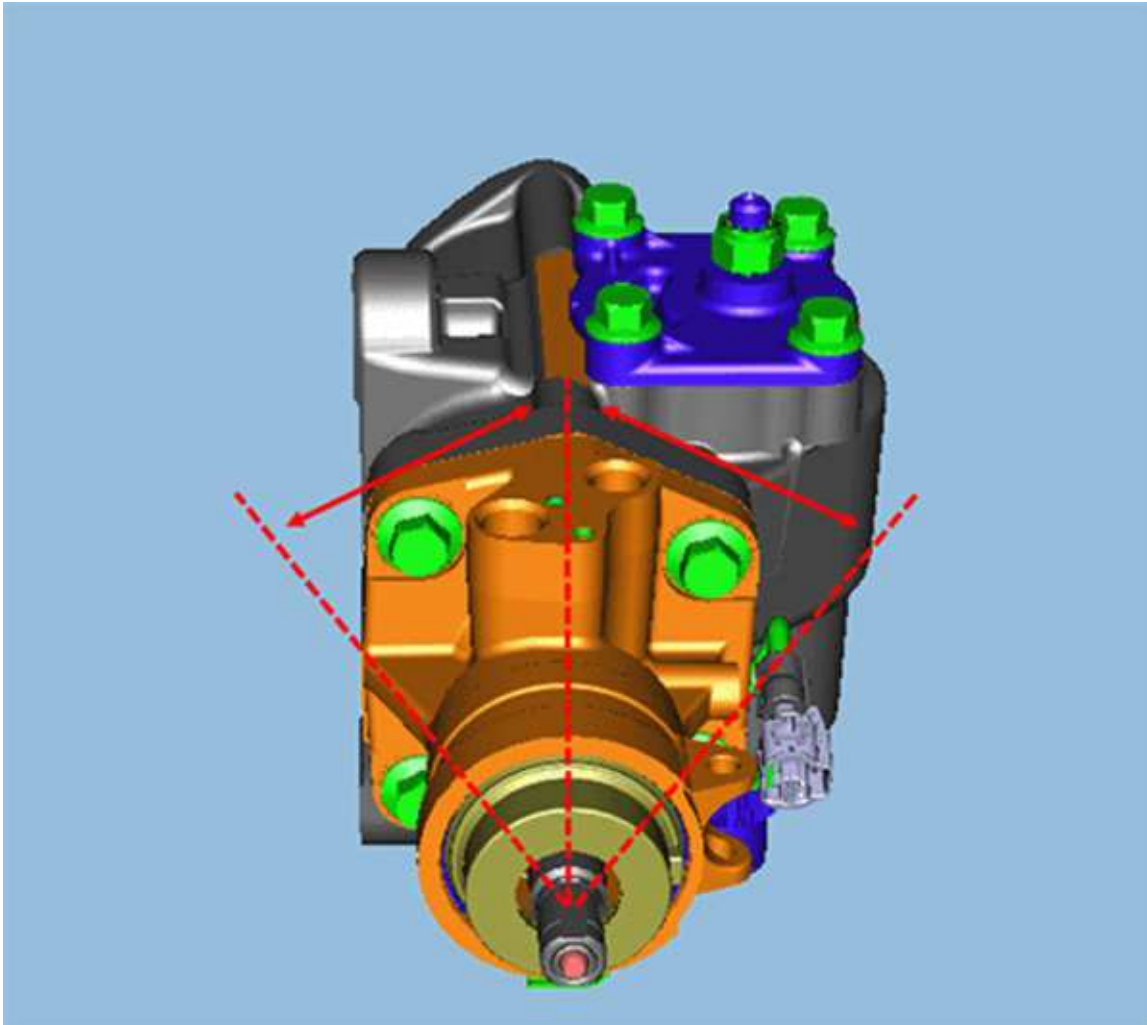
10. Record the average turning torque from -300 to +300 degree sweep. This value is the "off center friction" torque.
11. The average "off center friction" torque must be 0.4 to 1.1 Nm (4 to 10 in lbs). If the torque is outside this range, replace the steering gear assembly.

9. Rotate the steering gear input shaft 300 degrees from each side of the center of the input shaft.

The input shaft MUST rotate smoothly and must NOT stick or bind.
