Service Bulletin

PRELIMINARY INFORMATION

Subject: Check Engine Light MIL P015B and / or P1101 Reduce Engine Power

Models: 2013 - 2016 Buick Regal
2013 - 2016 Cadillac ATS
2014 - 2016 Cadillac CTS
2016 Cadillac CT6
2013 - 2016 Chevrolet Malibu
(with engine 2.0L RPO LTG)

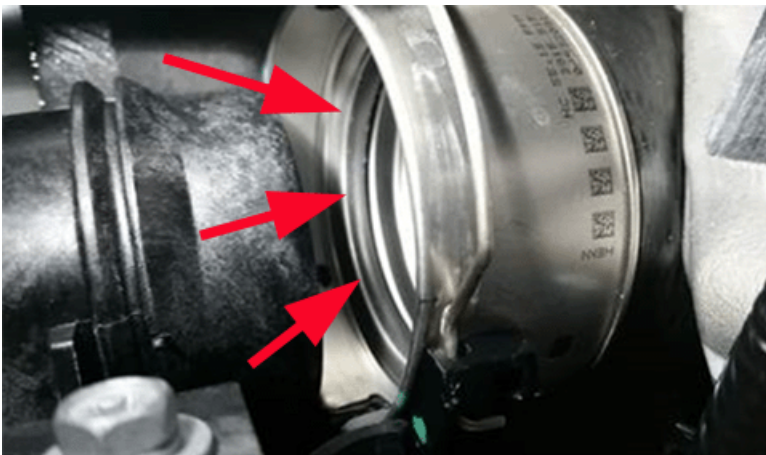
This coupler is located on the passenger side of the charge air cooler where the air duct slips into it.

The arrows in the picture below are pointing to the O-ring seal being discussed.

The picture below is from an ATS. Other models are similar.

After following normal SI diagnostics, if a solution is not found, inspect for a missing/damaged O-ring seal in the charge air cooler coupler.
