# Service Bulletin

## PRELIMINARY INFORMATION

**Subject:** Engine Runs Rough With Knock Noise and/or Backfire Pop Sound Coming From Air Filter

**Models:** 2016 Chevrolet Express and Silverado  
2016 GMC Savana and Sierra  
Equipped with the Duramax Diesel Engine RPO codes LGH or LML

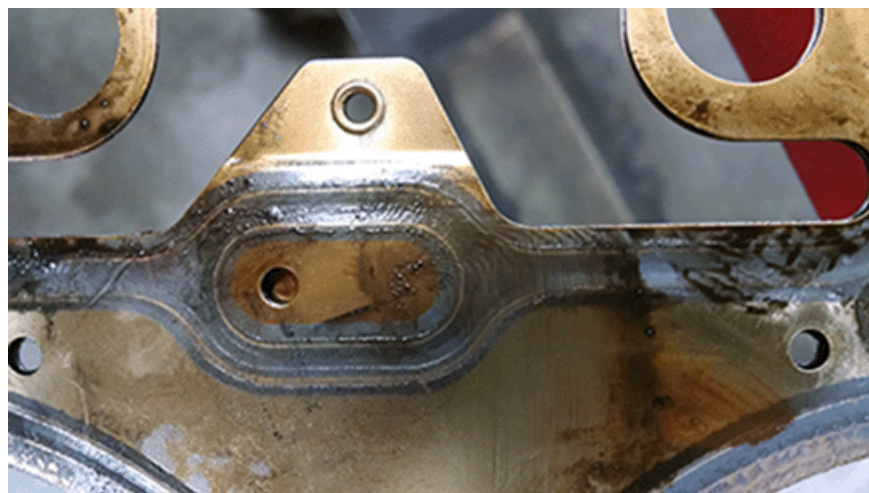
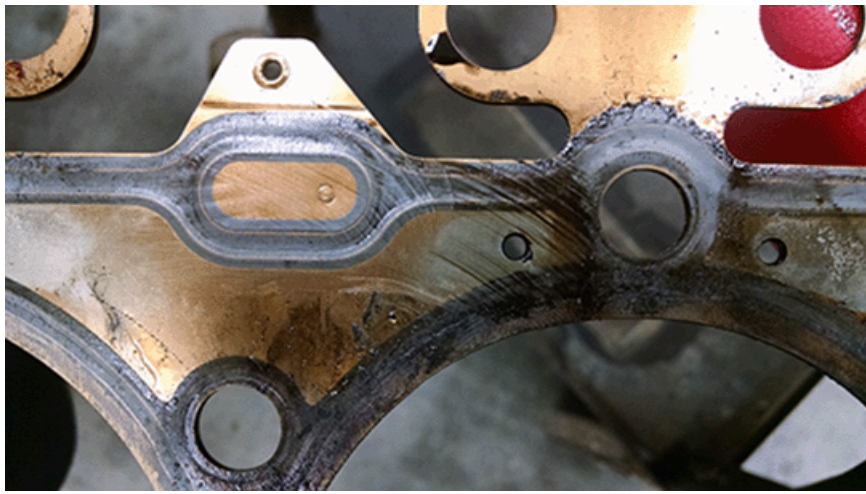
If SI diagnosis does not isolate the cause of this concern, it may be the result of a lack of lubrication to the rocker arms and valve train components. The cause of the lack of lubrication may be oil feed holes through the head gasket(s) that are not completely punched through.

Vehicles produced in January 2016 are the most likely to be affected.

If the gasket is confirmed to have a missing lubrication hole, the affected cylinder head and head gasket as well as all lubricated parts (pushrods, rockers, rocker shafts, lifters, and bridge pads) **MUST** be replaced. In addition all valves and valve seals must be replaced as well.

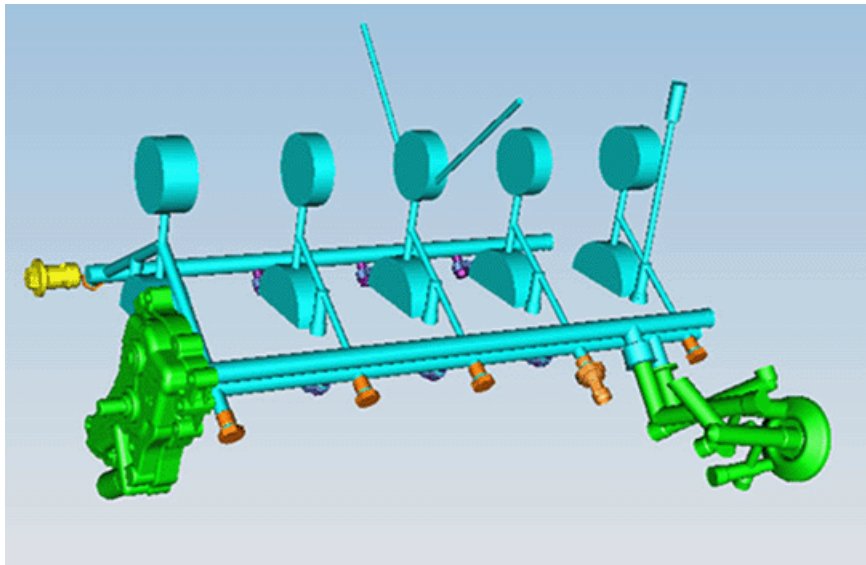
Oil flows from the crankshaft/camshaft bearing galleries to the number 3 camshaft bearing, where it exits to both cylinder heads and enters the hollow rocker arm shafts. Oil flows through the rocker arm shafts and rocker arms where it lubricates the upper valve train components. Reference SI Lubrication Description and the diagram below for more details.

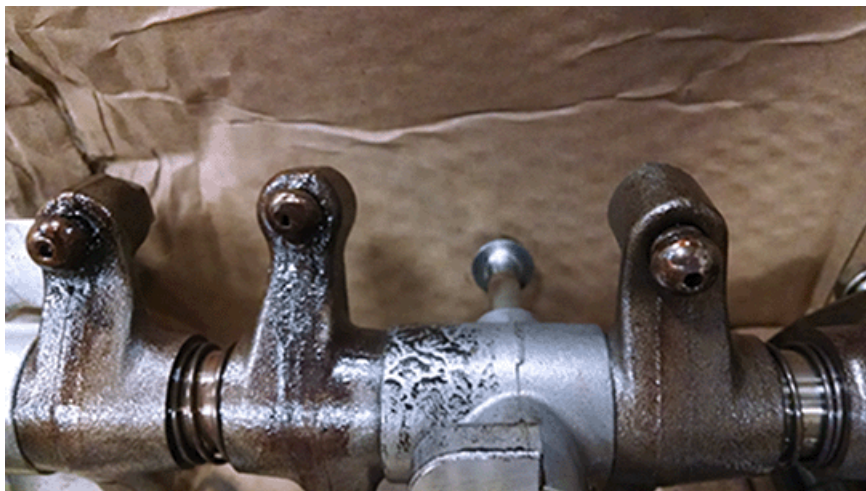
If suspected, check for signs of lack of lubrication to the rocker arms and valve train components. Inspect for worn cups on the pushrods and / or for worn pushrod seats on the rocker arms.
