Service Bulletin

PRELIMINARY INFORMATION

Subject: Phone Icon On Radio Display Intermittently Will Not Respond Or Spins When Pressed

Models: 2014-2016 Buick Encore, Verano
2016 Buick Cascada
2014-2016 Chevrolet Camaro, Caprice, Cruze, Equinox, Malibu, Orlando, SS, Volt
2014-2016 GMC Terrain
Equipped with radio RPO UP9

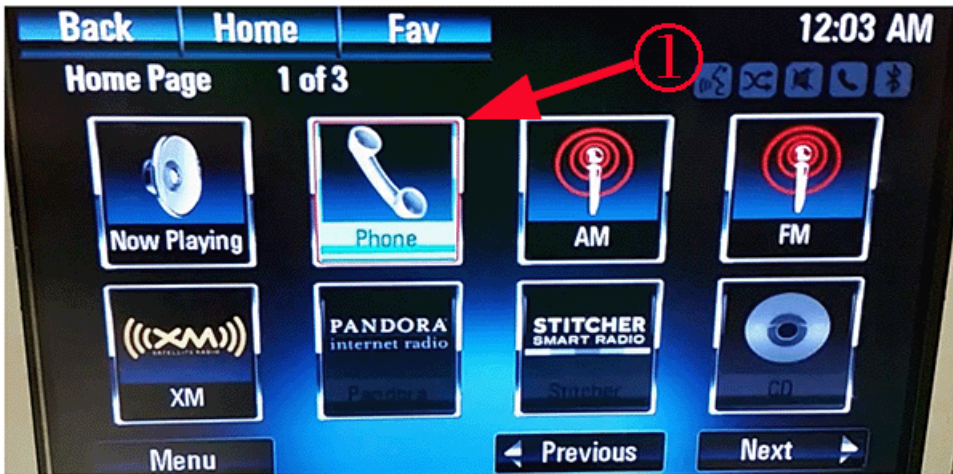
A customer may comment that when pressing the phone icon on the radio display that it will highlight, or highlight and spin, but the radio will not change from the screen.

Please order a replacement radio for this concern. Follow SI documents to SPS and then USB update the replacement radio to the latest version. Please refer to the latest version of PIT5411 for the restricted parts ordering process.
