Service Bulletin

PRELIMINARY INFORMATION

Subject: Engine Noise

Models: 2006-2007 Buick Lucerne
Equipped with a 3800 engine

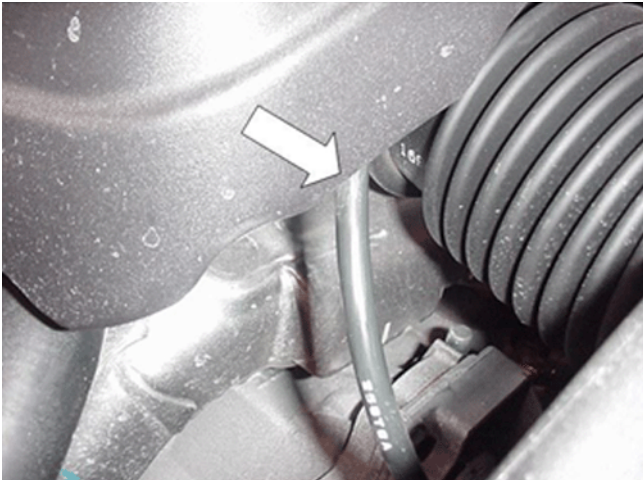
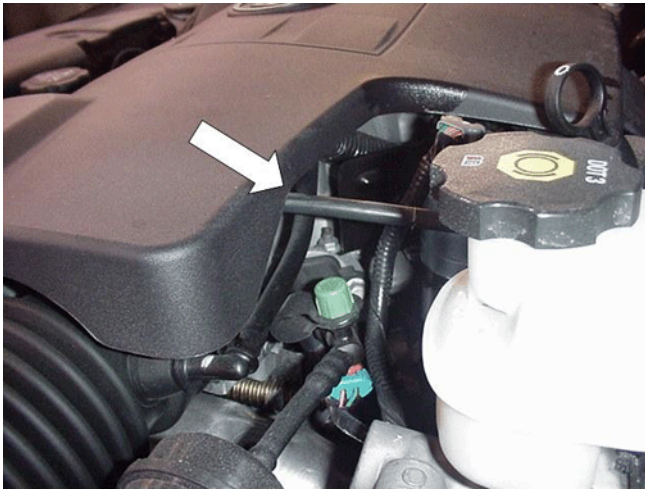
Some owners may comment about a noise coming from the engine when accelerating or when at steady speeds. Some may comment that the noise sounds like spark knock.

The engine cover may be contacting or vibrating against the transmission shift cable. In addition the shift cable may be contacting the side of the brake booster down behind the engine.

If the engine cover is contacting the cable then remove the cover and using plastic tie straps, attach a small piece of closed cell foam material to the cable at the point(s) where contact is taking place with the engine cover. Use a plastic tie strap to secure the shift cable away from the brake booster.
