TO: Service Locations

FROM: Service Systems Development

SUBJECT: **GHG17 DD Engine Platform With Water-In-Fuel Fault Codes SPN: 97
And Multiple FMI**

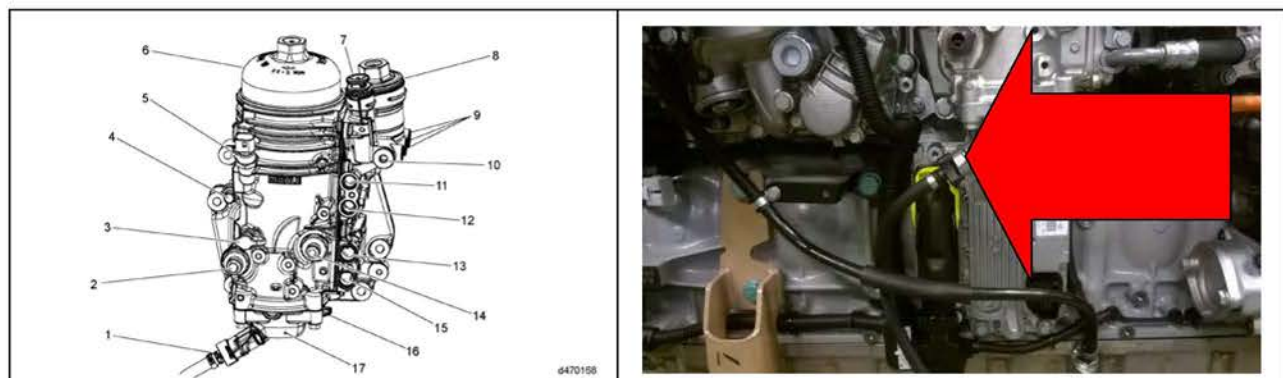
Some trucks are logging Water-In-Fuel fault codes SPN: 97 with multiple FMI variations. However, there is no actual water in the fuel tanks or on the bottom of the fuel filter module when the Water Drain Bowl Valve is opened. See Figure 1, item #1 in the left picture, for the location of the Water Drain Bowl Valve.

Figure 1 – Location of Water Drain Bowl Valve

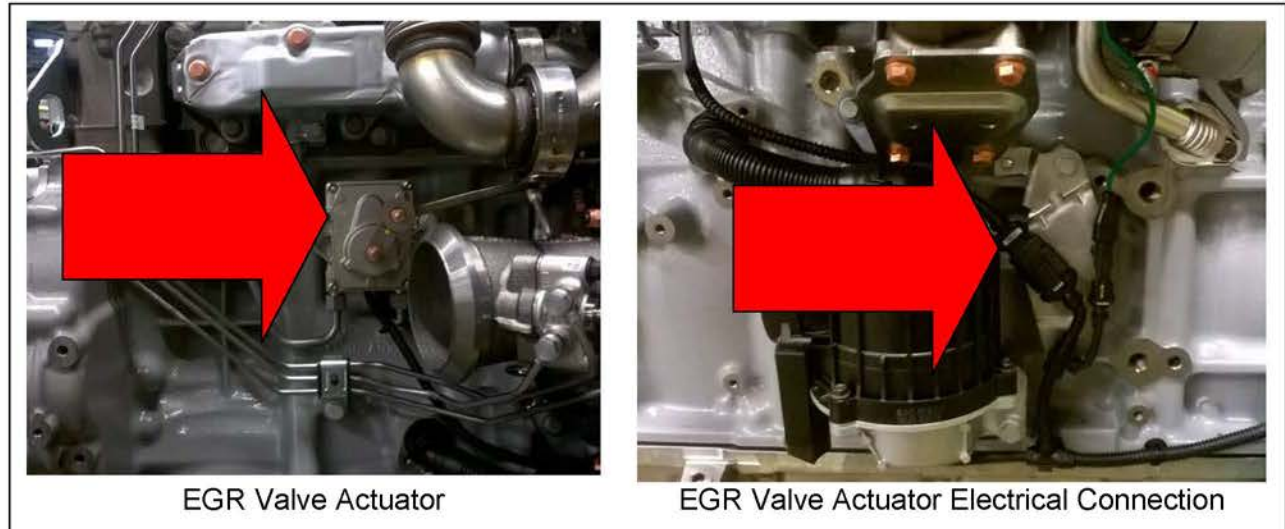
The cause of the fault codes is due to coolant leaking internally in the watercooled Exhaust Gas Recirculation (EGR) Valve Actuator. The coolant then wicks down the electrical connector pigtail to the Engine Sensor Harness, and then to the Motor Control Module (MCM) 120-pin electrical connector. The EGR Valve Actuator and Water-In-Fuel Sensor share some wiring in the Engine Sensor Harness.

Figure 2 – Location of EGR Valve Actuator and Electrical Connection

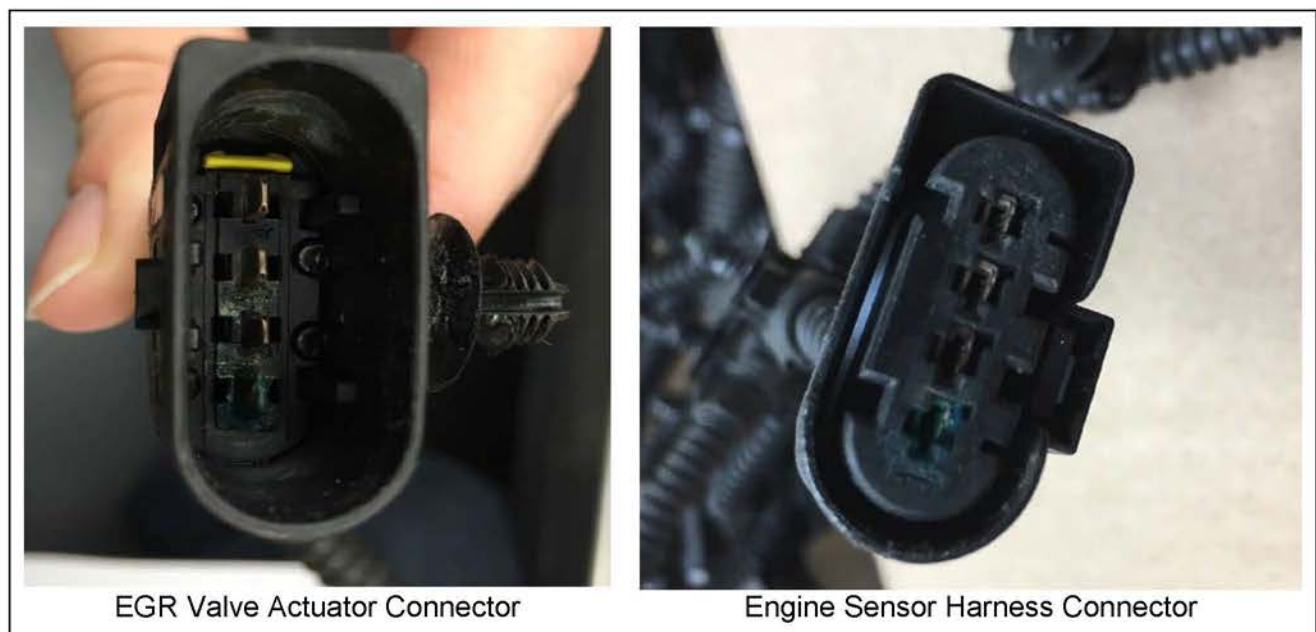
Figure 3 – Example of Damaged Connection at EGR Valve Actuator Connection

Follow the published troubleshooting for the applicable Water-In-Fuel code in Power Service Literature in the *GHG17 Troubleshooting Manual* (DDC-SVC-MAN-0191). If no water is found in the Water Drain Bowl, disconnect the EGR Valve Actuator connection to the Engine Sensor Harness and inspect both connectors for signs of coolant intrusion, corrosion, etc. If found, replace both the EGR Valve Actuator and Engine Sensor Harness. Inspect the Water-In-Fuel Sensor electrical connector for signs of coolant intrusion, corrosion, etc. If found, replace the Water-In-Fuel Sensor. Inspect the 120-pin connector at the MCM for signs of coolant intrusion, corrosion, etc. If found, replace the MCM. See Figures 3-5 for examples of damaged connectors.

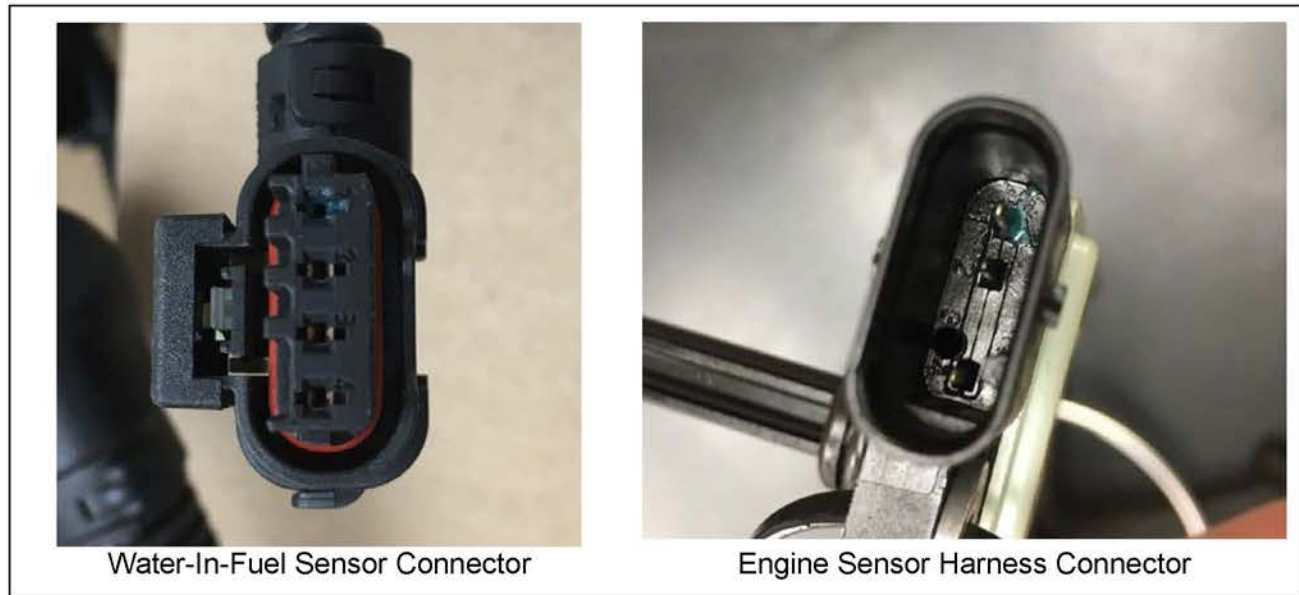
Figure 4 – Example of Damaged Connection at Water-In-Fuel Sensor Connection

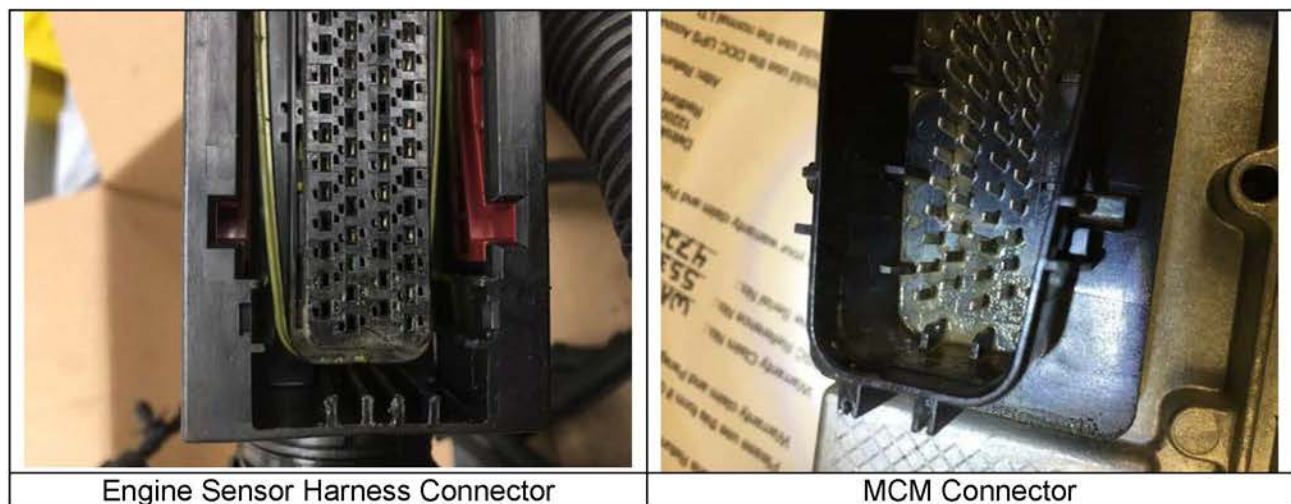
Figure 5 – Example of Damaged Connection at MCM 120-Pin Connection
