## 1 06 01-16

## Service Information Bulletin

| SUBJECT | DATE |
|---|---|
| SPN 103 (MCM) (GHG17) and SPN 103 (MCM)<br>(EPA07;EPA10;GHG14) | June 2016 |

### Additions, Revisions, or Updates

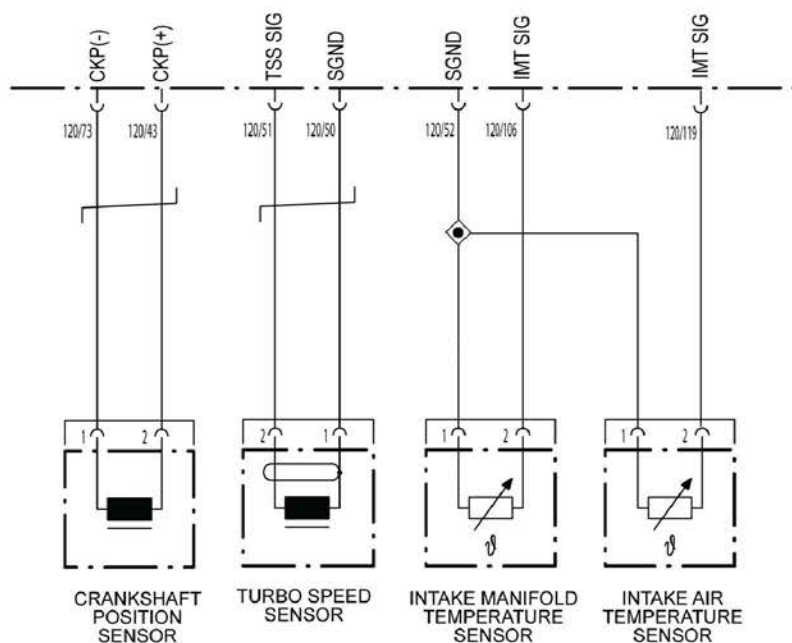
d150023

Turbo Speed Sensor Failed Low

| SPN 103/FMI 4 | |
|---|---|
| Description | This fault Sets when the Motor Control Module (MCM) Detects a Short to Ground on the Turbocharger Speed Sensor Circuit. |

1. Connect DiagnosticLink<sup>®</sup>.
2. Disconnect and inspect the turbocharger speed sensor electrical connector harness side. Is there corrosion present?
  - a. Yes; replace the turbocharger speed sensor and the electrical connector. Refer to section "Removal of the Turbocharger Speed Sensor". Verify repair.
  - b. No; Go to step 3.
3. Are any of the pins or the connector damaged?
  - a. Yes; Go to step 4.
  - b. No; Go to step 5.
4. Inspect the turbocharger speed sensor electrical connector component side. Are any of the pins or the connector damaged?
  - a. Yes; replace the turbocharger speed sensor and the electrical connector. Refer to section "Removal of the Turbocharger Speed Sensor". Verify repair.

- b. No; replace the turbocharger speed sensor electrical connector harness side. Verify repair.
5. Turn the ignition ON (key ON, engine OFF).
6. Is fault code SPN 103/FMI 4 active?

- a. Yes; Go to step 7.
  - b. No; replace the turbocharger speed sensor. Refer to section "Removal of the Turbocharger Speed Sensor". Verify repair.
7. Turn the ignition OFF.

8. Disconnect and inspect the MCM 120-pin electrical connector harness side. Is there corrosion present?
  - a. Yes; replace the MCM and the engine harness. Refer to section "Removal of the Motor Control Module". Verify repair.

- b. No; Go to step 9.
9. Is the connector damaged?
  - a. Yes; Go to step 10.
  - b. No; Go to step 11.
10. Inspect the MCM 120-pin electrical connector component side. Are any of the pins or the connector damaged?

- a. Yes; replace the MCM and the engine harness. Refer to section "Removal of the Motor Control Module". Verify repair.
  - b. No; replace the engine harness. Verify repair.

11. Measure the resistance between pin 2 of the turbocharger speed sensor electrical connector harness side and pin 52 of the MCM 120-pin electrical connector harness side. Is the resistance less than 10k ohms?

- a. Yes; repair the circuit between pin 2 of the turbocharger speed sensor electrical connector harness side and pin 52 of the MCM 120-pin electrical connector harness side.

- b. No; replace the MCM. Refer to section "Removal of the Motor Control Module". Verify repair.

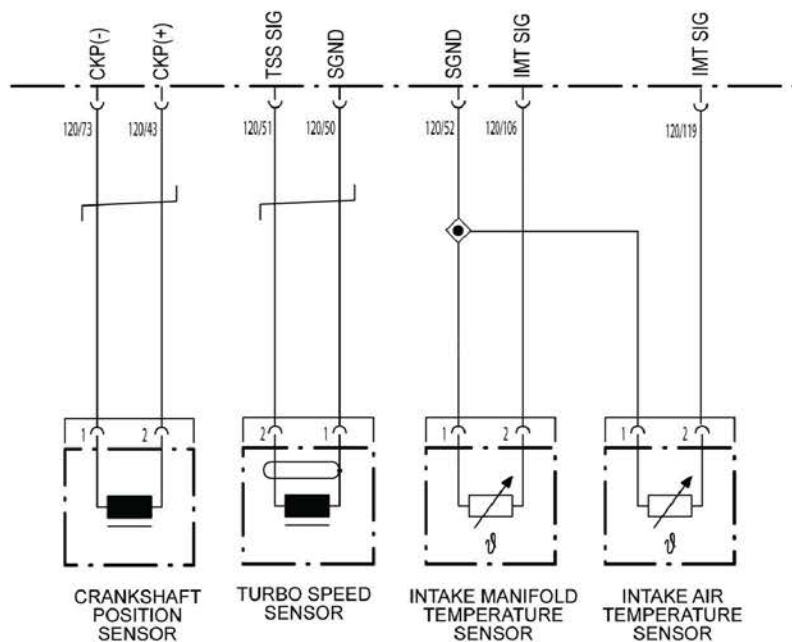
d150023

Turbo Speed Sensor Failed Low

| SPN 103/FMI 4 | |
|---|---|
| Description | This fault Sets when the Motor Control Module (MCM) Detects a Short to Ground on the Turbocharger Speed Sensor Circuit. |

1. Connect DiagnosticLink<sup>®</sup>.
2. Disconnect and inspect the turbocharger speed sensor electrical connector harness side. Is there corrosion present?
  - a. Yes; replace the turbocharger speed sensor and the electrical connector. Refer to section "Removal of the Turbocharger Speed Sensor". Verify repair.
  - b. No; Go to step 3.
3. Are any of the pins or the connector damaged?
  - a. Yes; Go to step 4.
  - b. No; Go to step 5.
4. Inspect the turbocharger speed sensor electrical connector component side. Are any of the pins or the connector damaged?
  - a. Yes; replace the turbocharger speed sensor and the electrical connector. Refer to section "Removal of the Turbocharger Speed Sensor". Verify repair.
  - b. No; replace the turbocharger speed sensor electrical connector harness side. Verify repair.

5. Turn the ignition ON (key ON, engine OFF).
6. Is fault code SPN 104/FMI 4 active?
  - a. Yes; Go to step 7.
  - b. No; replace the turbocharger speed sensor. Refer to section "Removal of the Turbocharger Speed Sensor" . Verify repair.

7. Turn the ignition OFF.
8. Disconnect and inspect the MCM 120-pin electrical connector harness side. Is there corrosion present?
  - a. Yes; replace the MCM and the engine harness. Refer to section "Removal of the Motor Control Module". Verify repair.

- b. No; Go to step 9.
9. Is the connector damaged?
  - a. Yes; Go to step 10.
  - b. No; Go to step 11.
10. Inspect the MCM 120-pin electrical connector component side. Are any of the pins or the connector damaged?

- a. Yes; replace the MCM and the engine harness. Refer to section "Removal of the Motor Control Module". Verify repair.
  - b. No; replace the engine harness. Verify repair.

11. Measure the resistance between pin 2 of the turbocharger speed sensor electrical connector harness side and pin 52 of the MCM 120-pin electrical connector harness side. Is the resistance less than 10k ohms?

- a. Yes; repair the circuit between pin 2 of the turbocharger speed sensor electrical connector harness side and pin 52 of the MCM 120-pin electrical connector harness side.

- b. No; replace the MCM. Refer to section "Removal of the Motor Control Module". Verify repair.
