Service Information Bulletin

SUBJECT	DATE
SPN 4364 (ACM) (GHG17)	June 2016

2 SPN 4364/FMI 17 - GHG17

SCR NOx Conversion Efficiency

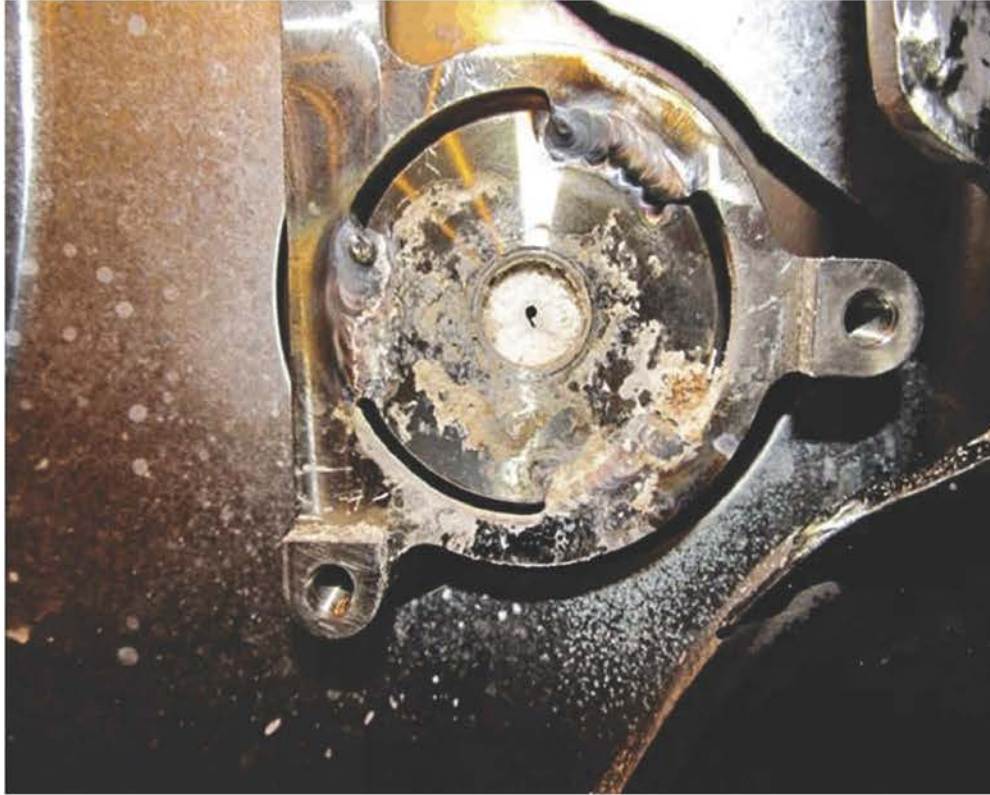
d140642

NOTICE: DEF crystallization inside the SCR mixing chamber or around the dosing unit does not indicate a failed/ leaking DEF doser. Do not replace the DEF dosing unit unless directed.

13. Inspect the area around the DEF dosing unit gasket for DEF crystallization. Is there any DEF crystallization build-up present?
 - a. Yes; this indicates the gasket has failed, NOT the DEF dosing unit. Replace the gasket after completing the DEF quantity test in the next step. Go to step 14.
 - b. No; Go to step 14.
14. Unbolt the DEF doser from the aftertreatment; do not disconnect the DEF lines or electrical connector.

Figure 1. Normal DEF Crystallization in the DEF Doser Port Hole

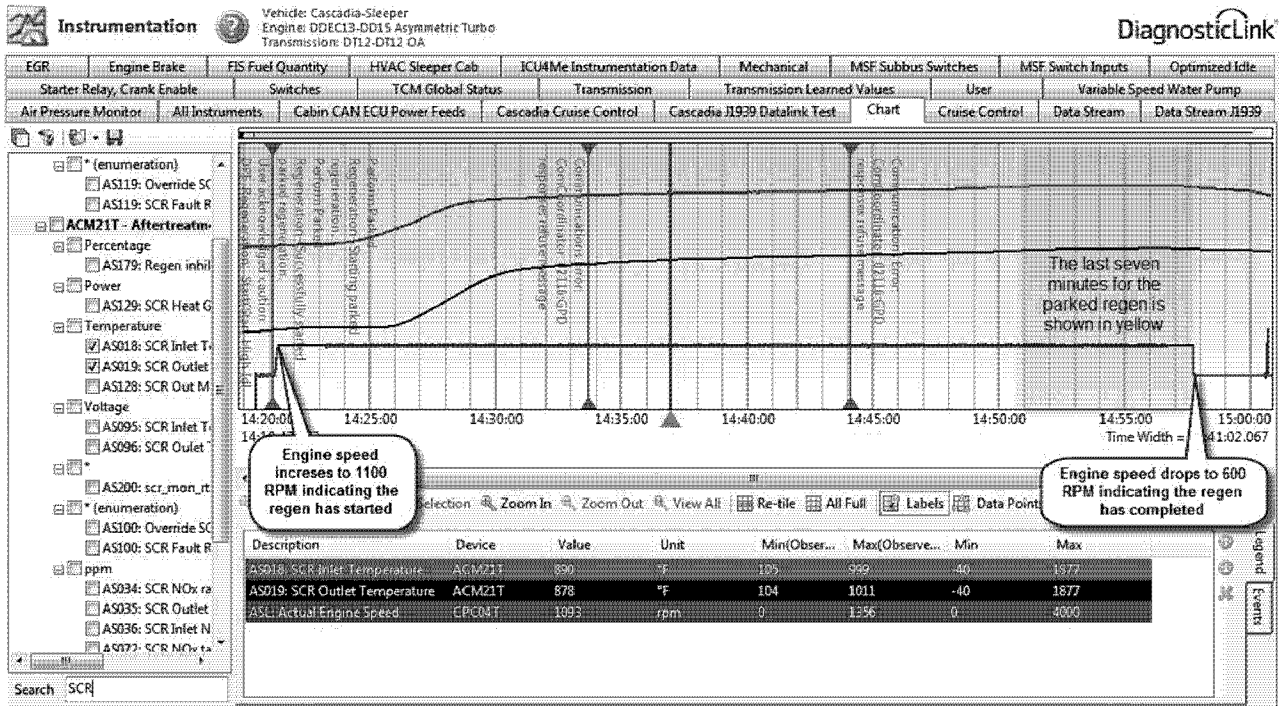
d500301

24. Review the last seven minutes of the parked regeneration log data from step 23. The illustration below identifies the last seven minutes of the parked regen.

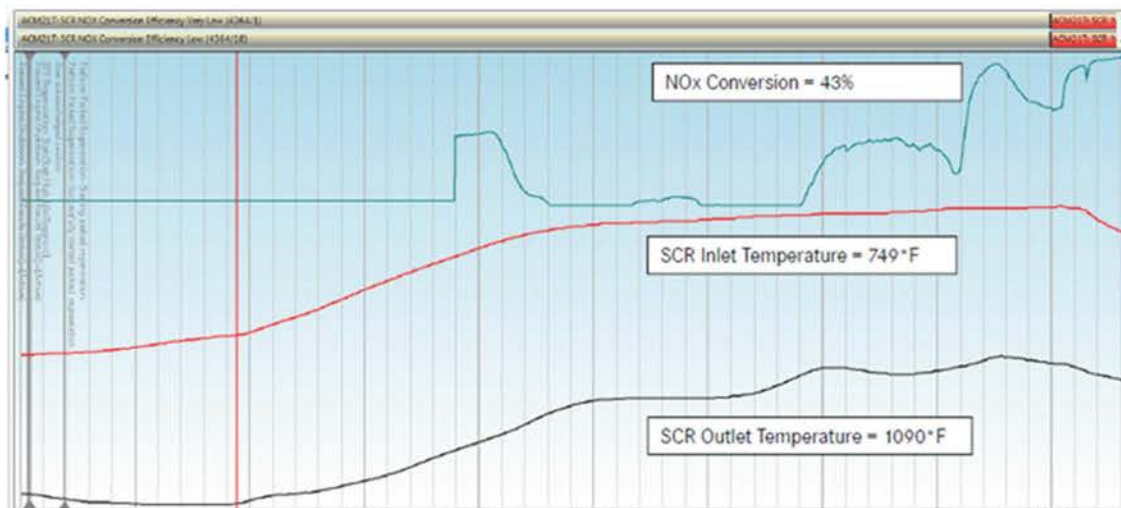
d500302

25. Is the Selective Catalyst Reduction (SCR) inlet temperature lower than SCR outlet temperature by more than 38°C (68.4°F)?

Example: SCR outlet temperature is 588°C (1090°F) - SCR Inlet Temp 398°C (749°F) = 171°C (341°F). Difference between inlet and outlet is 171°C (341°F), which is greater than 38°C (68.4°F)?

- a. Yes; Go to step 27.
 - b. No; for a 1-Box™ system, replace the DOC/SCR module. For a Two-Box system, replace the SCR module. Complete the ATD checklist to identify cause of failure. Go to step 26.
26. Perform a Parked SCR Efficiency Test to clear the regulatory fault. Refer to section "GHG17 Perform Parked SCR Efficiency Test".
27. Review the data from the "Perform the GHG17 Perform Performance Check - Low Temperature ATD" check in step 20. Is the calculated SCR inlet temperature and SCR outlet temperatures sensor readings within 25°C (45°F) at the end of the low temp regen?
- a. Yes; this indicates internal structural damage for a One-Box, replace the DOC/SCR module. The ATD checklist is **NOT** required since the ATD is the primary failed part. This image below illustrates the possible internal damage to the aftertreatment. Go to step 28.
