## **Subject: ParkSmart HVAC Modules**

**Models Affected: Specific Freightliner Cascadia vehicles manufactured March 25, 2014, through November 9, 2015 and equipped with a certain ParkSmart Auxiliary HVAC system.**

June 2016  
FL703A  
NHTSA #16V-143  
Transport Canada #16-113  
REVISED NOTICE

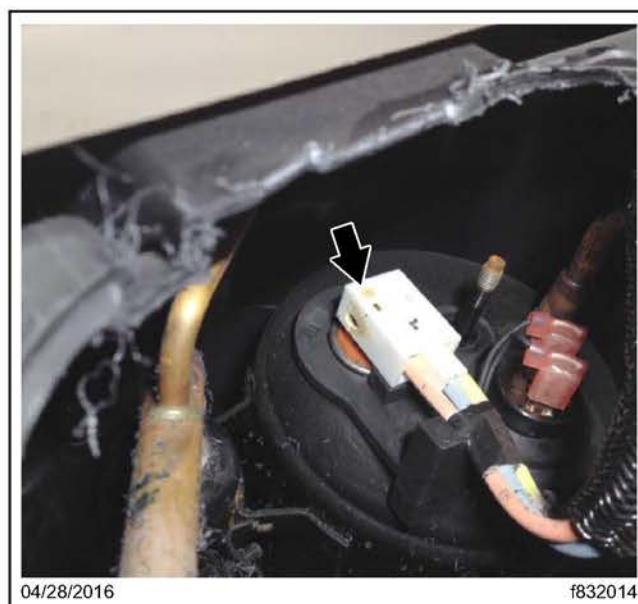
**Fig. 8, Yellow Discoloration and Melting of the Block Connector**

14. Using a mirror as needed, inspect all sides of the block connector for evidence of heat damage such as discoloration and/or melting. See **Fig. 8**.

If the block connector shows evidence of heat damage, go to "Compressor Harness Replacement" on page 12 of these work instructions.

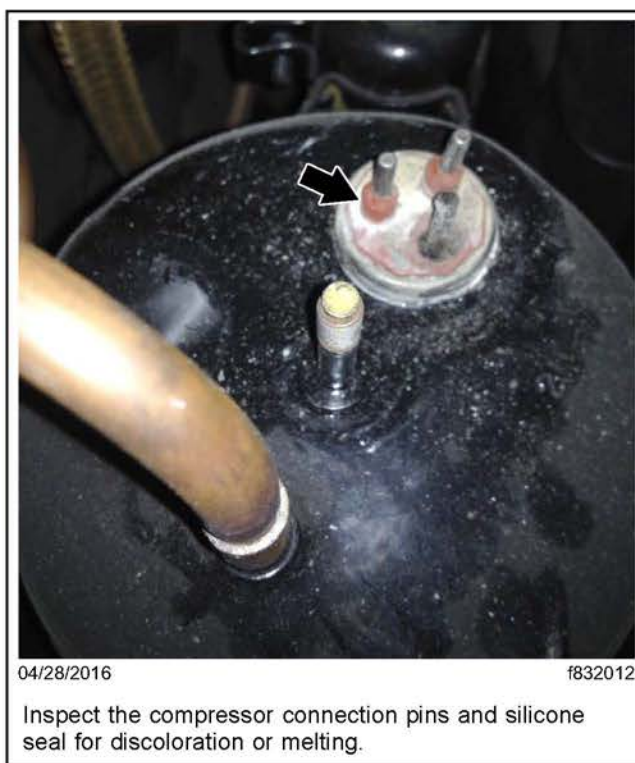
**Fig. 11, Melted Silicone Insulator and Compressor Pin Damage**

3. Disconnect the harness block connector from the compressor.
4. Clean up any debris around the pins, and use alcohol wipes to clean the pins.
5. Inspect the compressor connection pins and surrounding orange silicone insulator. See **Fig. 11**.

If the orange silicone insulator around the compressor connection pins shows evidence of heat damage, go to "Refrigerant Loop Assembly Replacement" on page 16 of these work instructions.
