# Field Service Campaign

July 2016  
SF530A

## Subject: TBB HDX Alternator Belts

**Models Affected: Specific Thomas Built Buses Saf-T-Liner HDX buses manufactured December 7, 2012, through January 18, 2016.**

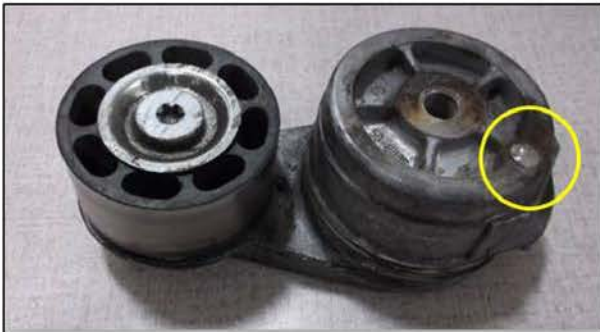
On certain vehicles, the alternator belt and/or tensioner are failing due to the incorrect alternator belt length.

Figure 1: Belt Tensioner Locating Pin Failure

4. Replace the alternator belt with a Cummins 2,290 mm length alternator belt. Cummins Part number 5264521 or approved equivalent.
5. Replace alternator belt tensioner if failed. See Cummins service procedure 008-087 in the ISB6.7 CM2350 B101 Service Manual, Bulletin 2883567.
6. Confirm the belt tensioner is centered between stops. See **Figure 3** and **Figure 4**.

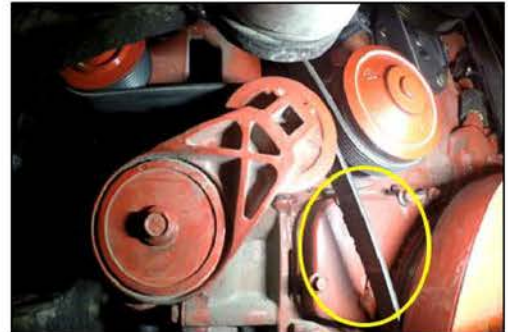
Figure 2: Cooling Fan Belt Shredding

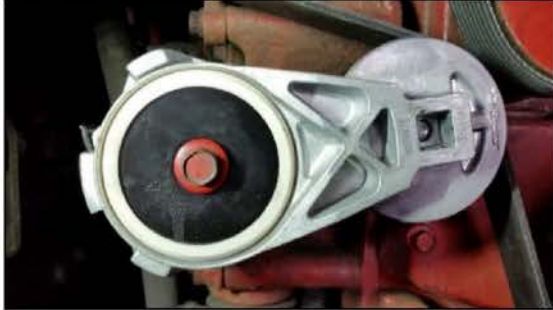
Figure 3: Belt Tensioner Not Centered

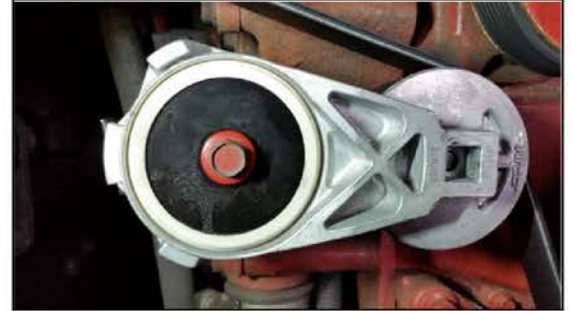
Figure 4: Belt Tensioner Centered
