Dometic Blizzard AC water migration into return air cavity

Blizzard Whisper Quiet Dometic AC units on the Landmark, Big Horn & Big Country Models. It has been determined that there are mounting holes that are not used, These holes will need to be plugged to prevent condensation or water from entering the AC ducting on the interior of the RV. Additional holes will also need to be added to the pan to allow all the water to drain from the pan.

5SFBG4325GE [REDACTED] to 5SFBG3428HE [REDACTED]

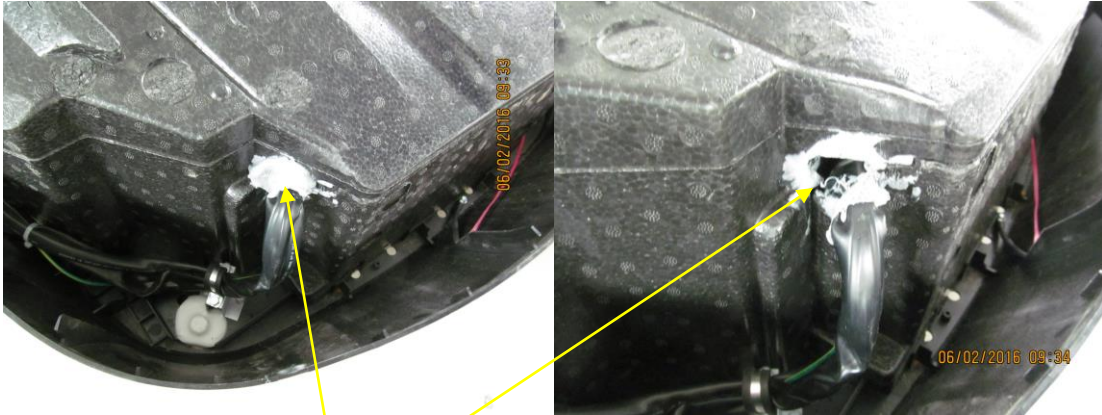
Electrical connection before and after.

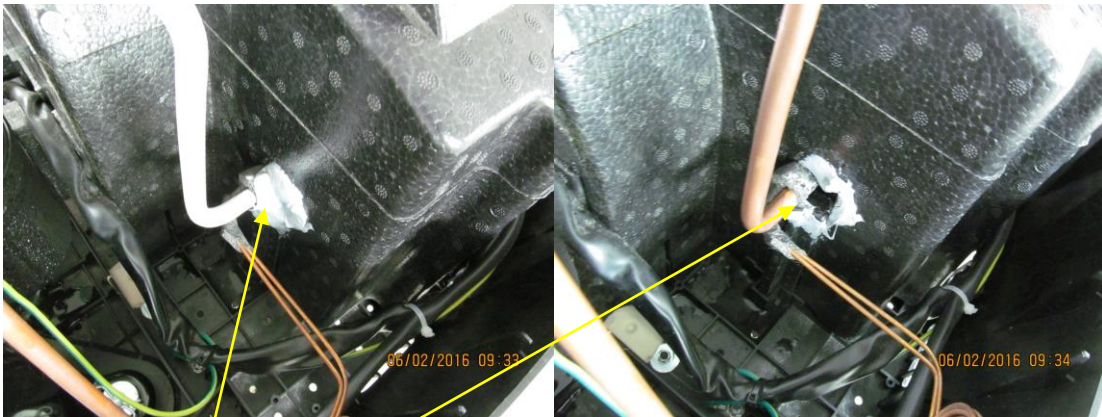
Freon tube before and after.
