TECHNICAL BULLETIN  
K391 UPS3316-2bNAS1  
21 JUN 2016

Update Prior to Sale: Panoramic Roof Mechanical Arm Inserts Missing

**XJ Range (X351)**

**Situation:** An issue has been identified on a limited number of vehicles within the listed Affected Vehicle Range where creaking noises from the panoramic roof, with the moving panel in the closed position, may be evident during torsional inputs to the vehicle.

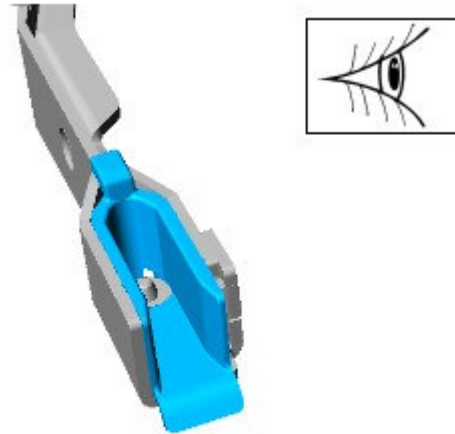
E192104

1. With the roof opening panel in the fully tilt position, check if the rear left-hand and right-hand mechanism inserts are installed.

- If both rear left-hand and right-hand mechanism inserts are installed, no further action is required.
- If one or both rear mechanism inserts are missing, continue to the next Step.
